## **A-JACKS AND AQUAWRAP INSTALLATIONS IN UTAH**

**SCOUR REVETMENT  
PERFORMANCE  
EVALUATION**

**Experimental Feature Final Report**

**December 2009**

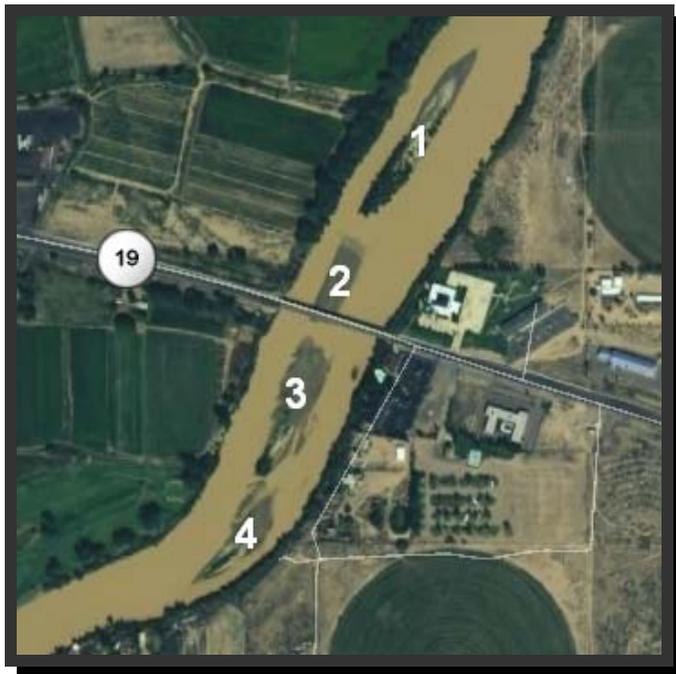
Over time, the scour along the west abutment continued to develop. The aggradation near the center of the channel caused the flow through the span to hit the Piers at an angle, increasing scour. The aggradation also caused two sand bars to develop containing moderate to heavy vegetation.

Figure 2: SR-19 Green River Sand Bars, Google Image 2006

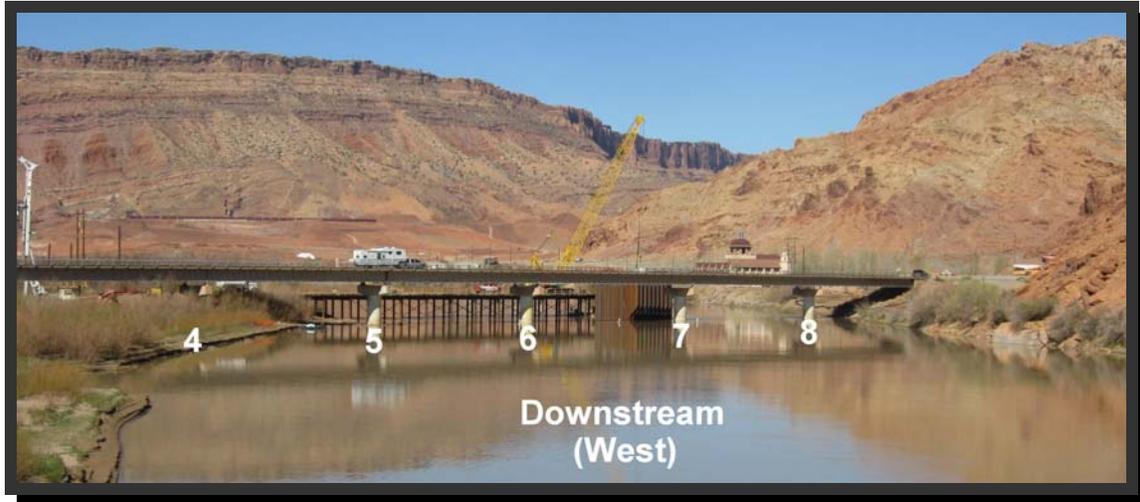
Figure 5: US 191 Colorado River Bridge during construction, April 2009. Notice the dramatic changes in the river bed width from the time of the original bridge construction up until now.

The underwater inspection did reveal increased localized and general scour. The northern side of the channel bottom exhibited as much as 5 ft of degradation. In the northern quarter of the waterway, 100 ft upstream of the bridge, the channel had deepened approximately 3 ft. Similarly, 100 ft downstream of the bridge, the river had carved out an additional 4 ft. The channel bottom is comprised of rocks and boulders, making it difficult to define localized scour swales at the Piers. However, the size of the undermined area at Pier 6 was conclusively larger than what was measured at the previous underwater inspection.

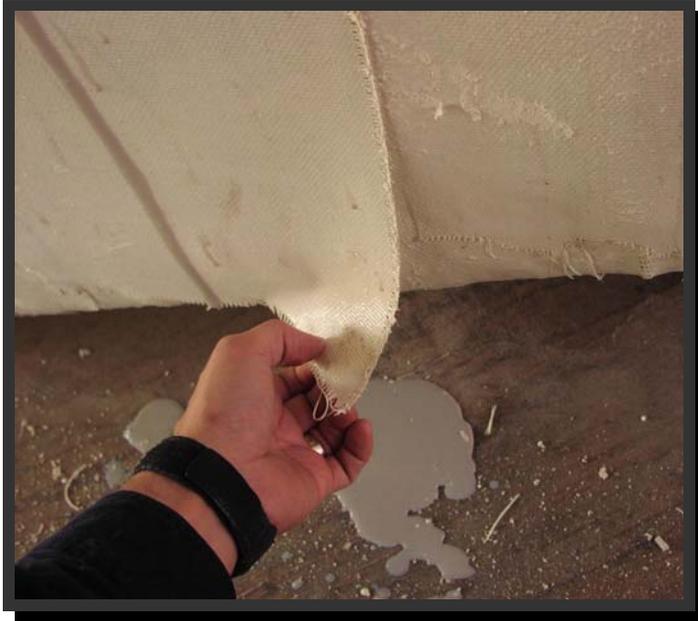
Figure 29: Close-up view of Aquawrap not sticking to the surface below, 2003

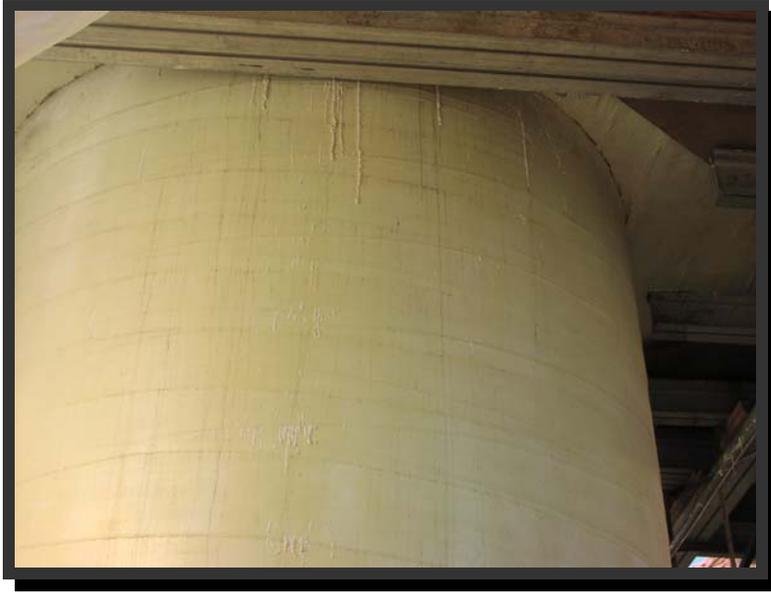
Figure 31: Aquawrap oozeage, 2003

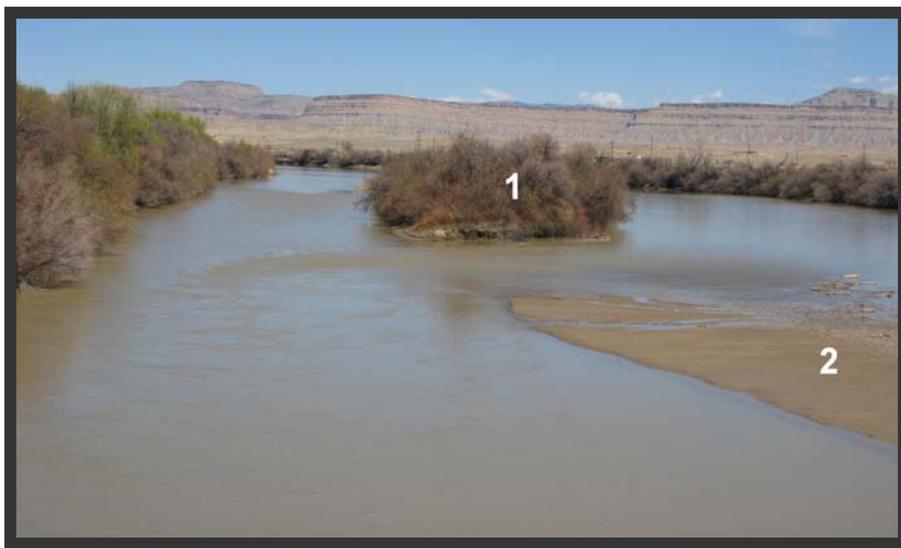
Representatives from UDOT Research, Hydraulics and Structures conducted an additional site survey in April 2009. The sand bars at the Green River Bridge have been significantly reduced since the installation of the A-Jacks, especially upstream of the bridge.

Figure 36: Green River Bridge sand bars looking upstream (North)

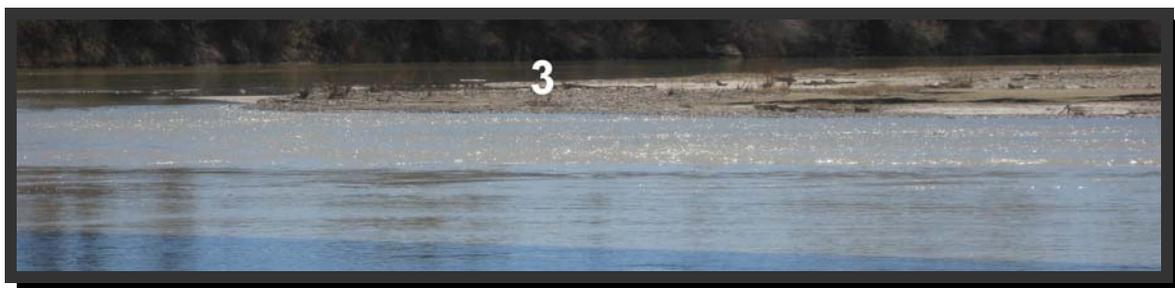
As the river merges together downstream of the bridge, there is a noticeable elevation change between the east and west channels.

Figure 38: Green River Bridge elevation change from the East channel to the West channel (Pre)

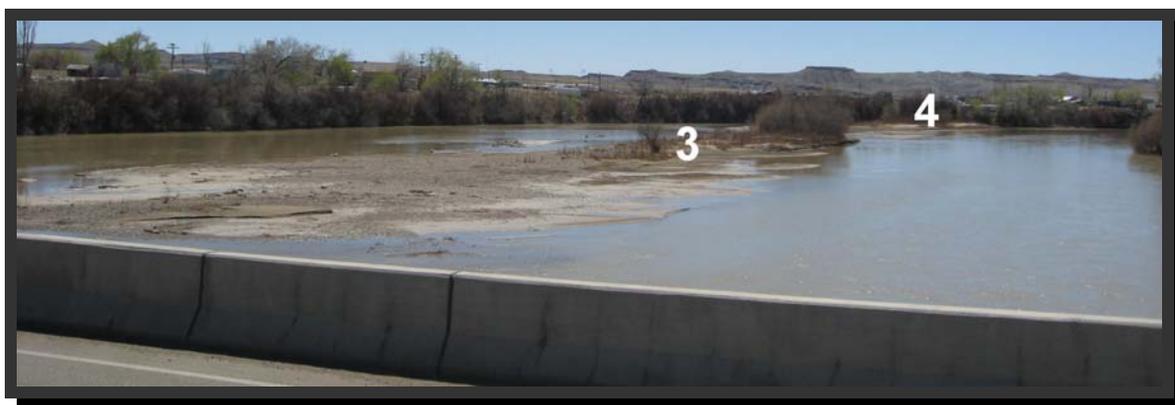
The downstream islands have not been affected nearly as much as the upstream islands. However, as the river erodes away islands 1 and 2, the river will have a greater access to wear down islands 3 and 4. See Figure 2 for the island locations.

Figure 39: Green River Bridge Sand Bars looking South (Pre-installation)

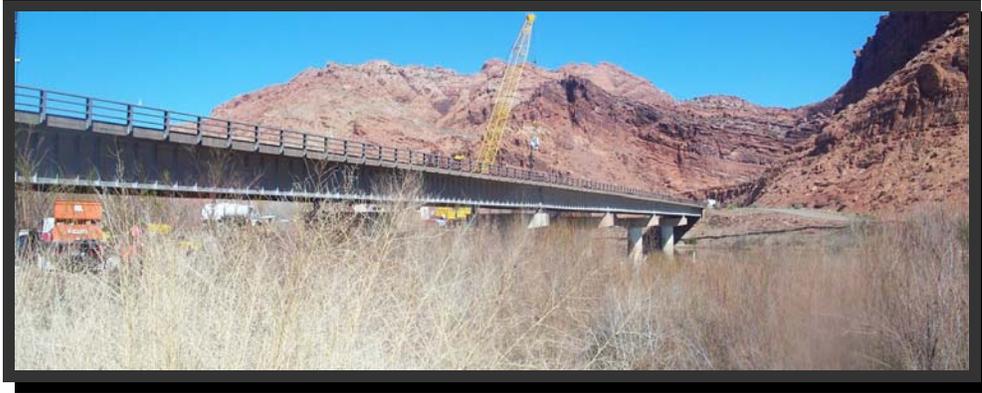
Representatives from UDOT Research, Hydraulics and Structures conducted an additional site survey of the Colorado River Bridge site in April 2009. The tamarisk now occupies most of the south bank.

Figure 40: Colorado River Bridge and Tamarisk, 2009

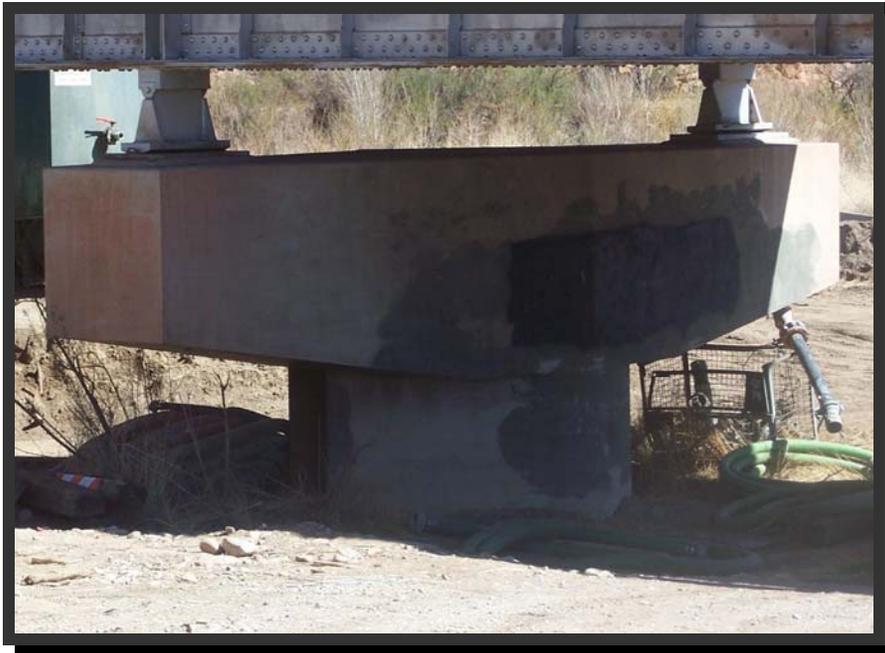
The once developing sand bar on the south end of the bridge has now become the newly defined river bank, nearly covering Piers 1 through 4.

Figure 41: Pier 4 on the Colorado River Bridge, 2009

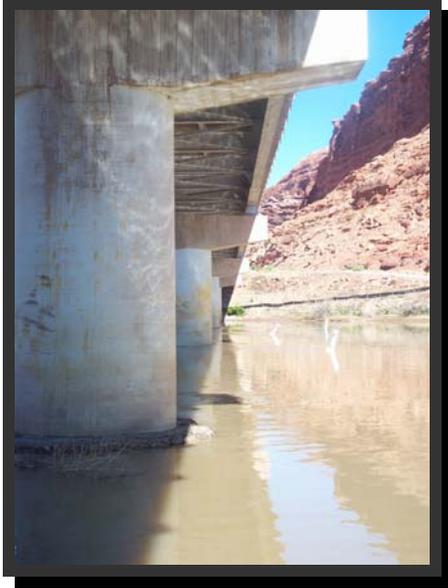
The Aquawrap on Piers 5 through 8 is still in good condition. The following pictures were taken before peak runoff season.

Figure 42: Colorado River Bridge Piers 5-8, 2009

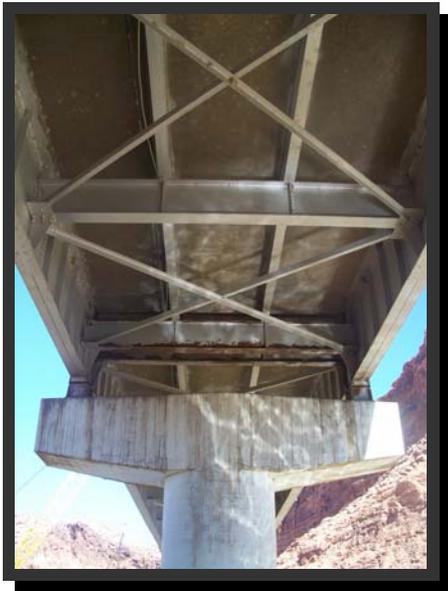
Figure 43: Colorado River Bridge Bent 5, 2009
