Report No. UT-10.05

FAILURE OF SURFACE COURSES BENEATH PAVEMENT MARKINGS

Utah Department of Transportation
Research Division

University of Utah
Department of Civil and Environmental
Engineering

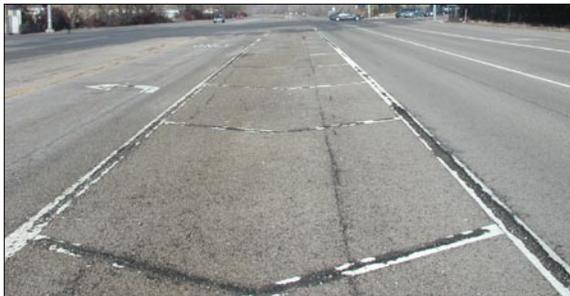
a) Damage observed on the lane markings

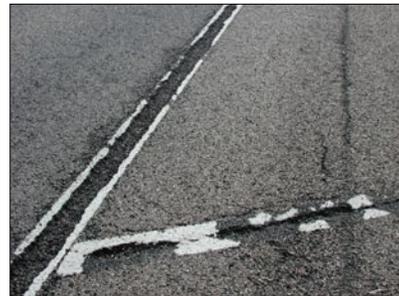
b) Close up of damage

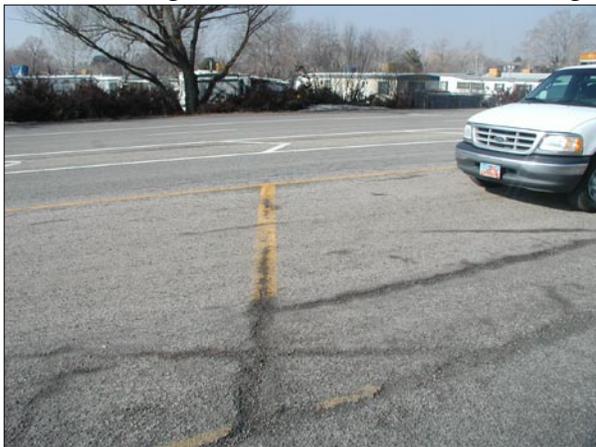
c) Distresses shown almost exclusively along the marking

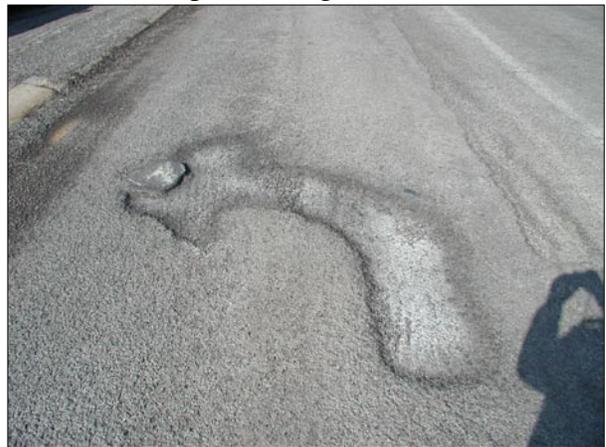
d) Damage not limited to stripes.

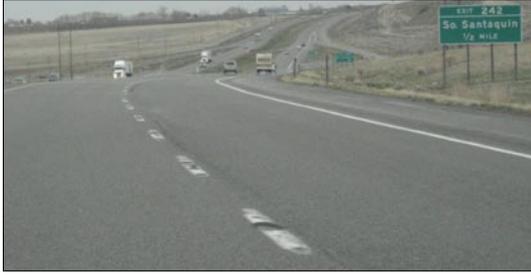
a) Damage shown on the lane markings

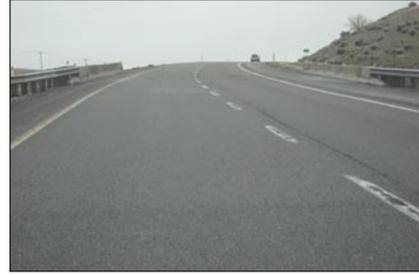
b) Distress shown almost exclusively on the markings

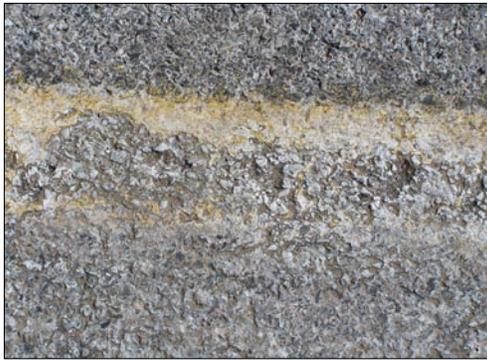
c) Close up of damage

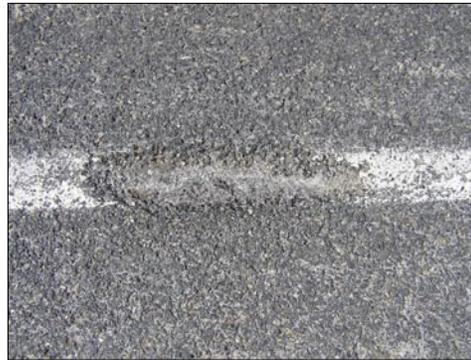
d) Close up of damage

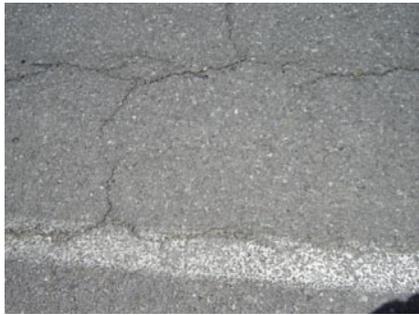
SR 36 is the Main Street in Tooele. It was observed that the majority of the damage is due to moderate to severe transverse cracking. The transverse cracking is not isolated to the paint marking areas as it extends the entire width of the road. On the northbound lane there is longitudinal cracking considered severe in some areas. Most of the cracks are located along the white marking separating the road from the shoulder. In general the paint markings are worn and faded.

(a) longitudinal and transverse cracking

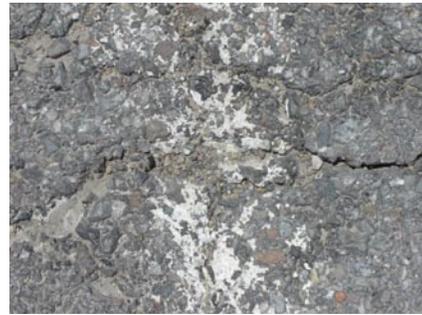
(b) faded paint markings along with surface deterioration

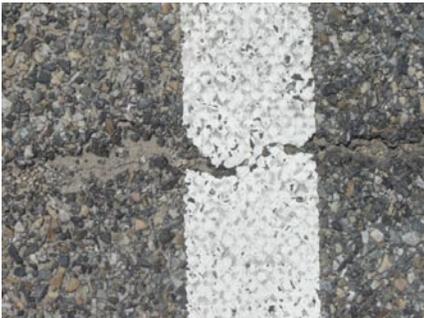
(c) transverse crack extending through the paint marking

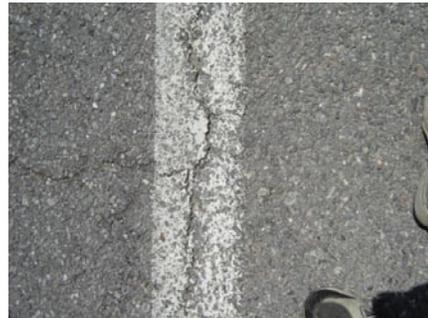
(d) longitudinal cracking along the paint marking on the northbound lane

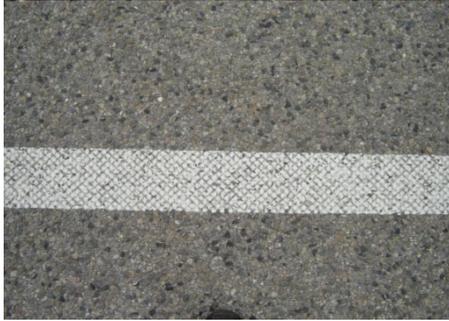
(a) fairly new surface and markings

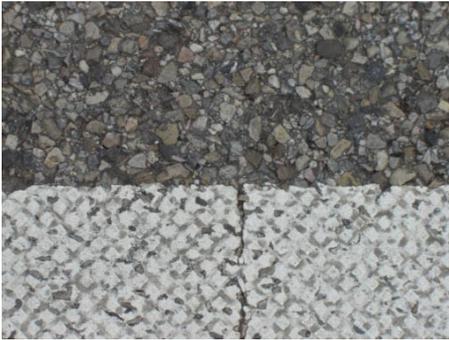
(c) transverse crack extending through the paint marking (WB Lane)

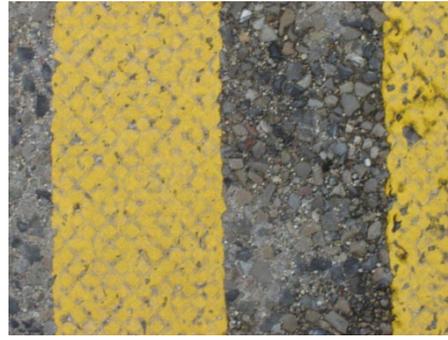
(d) center marking showing some joint deterioration.

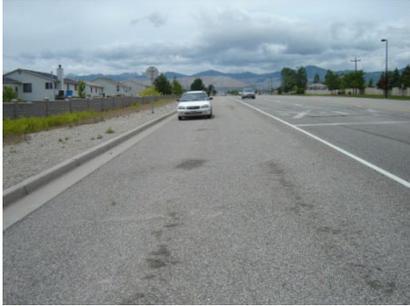
(a) raveling observed on the shoulder. Note old markings on the road.

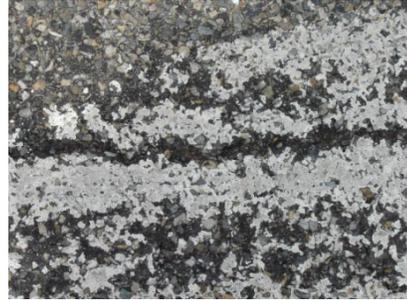
(b) raveling in area near the old paint marking

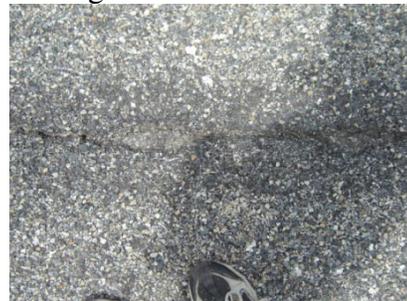
(d) Transverse crack

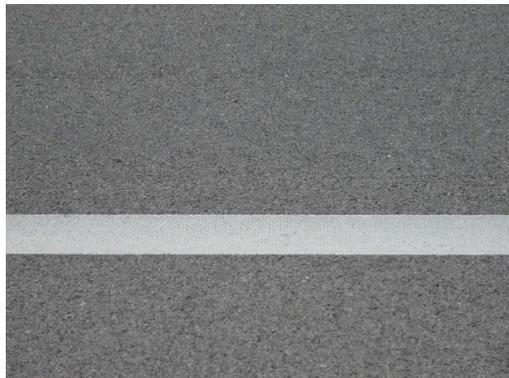
(a) No sign of distress observed

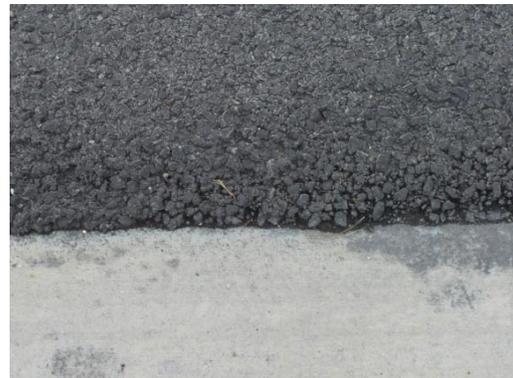
(b) New surface appears to be in good shape

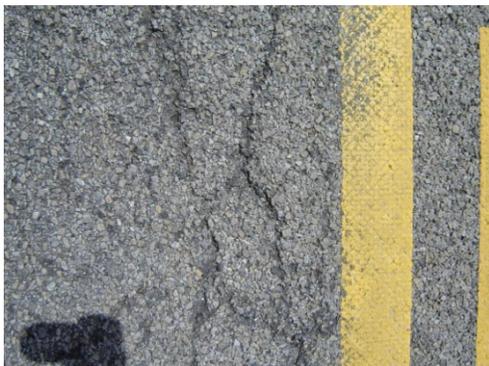
(a) Longitudinal cracking along the middle of the road

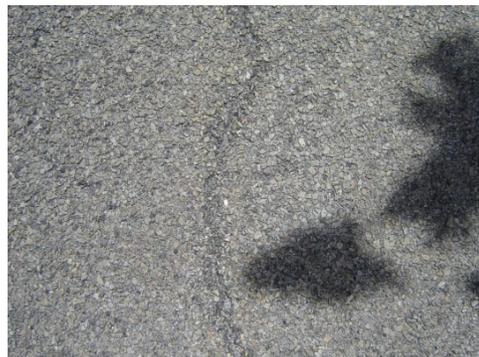
(b) Typical longitudinal crack with minor raveling

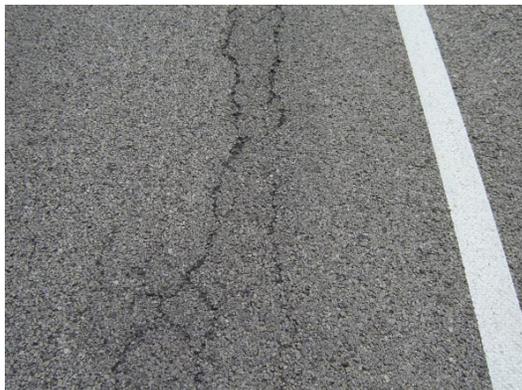
(c) Longitudinal and possibly fatigue cracks along the wheelpath

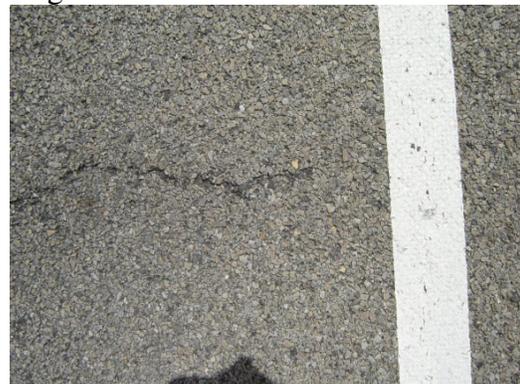
(d) Transverse crack showing the paint stripe being in good shape.

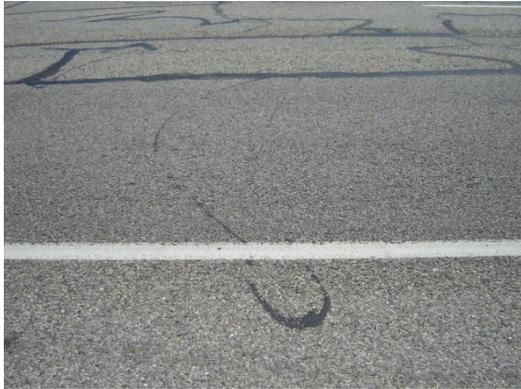
(a) Cracking and sealing along the construction joint

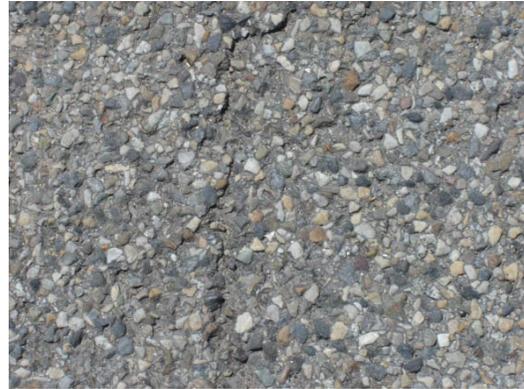
(b) Longitudinal crack showing signs of raveling

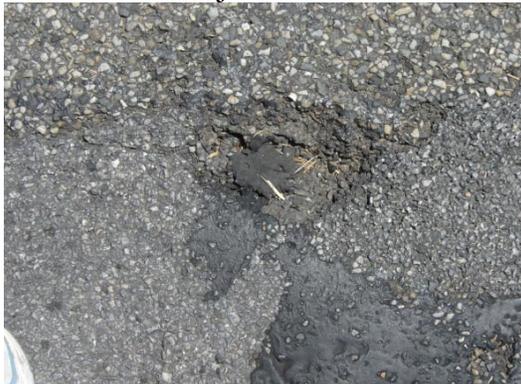
(c) Initiation of a pothole

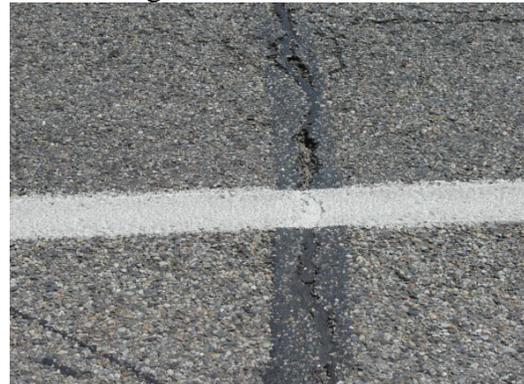
(d) Transverse crack

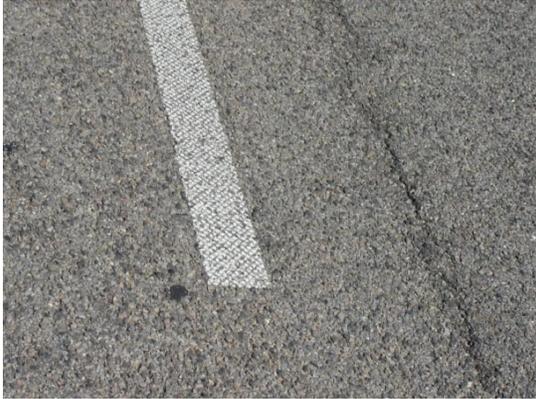
(a) Severe longitudinal crack at the joint

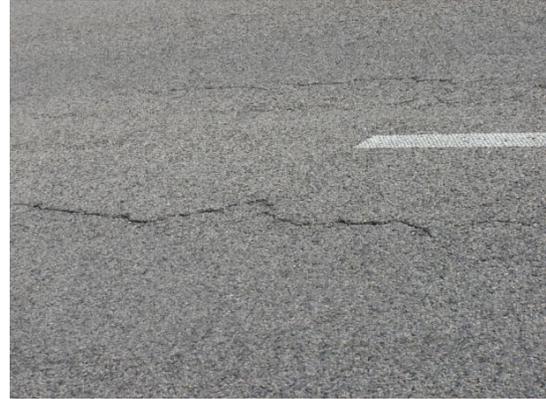
(b) Fatigue cracking observed on the wheelpath

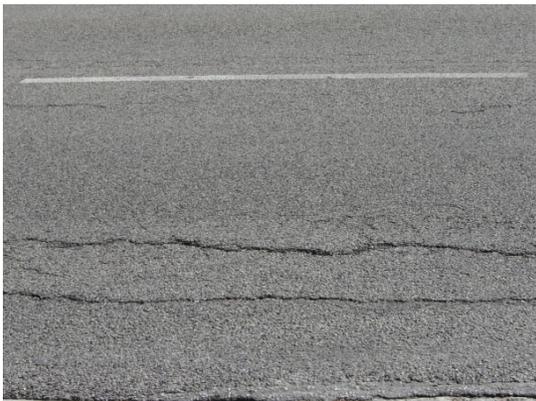
(c) Combination of longitudinal and transverse cracking.

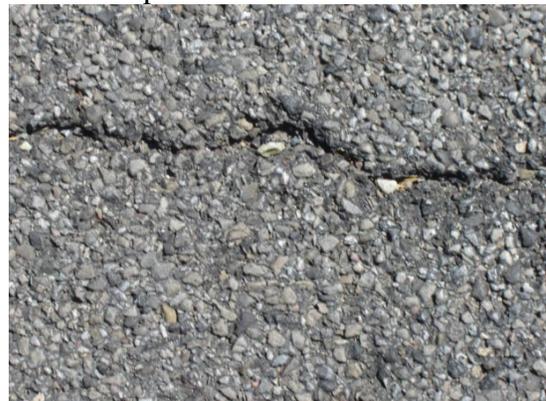
(d) Transverse crack seen at regular intervals

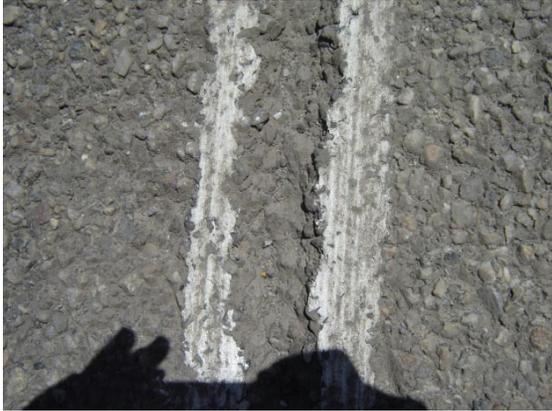
(a) Significant raveling is observed underneath the paint marking

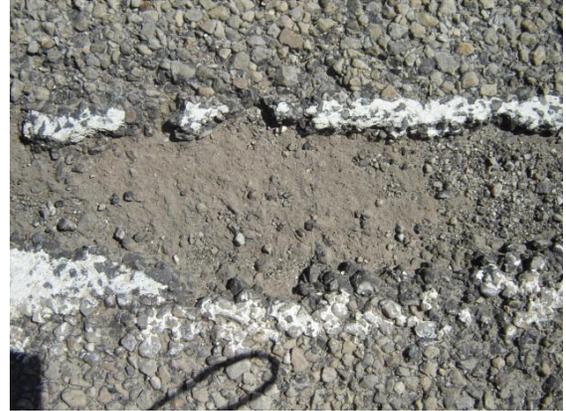
(b) Area where the raveling has led to a large pothole

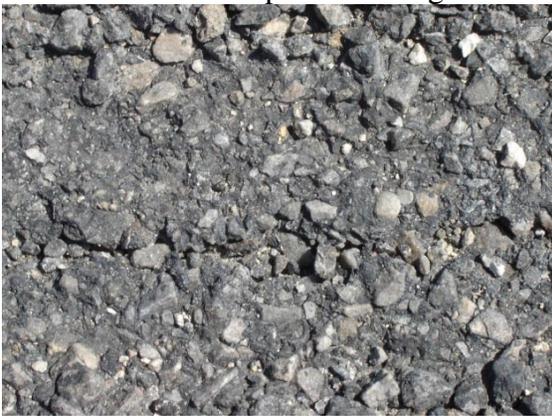
(c) Longitudinal crack

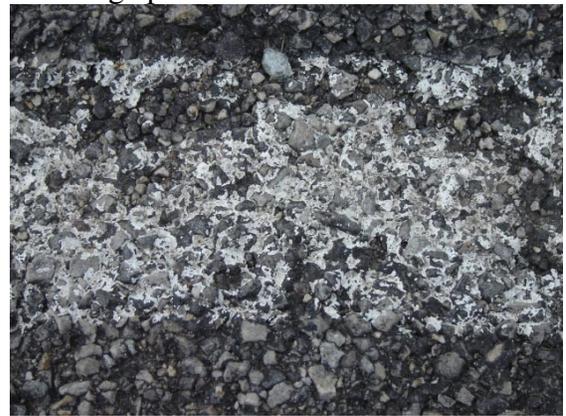
(d) Deterioration underneath the paint marking

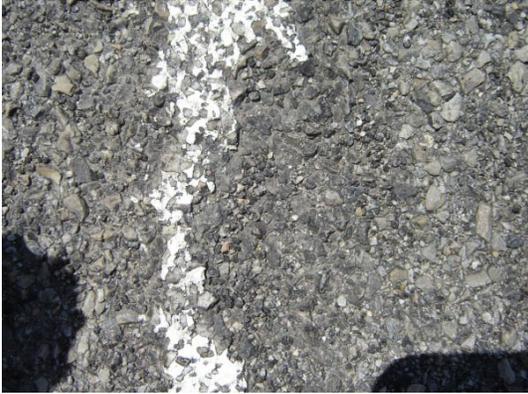
(a) Severe raveling appears along the paint marking

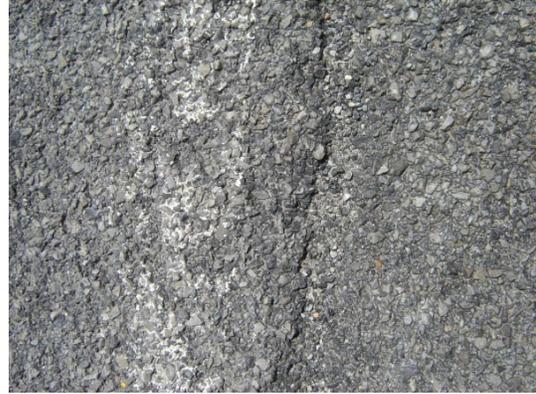
(b) Longitudinal cracking along a worn out paint marking

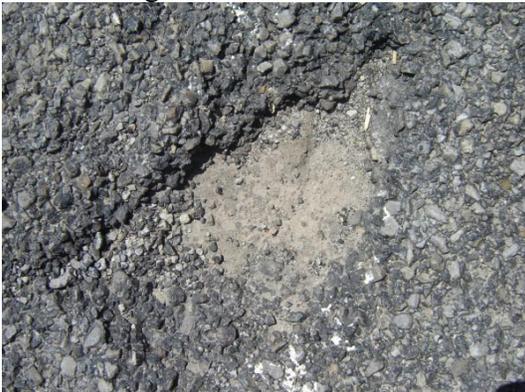
(c) Pothole resulting from the raveling also along the paint marking

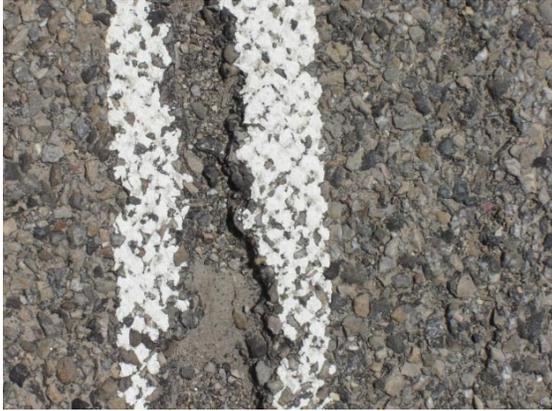
(a) Longitudinal crack and raveling observed along the paint marking

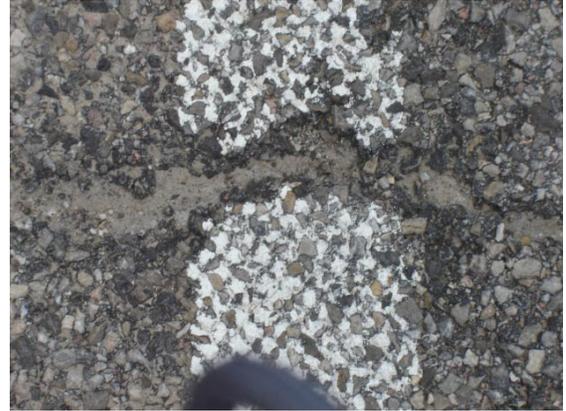
(b) Transverse crack along with worn out paint stripe

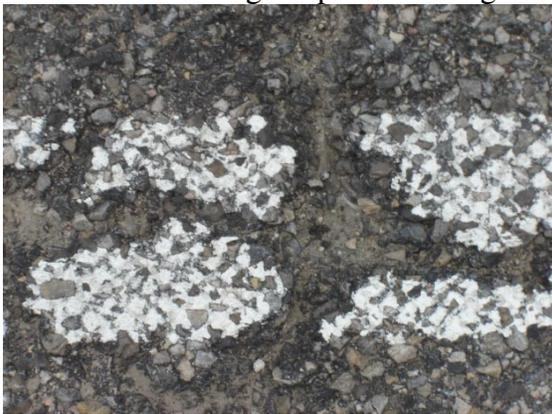
(c) Severe raveling and cracking observed along the paint marking

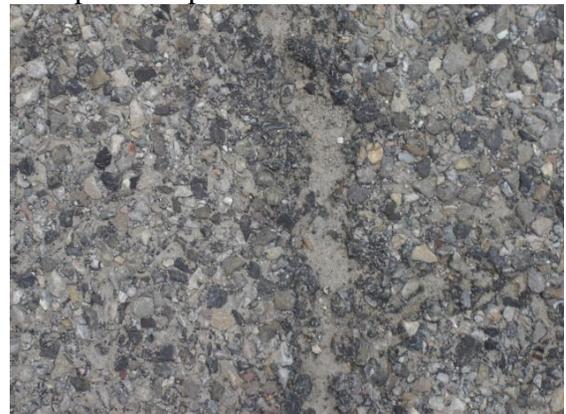
(d) Longitudinal crack along a construction joint

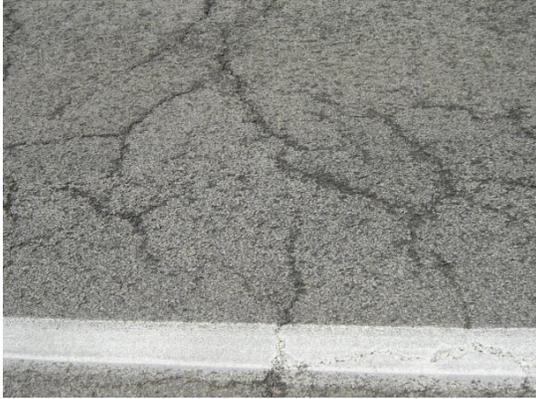
(a) Moderate fatigue cracking

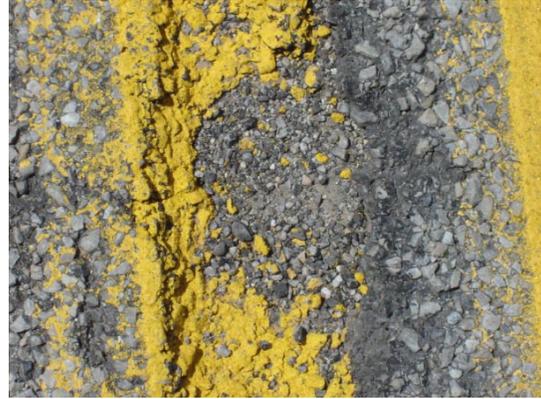
(b) Raveling underneath the paint marking.
Note presence of old marking

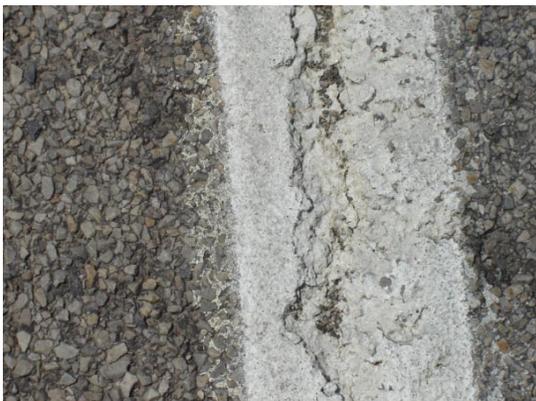
(c) Longitudinal crack along the paint stripe

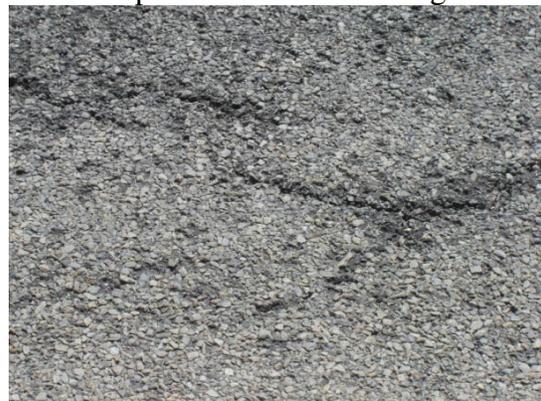
(d) Raveling
