UTAH DEPARTMENT OF TRANSPORTATION SALT LAKE CITY, UTAH STRUCTURES DIVISION			
SR-163 AT MEXICAN HAT SAN JUAN RIVER BRIDGE REPAIR DETAIL			
DESIGN	ABBY 3-88	CHECK	
DRAWN	M.U.S. 3-88	CHECK	R.L.R. 3-88
QUANT.	R.L.R. 3-88	CHECK	ABBY 3-88
APPROVAL	4/12/88	DATE	
RECOMM.		DATE	
PROJECT NUMBER			25+42.1
DRG. NO.			C-274 RI
SHT. 1 OF 1

Special Attention Items:	Notes:
Other	Bridge is on a 6-month special inspection cycle due to superstructure NBI rating of 4 and also containing fracture critical members. A defect plan was created from the defects found at the previous special inspection. Tables showing defects by element were also created. Verify the defects indicated on the plan and tables. Mark the end of the cracks with a sharpie pen and/or a steel punch and indicate the date with a sharpie pen. UDOT materials will be on-site to provide NDT of the known cracks to check for crack propagation. If time permits, check stringer to floor beam connections for cracks using mag-particle testing. For purposes of orientation, proper picture labeling and defect locating, label each floor beam in accordance with the naming shown on the defect plan. Consider also labeling the east and west ends of eac

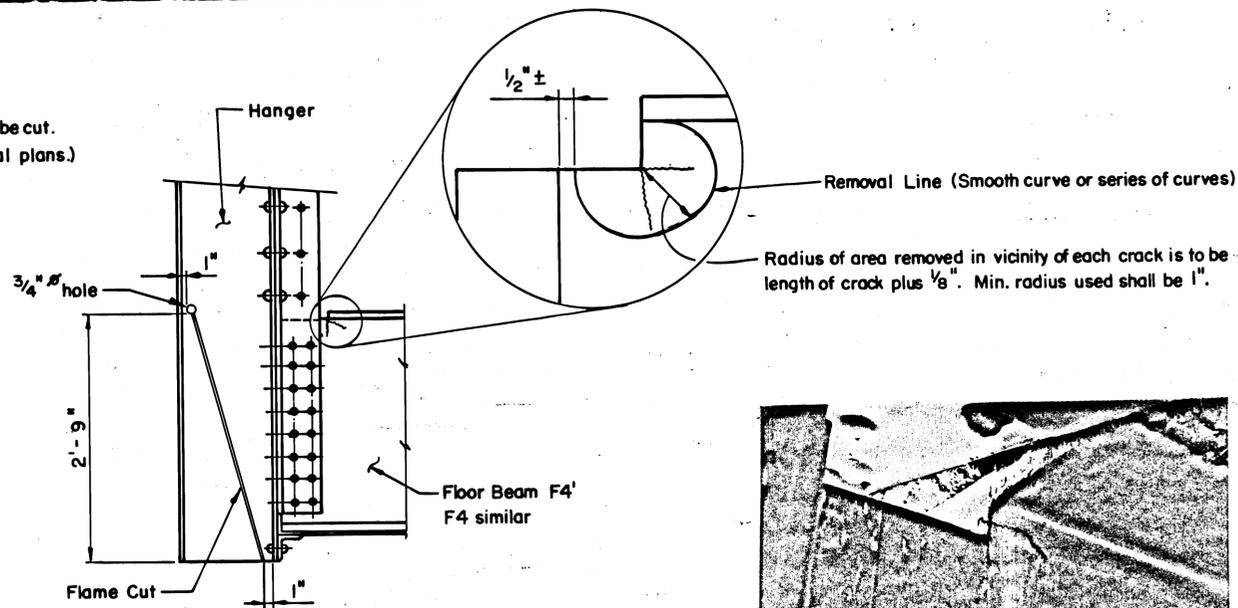
HANGER & BEAM REPAIR DETAIL

Note:
10 Hangers at Bents 3,4 and 5 to be cut.
(See sheets 2, 14 and 16 of original plans.)

- 1.- Contractor shall locate the tip of the cracks using nondestructive testing. (E.g. Dye penetrant, ultrasonic testing)
- 2.- The tip of the crack and area to be removed shall be verified by the UDOT Inspector.
- 3.- Remove area of cracking by flame cutting. This is to be done in such a manner that circular surface results.
- 4.- Flame cut surface is to be ground to a smooth surface
- 5.- After all grinding of the new surface is complete, that surface plus the adjacent original surface shall again be checked for cracks by Non-Destructive testing methods.
- 6.- If additional cracking is found by the Non-Destructive testing indicated in note # 5 additional material shall be removed and the surfaces again ground smooth.
- 7.- If cracking is found in areas other than those indicated by the plans, the Engineer shall determine further action.

- 1.- Hangers shall be cut through the web as shown.
- 2.- Flame cutting must be mechanized so that cuts will be straight and smooth.
- 3.- A 3/4" hole shall be drilled at the end of the cut before starting the flame cut. All surfaces of the hole must be smooth after completion of flame cutting.

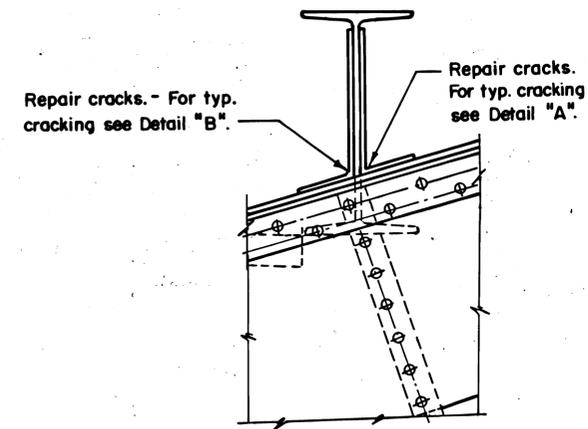
GUSSET PLATE REPAIR DETAIL

Note:
8 Plates at Bents 2 to be repaired.
(See sheets 2 and 14 of original plans.)

- 1.- Contractor shall locate tip of cracks using non-destructive testing procedures
- 2.- Cracks in the Gusset Plates shall be removed by hand grinding.
- 3.- Careful consideration must be given in not to damage web plate of the floor beam or flange of the arch girder while grinding.
- 4.- Ground-out area shall be inspected by Non-Destructive testing to insure that all of the crack has been removed.
- 5.- Excavated area shall be filled with a full penetration weld and the surface ground flush with surrounding surfaces.

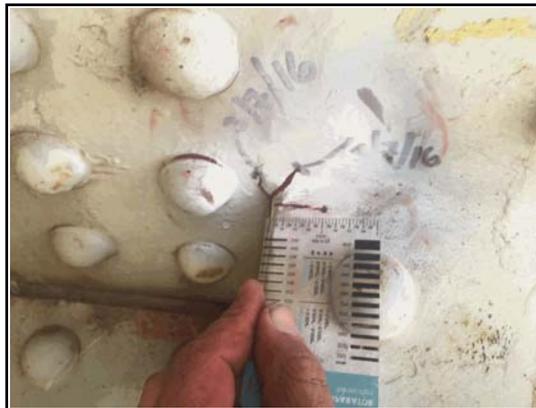
arch1-fb2n n_cxn plate

FB2N: on the east side there is a crack in the floorbeam to arch connection plate. On the west side there are two cracks in the floorbeam to arch connection plate (0.75in long 0.013in wide on the "up -hill" side of the arch, 0.5 in long 0.023 in wide on the "down-hill" side of the arch)

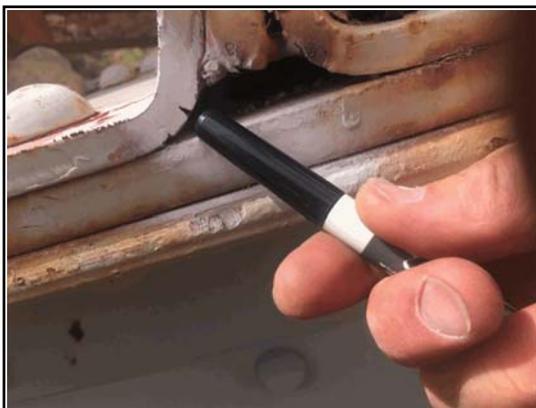
arch2-fb2s cxn plate tear

FB2S: The floorbeam to arch connection plates are cracking. There are four cracks in the connection plate on the east side, and five cracks in the plate on the west side.

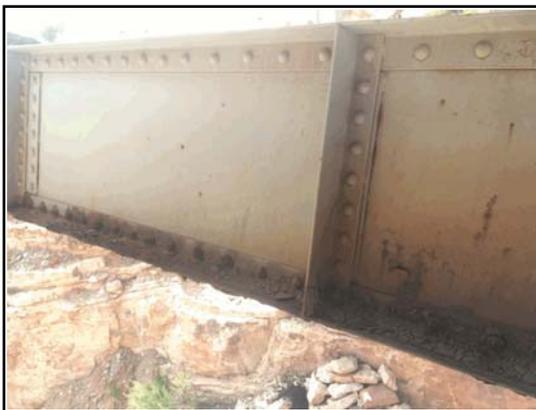
bracing under fb1s

Lateral bracing below FB1S has pack rust and section loss all along the bottom flange portion of the element. The section loss is most pronounced along the middle portion of the bracing (see photos).

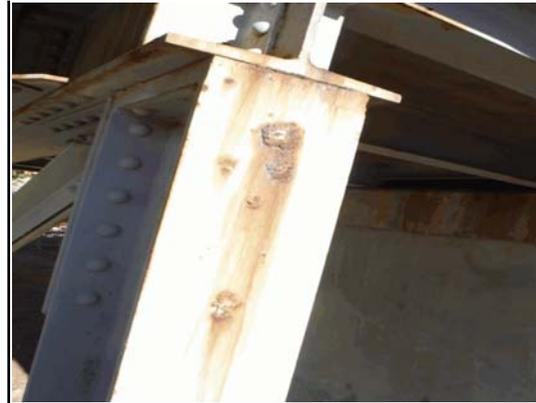
fb1n column2 rust bubbles

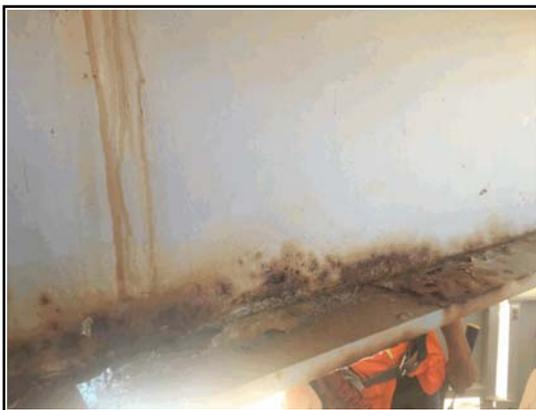
stringer1 @ fb2n-3n north side

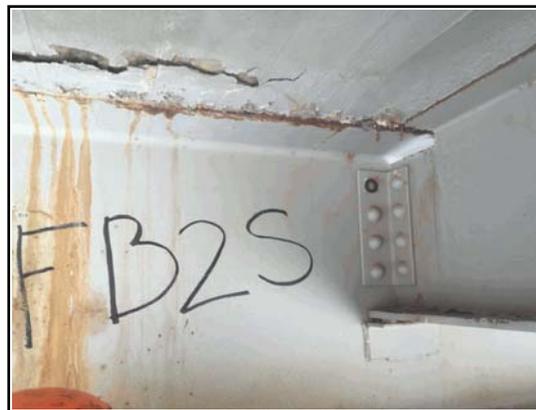
stringer3 @ fb2s msg rivet

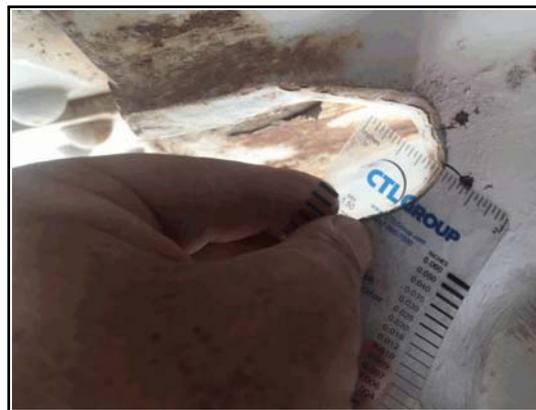
fb3s at west side

FB3S: on the east side there are "delamination" cracks in the floorbeam coping.

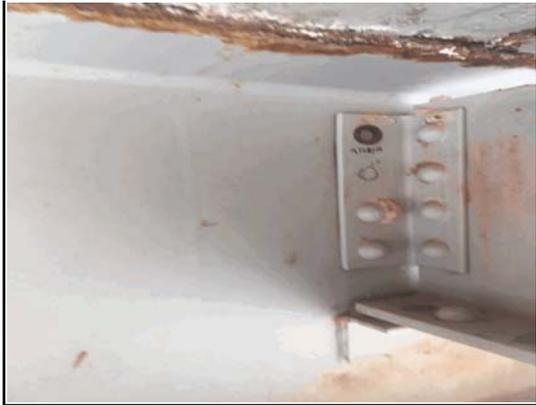
stringer2 at fb3s-4s msg rivet

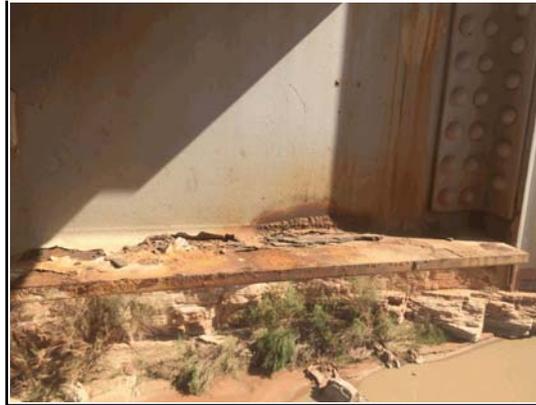
fb4n east side

FB4N: on the east and west sides there are "delamination" cracks in the floorbeam coping. On the east side of the floorbeam there is approx. 0.125 inches of section loss on the bottom flange of the floorbeam for a length of two feet.

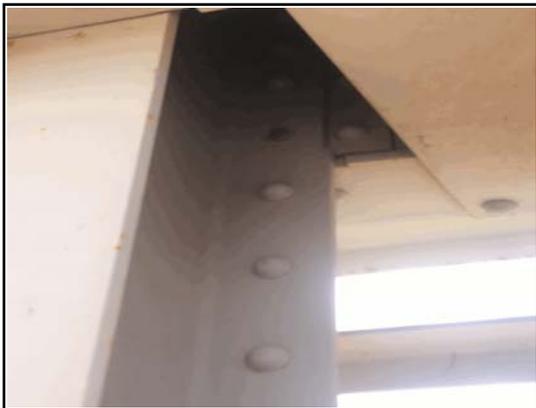
fb4s column 1 msg rivet

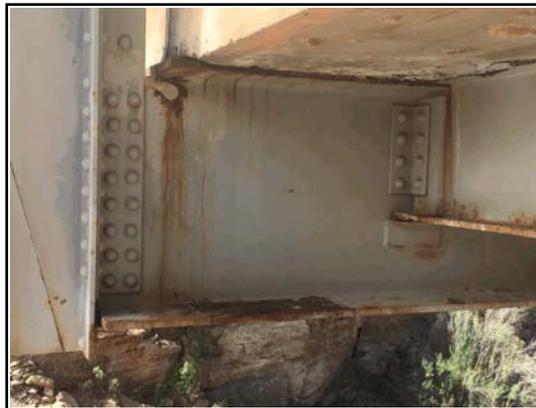
fb5 east side

FB5: on the east and west sides there are "delamination" cracks in the floorbeam coping. On the west side there is a crack in the weld at the floorbeam to column bracket (2.75 in long 0.036 in wide).

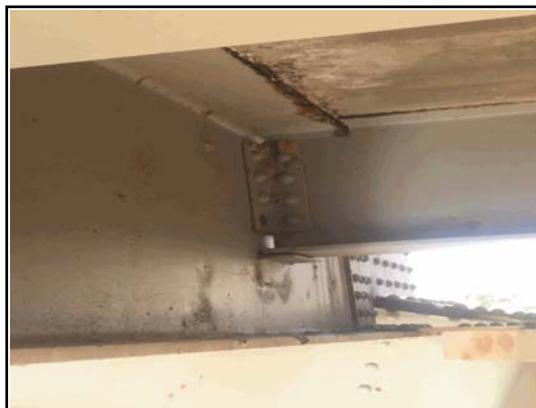
stringer1 @ fb2n msg rivet

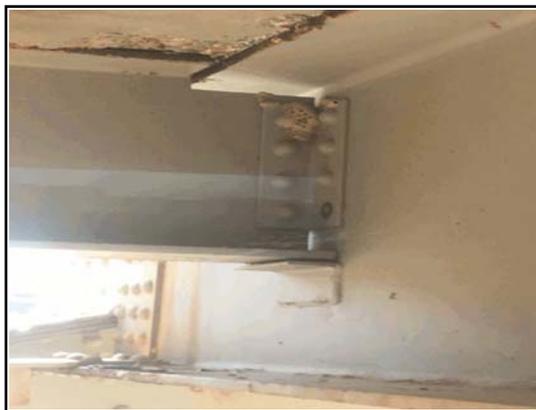
stringer4 @ fb2n msg rivet

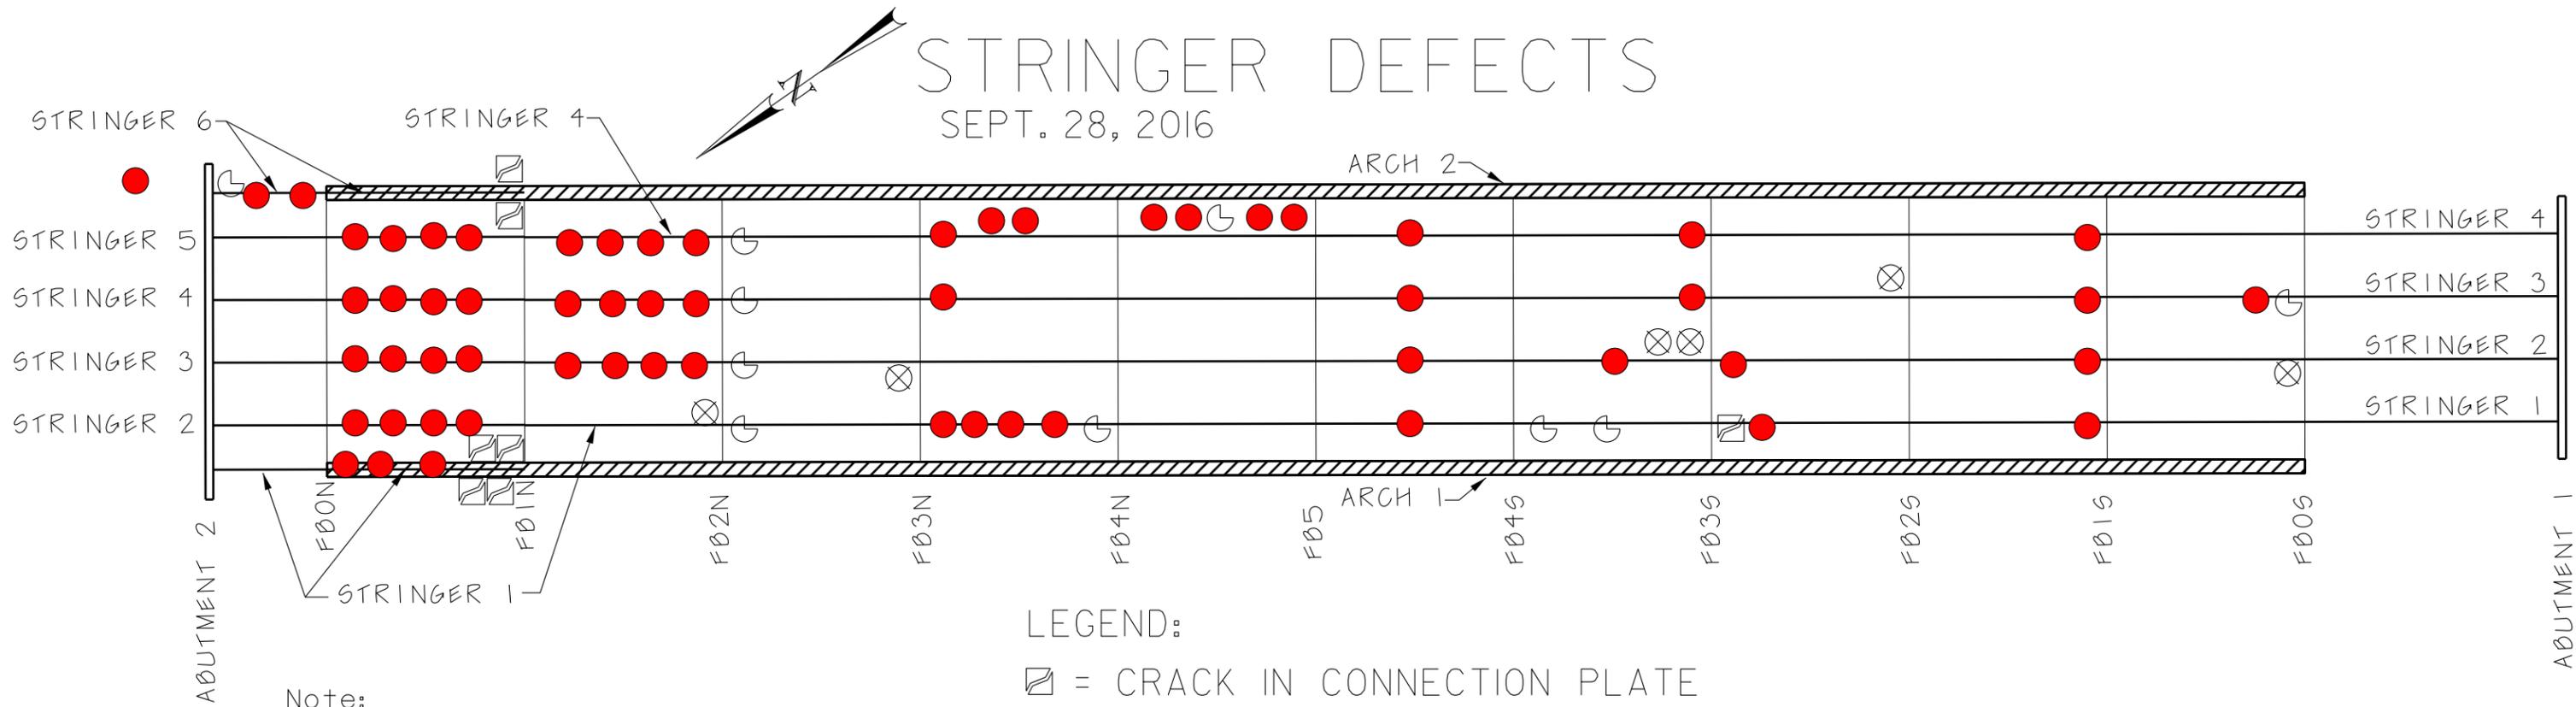
STRINGER DEFECTS

09/28/2016 Travis Jones See attached defects tables and figure of stringer defects. Six rivets were found to be missing from stringer connections. Several looked to be recent losses as the newly exposed surface was not yet rusted. Quantities of condition states are shown in the attached table of defects. Total defect quantities are as follows:
CS2 = 337 feet
CS3 = 37 feet

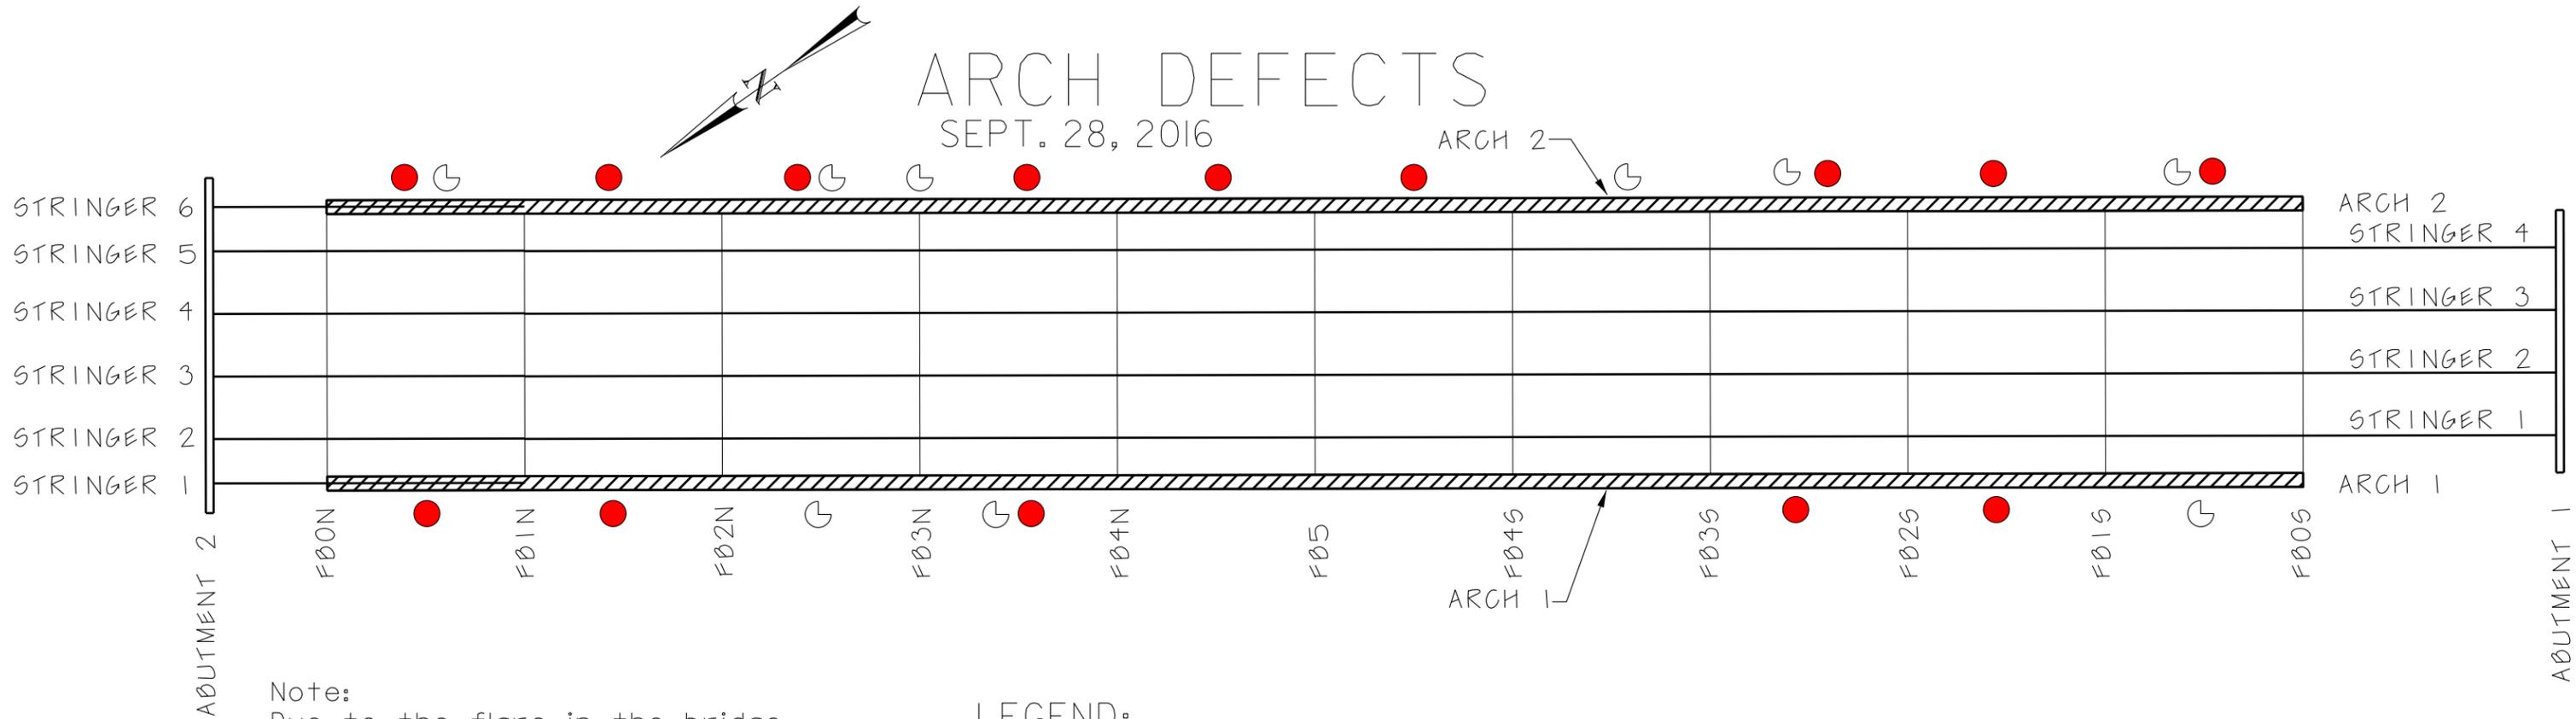
ARCH DEFECTS

09/28/2016 Travis Jones See attached defects tables and figure of arch defects.
Arch has localized areas beginning to show section loss/rust bubbling.
Quantities of condition states are shown in the attached table of defects. Total condition state quantities are CS2=272 feet and CS3=35 feet.

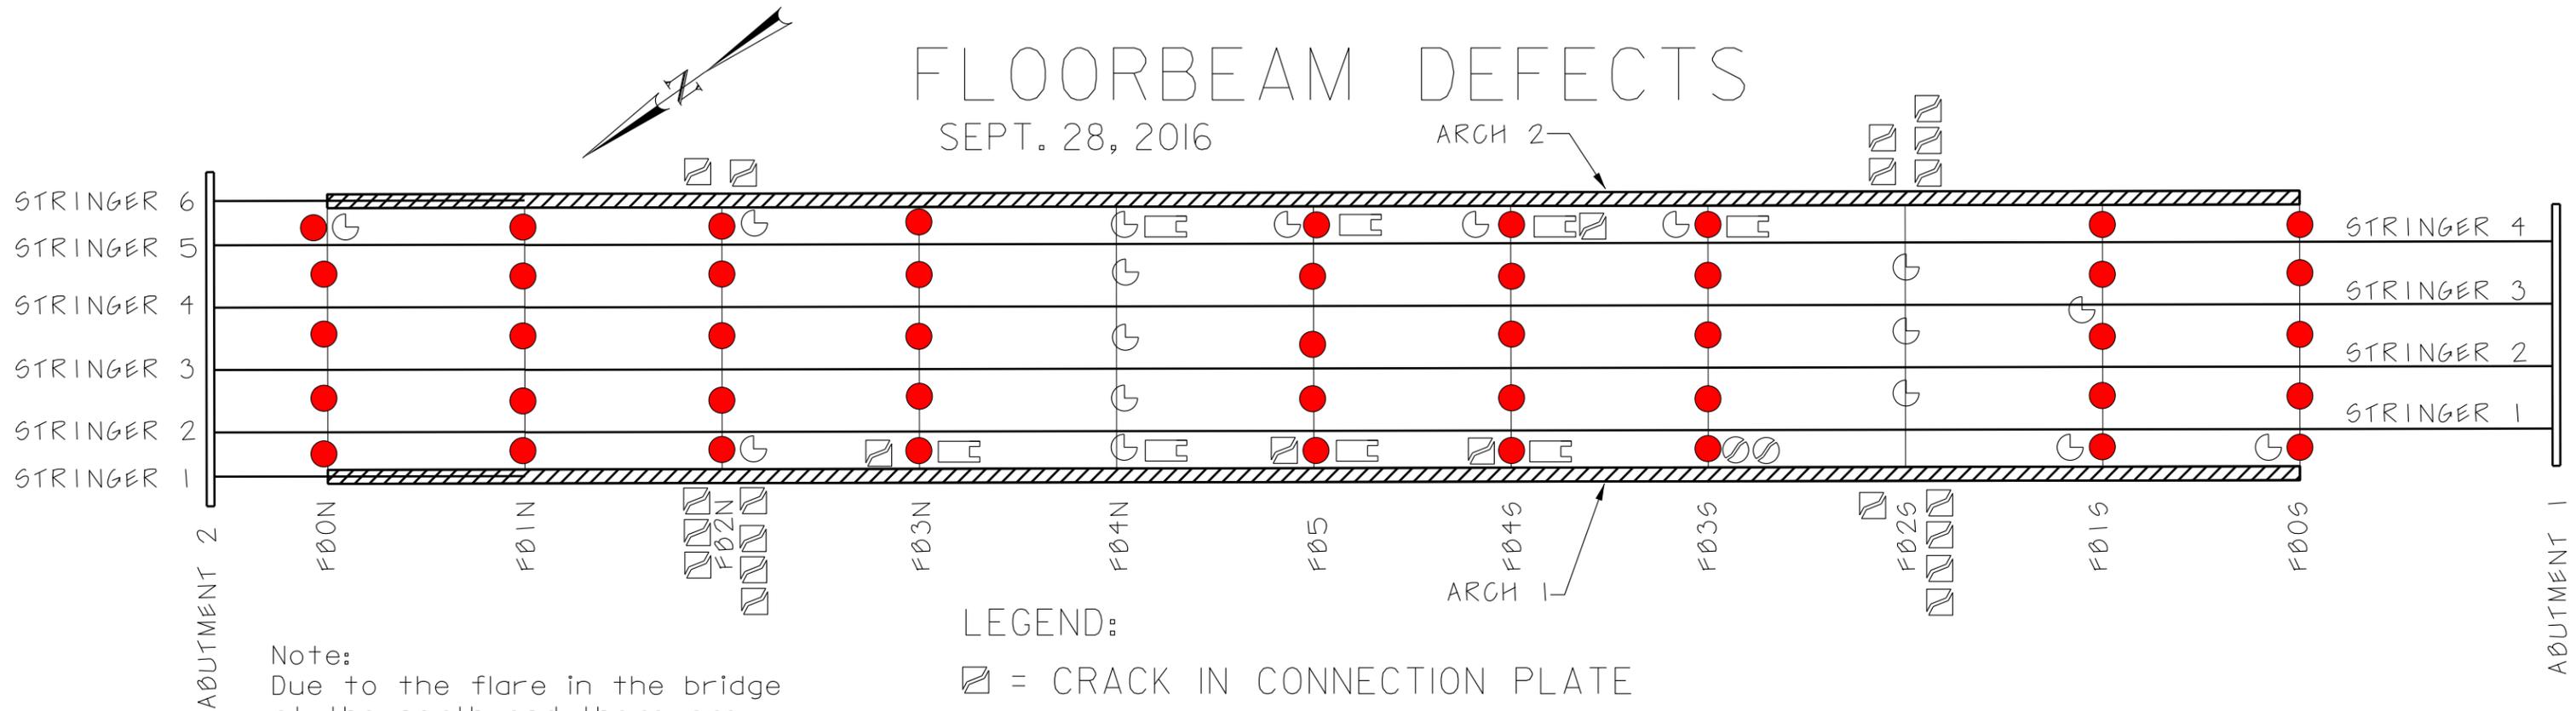
FLOORBEAM DEFECTS

09/28/2016 Travis Jones Floorbeam total quantity was incorrect. Old quantity was 336 feet. According to plans, there are 11 floorbeams, each 27 feet long, for a total length of 297 feet. Quantity was changed on 12/2/2016.
See attached defects tables and figure of floorbeam defects.
Total defect quantities are CS2=205 feet, and CS3=92 feet.
