Report No. UT-13.14

## **MONITORING OF DUROMAXX PIPES INSTALLED ON MANHEAD ROAD IN RICH COUNTY, UTAH**

Utah State University  
Buried Structures Laboratory

**Final Report  
September 2013**

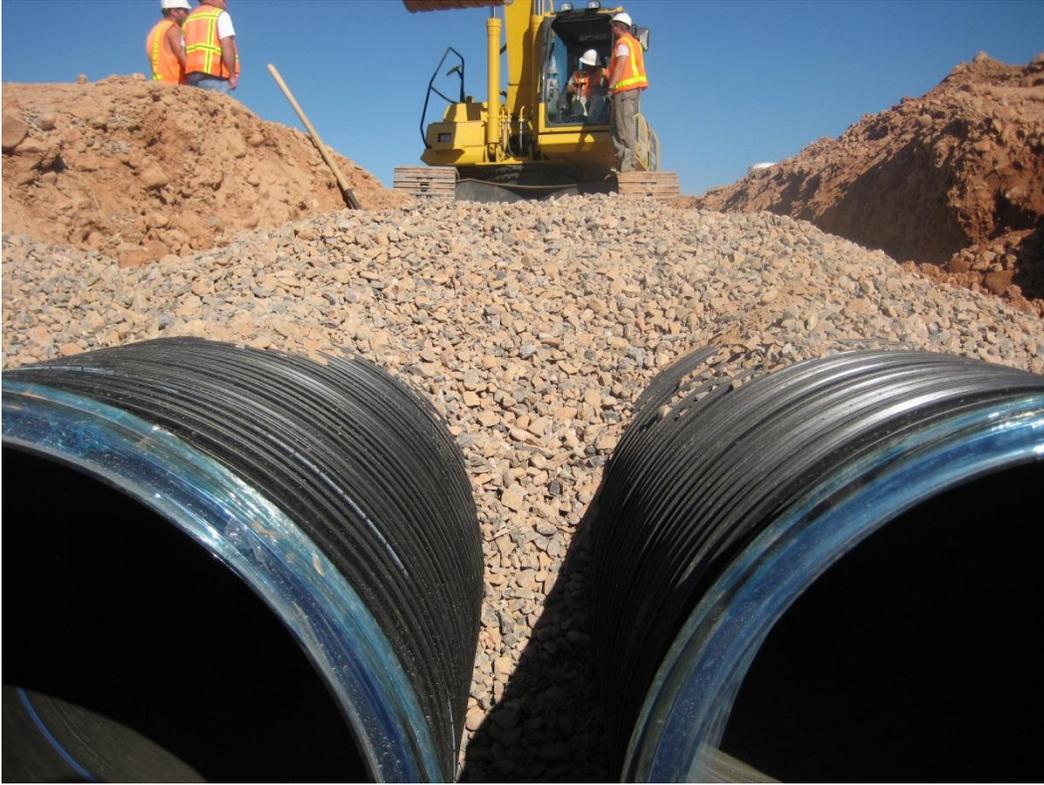
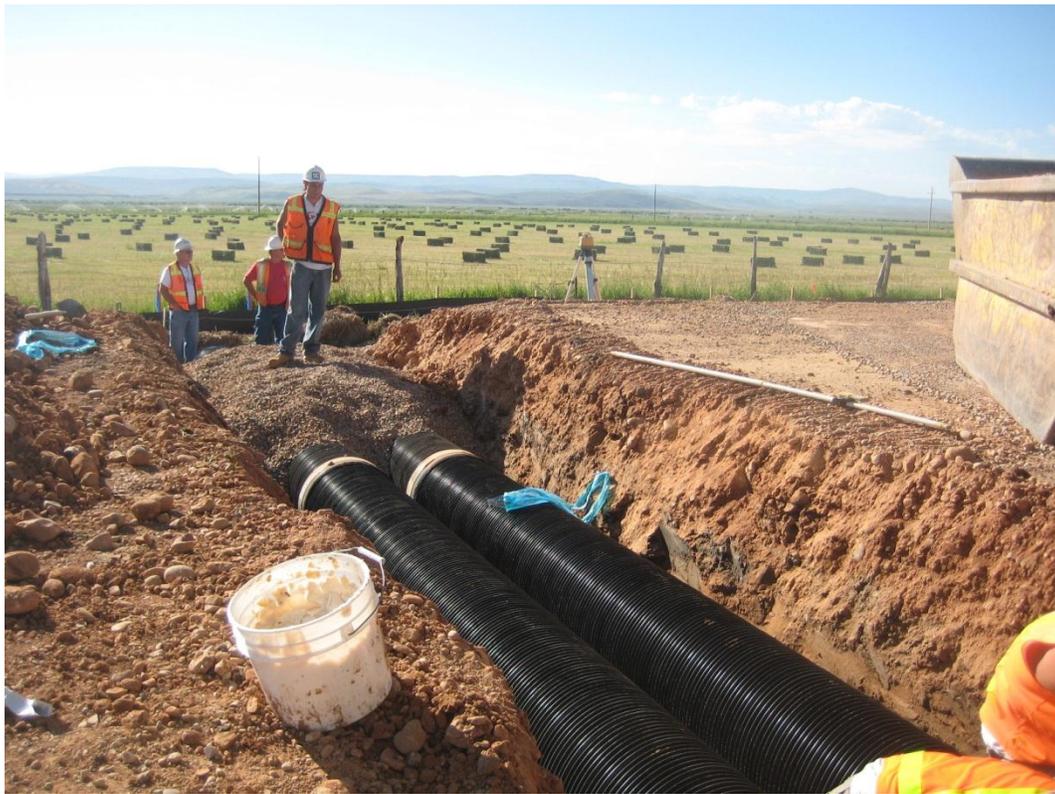
**Figure 2.** Photographs of the DuroMaxx pipe installation (photos from UDOT).

smallest trench width specification. It is difficult to determine from the available photographs of the installation what the overall trench width was. Nevertheless, the clearance between adjacent pipes did not meet UDOT project plans or ASTM D2321 guidelines. When a trench width is too small, compaction equipment cannot move compacted soil into the haunch regions. The crushed stone backfill material was an excellent material, if properly compacted. In the region between the pipes and particularly in the pipe haunch regions, the fill would have been in an “as dumped” condition with very low compaction and would lead to increased pipe deflections.

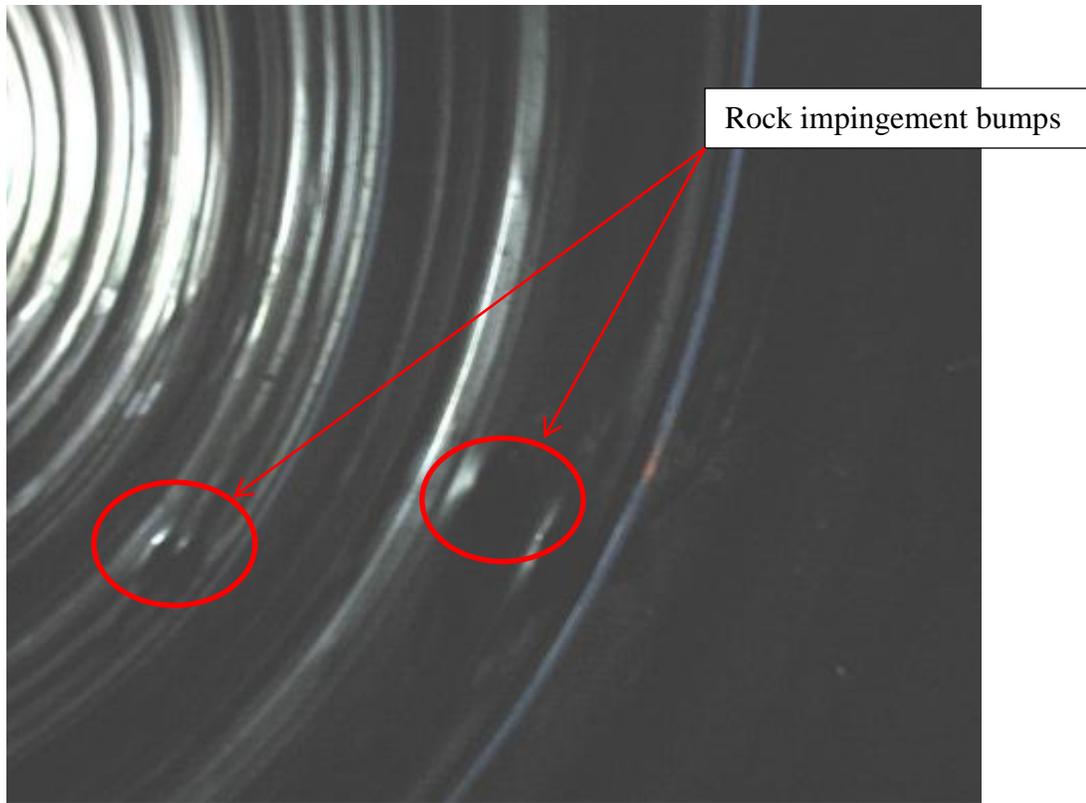
**Figure 14.** Rock impingement bumps in the north DuroMaxx pipe.

An effort was made to identify any localized deflections that could be identified visually on the interior of the pipe. No significant issues were observed during the visual inspections of the inside pipe surfaces. However, on the two-year visit, minor rock impingement bumps were observed in the haunch region of the north DuroMaxx pipe between stations 1 and 2. Figure 14 is a photo of the “bumps.” Please note that it is difficult to capture these minor bumps if the camera flash is operating. Figure 14 has the flash turned off requiring a long shutter time (causing some blurring) and the pipe exit cropped out to better highlight the bumps. These very minor bumps did not change between the year-2 and year-3 visits and likely have been present all along. Minor damage was also observed during the final inspection in the blue plastic seals that cover the spiral weld seams in the south DuroMaxx pipe. Figure 15 has a photograph of the damage. After careful inspection it was determined that the loops were pulled away from the pipe during our inspections. It is believed that in process of pushing ourselves through the pipes that our feet pulled these seals out as shown. Since these are located above the spring-line of the pipe, no leakage or soil migration issues are expected.

There were also observations of minor damage. It was noted that there are rock impingement marks in the north DuroMaxx pipe between stations 1 and 2. These marks are very small and were first observed during the year-two visit. No growth of these impingement marks was observed in the final year-three visit, and these marks were likely present during all the visits. These are of no concern at this time. The blue plastic seal at the helical weld seams was pulled out slightly at three locations in the south DuroMaxx pipe. It is believed that this damage was done during the inspection process. Again, there is no concern about this minor damage.

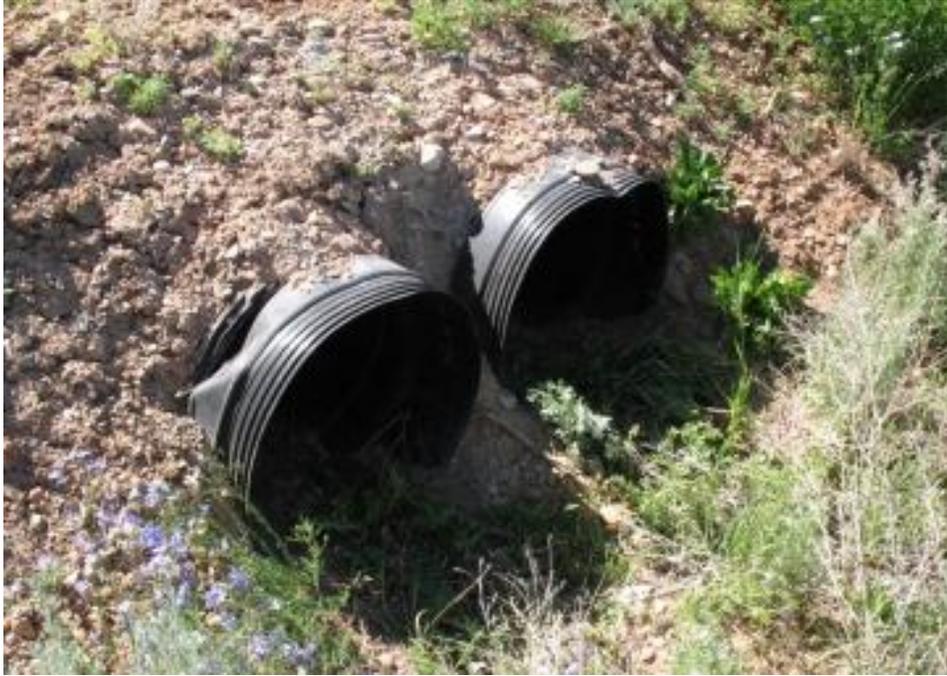
**Figure 16.** Damage to the west entrance to the DuroMaxx pipe.

In the final inspection there was some damage observed in the DuroMaxx pipes in the west entrance to both pipes. The damage is localized to the portion extending past the soil. This may be a concern if the additional damage causes erosion of the shoulder material.

Some significant damage was observed on the final, year-3 inspection on the west entrance of the DuroMaxx pipes. Figures 16 and 17 are photographs of the pipe at the west entrance. Figure 17 shows the tear at a rib location that occurred. The soil above the pipe may

be more subject to erosion because of this. No damage was observed on the exterior of the ADS pipe. The cause of this damage is unknown.

Both the ADS and DuroMaxx pipes have performed adequately to date with two exceptions. Station 1 of the south ADS pipe is at a 7% deflection, but is holding steady at that deflection. Also damage has been done on the west entrance to the DuroMaxx pipe. The cause of the damage is unknown. This damage might lead to additional erosion of the road shoulder at this location. It may be wise to consider monitoring this in the future.
