Report No. UT-12.07

DETERMINING WILDLIFE USE OF WILDLIFE CROSSING STRUCTURES UNDER DIFFERENT SCENARIOS

**Final Report
May 2012**

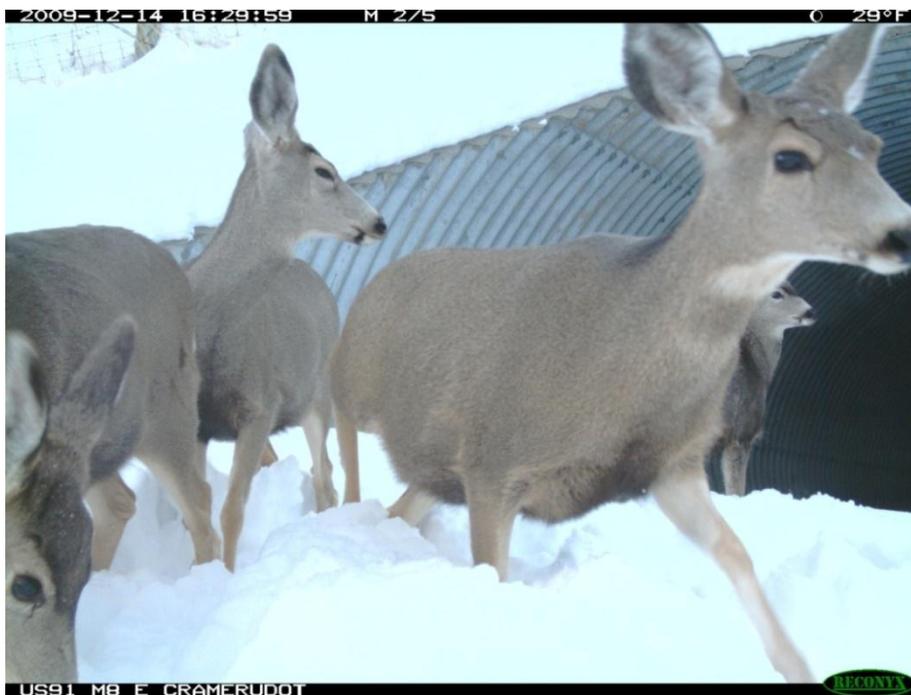
Figure 8. Herd of mule deer repelled from corrugated steel culvert under US 91 at MP 8. Wildlife exclusion fencing was present.

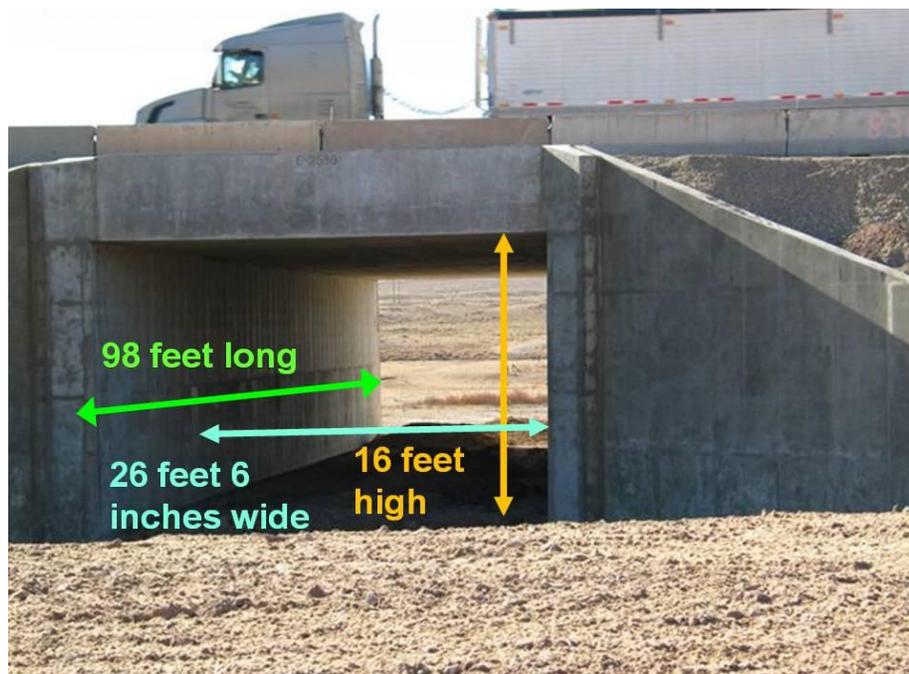
has at passing the mule deer. An ideal culvert for passing wildlife under four to five lanes of traffic would be the Colton Culvert under US 6 (Figure 23). Seven culverts constructed as wildlife crossings were monitored for this study. All passed mule deer, but some had higher rates of repellence than others. The data suggest the longer a culvert is as it traverses under the road, the higher the rate of repellence (Figure 24). A linear regression using R programming language (R Development Core Team 2008) of culvert dimensions found length together with width as predictors of culvert success (Schwender et al. 2011), with shorter, wider culverts exhibiting the greatest success in passing mule deer. A logistical regression was conducted using Akaike information criterion (AIC) to measure the relative goodness of fit of the statistical model. The AIC rankings found that culvert width and length were the best predictors of mule deer success, culvert width alone was the next best predictor, and the window ratio, a figure Megan Schwender was working on for her master's thesis, was the third best predictor. It is a measurement of the openness of the culvert. It is important to remember that single structure dimensions cannot be taken in isolation (such as we have presented in Figures 24, 25, and 26), and that in general, it is the openness of a culvert that encourages mule deer and other wildlife use.

Figure 23. Colton Culvert under five lanes of US 6.

At this time the best recommendations are to keep culverts under 120 feet (37 m) long, which is the length as they traverse under the road, and if the road is greater than two lanes, such as a divided highway, break up the culvert into two sections, one for each direction of travel. It appears that increasing the width (span) of the culvert is more important than increasing the height. This may help engineers in installing culverts under roads where there is a limited amount of flexibility for raising a road to accommodate a culvert.

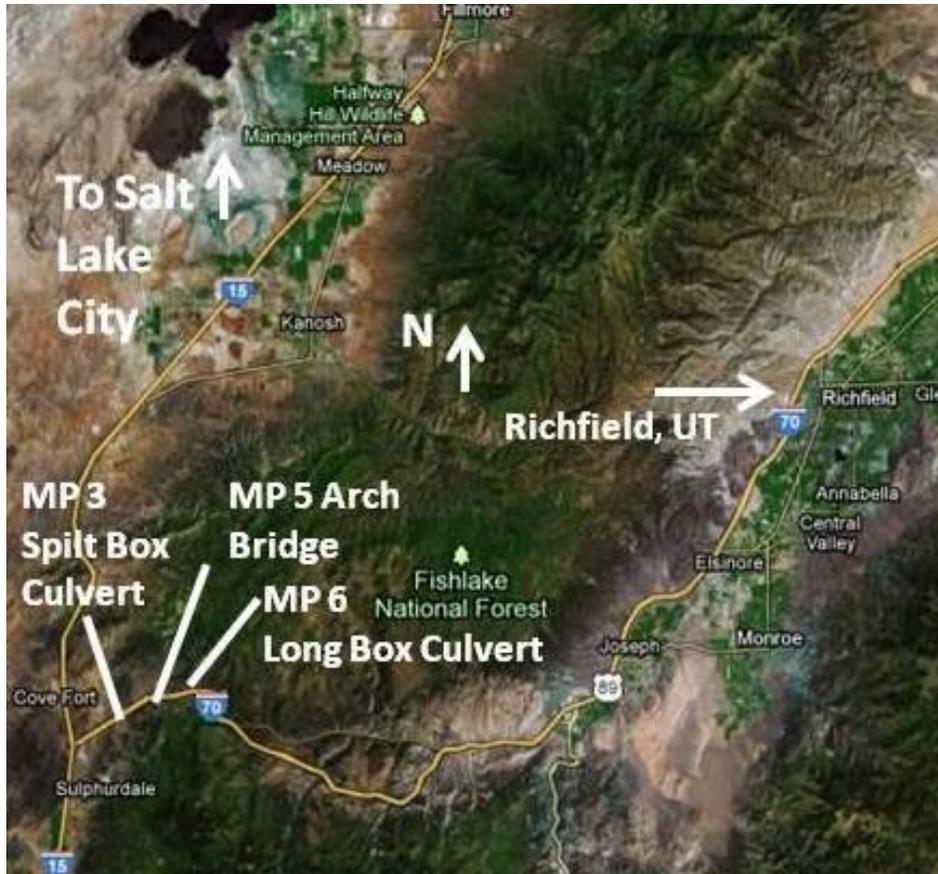
Figure 28. I-70 MP 5 Arch Bridge crossing location, with two existing box culverts monitored.

Once the arch bridge and wildlife fencing were completed, 86 mule deer used the new structure in the first 165 days of monitoring, with a 16% rate of repulsion. It appears this structure will work for mule deer and the rate of repulsion will decrease over time. Nine elk approaches were photographed at the new structure, and eight times elk went through. All of these were bull elk passages. Within the first snows of the winter of 2010-2011, UDWR biologists found evidence of a herd of elk approaching the structure from the south, outside the range of the camera, but all were repelled. As of 2011, no cow or calf elk used this structure. In March of 2011, Bruce Bonebrake of UDWR removed a panel of rails from each side of the rail fencing at the approaches to the structure in an effort to encourage elk use. Perhaps if this can be done each winter and spring when the mule deer and elk are migrating and when livestock are not placed on the land, it may increase elk use. At this time the structure appears to be successful for mule deer. It may over time become successful for elk, as other studies have recorded, but at this time it is of only limited success in passing elk. In Arizona (Gagnon et al. 2011) and Alberta

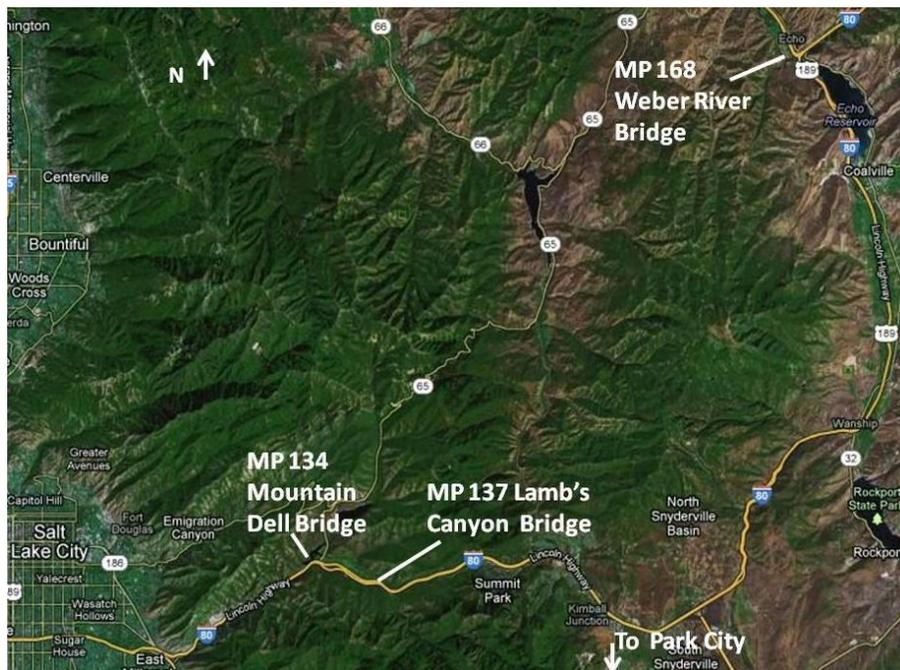
Although the Weber River Bridge on I-80 near Echo Junction (Figure 30) was not designed to pass wildlife, cameras recorded successful mule deer passes 361 times over 543 days of monitoring, for 0.7 deer per day. One moose was photographed at the entrance but did not use the structure. Elk are in the area but were not photographed. The bridge was replaced in 2012, with accommodations for wildlife with passage pathways along the edges of the river under the bridge. With this pre-construction monitoring data, we can predict that the new structure should pass at least 0.9 mule deer per day (at least 300 deer annually) over the time of post-construction monitoring, and the rate of repulsion should be under 10% as it was at this bridge when no impediments such as fencing were placed at the entrances. It is also expected that moose and elk will occasionally use the bridge each year. Future monitoring will help us determine how the success of the new structure correlates with these expectations.

Figure 30. I-80 Weber River Bridge site.

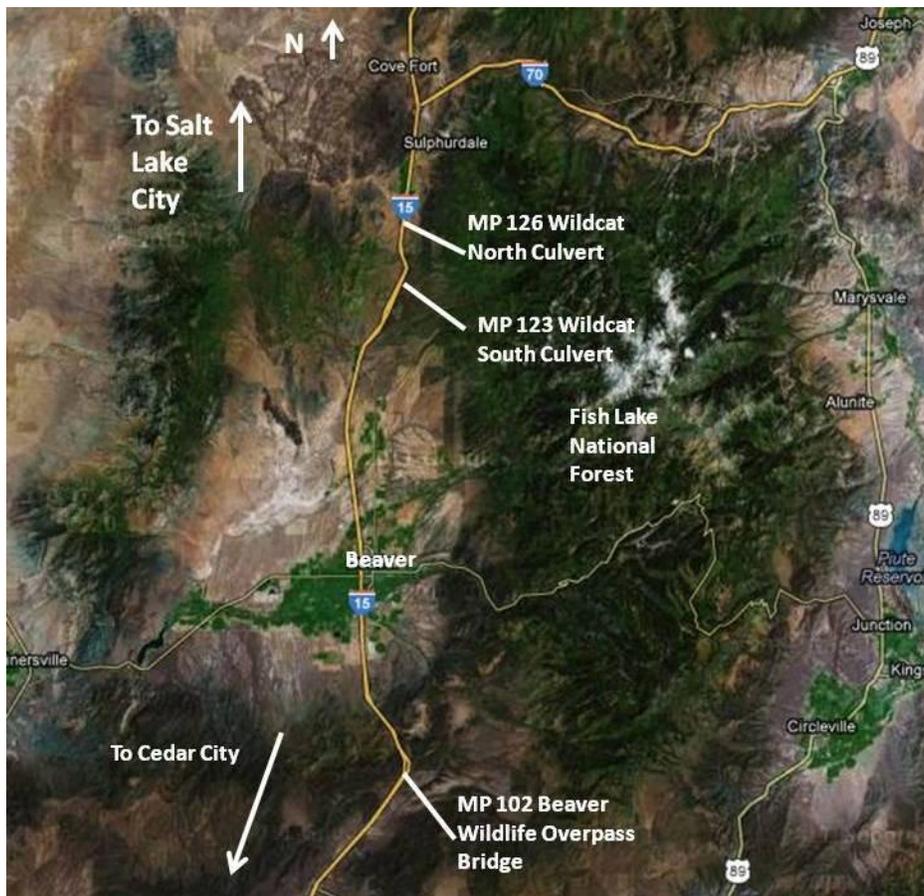
The camera on the wildlife overpass on I-15 near the town of Beaver (Figure 31) revealed 1,206 mule deer passes in 738 days of monitoring, for a value of 1.6 deer through per day. This equates to an average of 584 mule deer passes per year. Since the whole population of mule deer in this area needs to migrate to the west in the winter and the east in the summer, it is important that bucks use this crossing as well. The male passes were 16% of the total passes, which is comparable to the percentage of the males in the population. This lends credit to the idea that the wildlife overpass is allowing the majority of members of the population of mule deer to move to their seasonal habitats and is highly successful for mule deer.

Figure 31. I-15 wildlife crossings and camera sites near Beaver, Utah.

Camera evidence revealed 19 bull elk passes over the overpass. No female or young elk were photographed. Of all wildlife crossing structures and existing bridges and culverts monitored in Utah in this study, this wildlife overpass was the structure most highly used by elk. While the overpass appears to pass all age cohorts and genders of mule deer, it fails to pass members of the elk population. The overpass does not facilitate elk population movements to winter and summer ranges or any other movements on both sides of I-15. If the objective is to allow an occasional bull elk to move between populations to maintain genetic diversity, the overpass appears to facilitate that purpose. It is not known how to encourage cow elk to use this overpass. If panels were placed in the chain link fence along the overpass to block the view and possible noise of traffic, it may create more of a tunnel effect and discourage elk use. A potential improvement would be to plant sagebrush and juniper on the overpass segments to provide a more natural “feel” to the area and to provide cover.

Prescription for Improvement: While the overpass appears to pass all age cohorts and genders of mule deer, it fails to pass all members of the elk population. If an objective of the overpass is to allow the elk population to move between the east and west sides of the interstate, it fails. If the objective is to allow an occasional bull to move between populations to maintain genetic connectivity and thus diversity, it appears to serve that purpose. It is not known how to encourage cow elk to use this overpass. If panels were placed in the chain link fence along the overpass to block the view and possible noise of traffic, it may create more of a tunnel effect and

discourage elk use. A potential improvement would be to plant sagebrush and juniper on the overpass bridges to provide a more natural “feel” to the area and to provide cover. An additional improvement would be to discourage members of the hunting public from hunting in the area of the overpass and baiting by potential hunters at the entrances, as evidence was found in camera data and field visits.

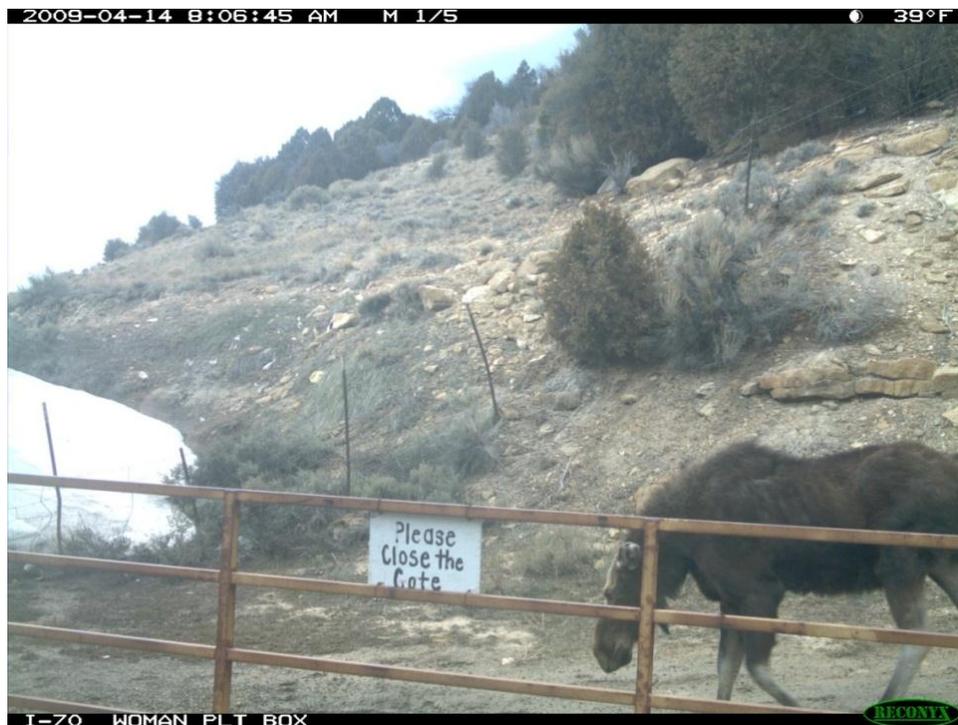
Figure 48. Moose approached Woman Plateau culvert under I-70 in Fish Lake National Forest.

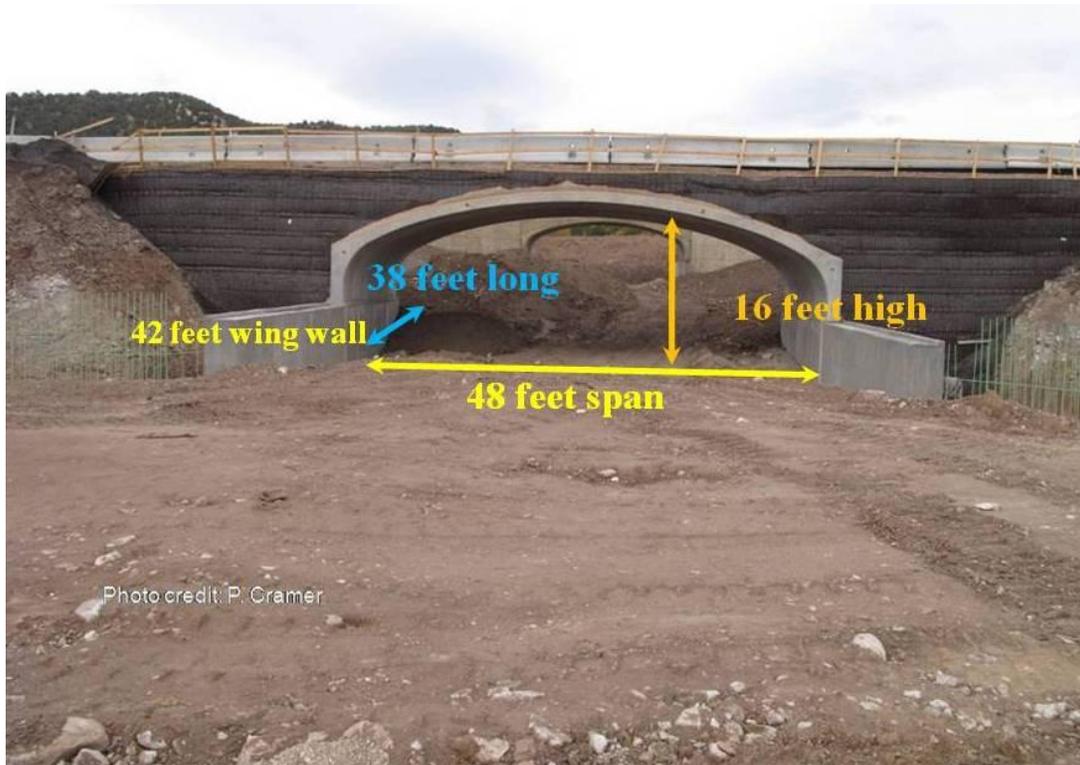
I-70 Arch bridge wildlife crossing at MP 5.3. Under construction. Completed November, 2010.

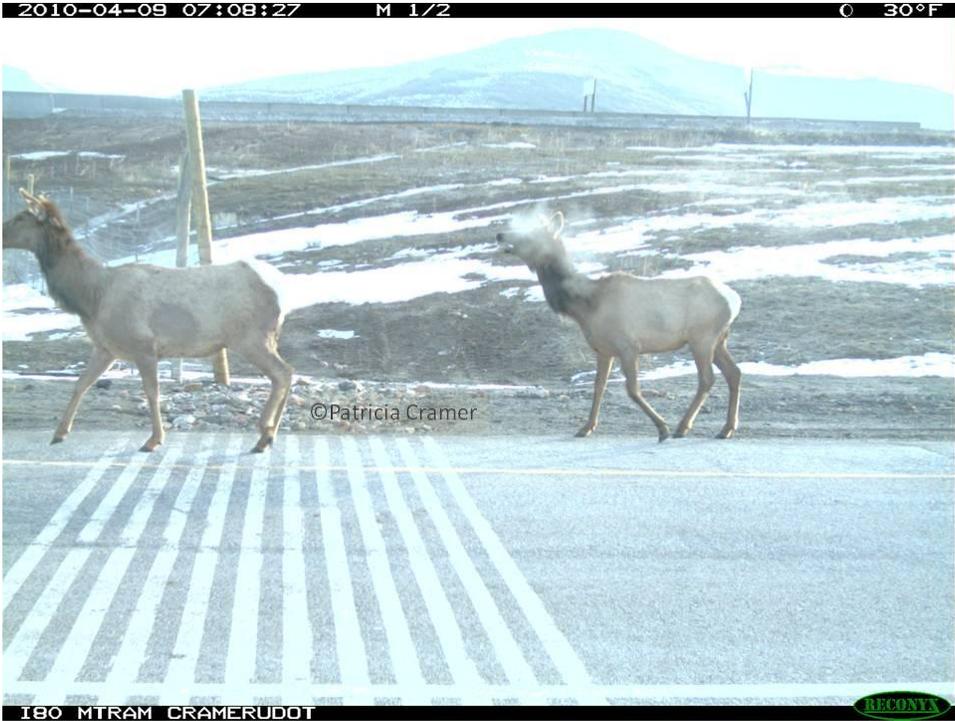
Elk came off of I-80 across painted stripes at Mountain Dell Reservoir exit, MP 134, eastbound entrance ramp.

interstate using these ramps and ignored the white stripes. Double cattle guards or wildlife guards are recommended for all eight ramps along this stretch of I-80.
