Report No. UT-08.24

EVALUATING SHALLOW-FLOW ROCK STRUCTURES AS SCOUR COUNTERMEASURES AT BRIDGES

Brigham Young University
Department of Civil & Environmental
Engineering

December 2009

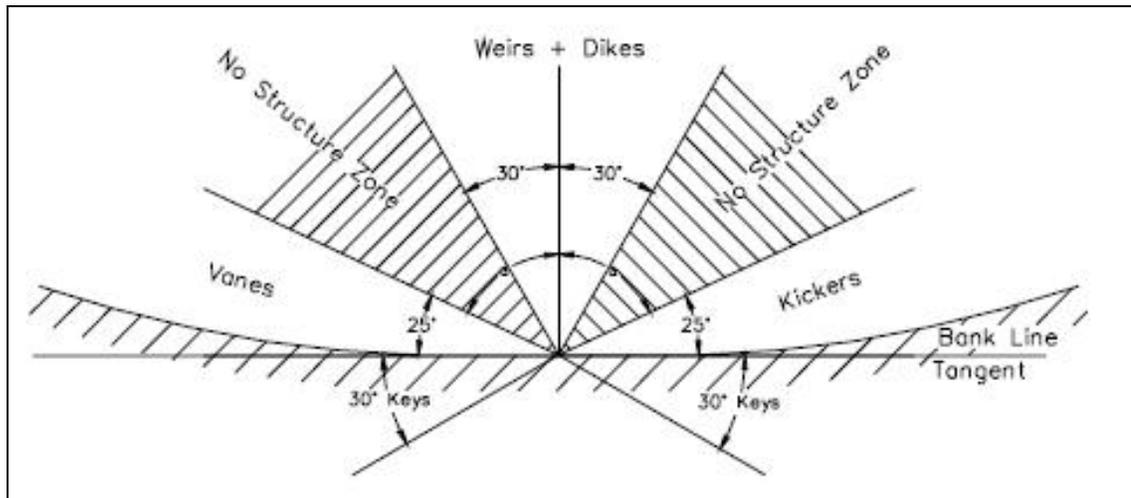
Figure 2-3. Bendway Weir and Vane Variations.

There are two variations with respect to bendway weirs and vanes. The variations of bendway weirs (barbs) and vanes can best be described using Figure 2-3 from *Stream Investigation, Stabilization and Restoration (SISR)* (Freeman 2005¹).

Variations of bendway weirs relate to the orientation of the structures with respect to the streambank. Bendway weir (barb) placement ranges from perpendicular to the bank or up- and downstream 30° from perpendicular. Vane orientation is always upstream as shown in Figure 2-3. Kickers are the mirror reflection of a vane from perpendicular as shown in Figure 2-3. See Figure 2-4 and Figure 2-5 for illustrations of a bendway weir and vane, respectively. Vane theory and design methodologies are found in *Stream Investigation, Stabilization and Restoration (SISR)* (Freeman 2005^{1,2}) and Johnson et al. (2001).

Vanes are oriented upstream 20° to 30° from the bank whereas bendway weirs are perpendicular to the bank give or take 30° (see Figure 2-3). Vanes, for the purposes of this study, have separate design criteria from bendway weirs, but by definition are the same. See the definition for bendway weir and Figure 2-9 for vane weir theory. (Freeman 2005¹). Further, Johnson et al. (2001) described the similarities between vanes and bendway weirs, “bendway weirs are low elevation stone sills similar to vane structures.”

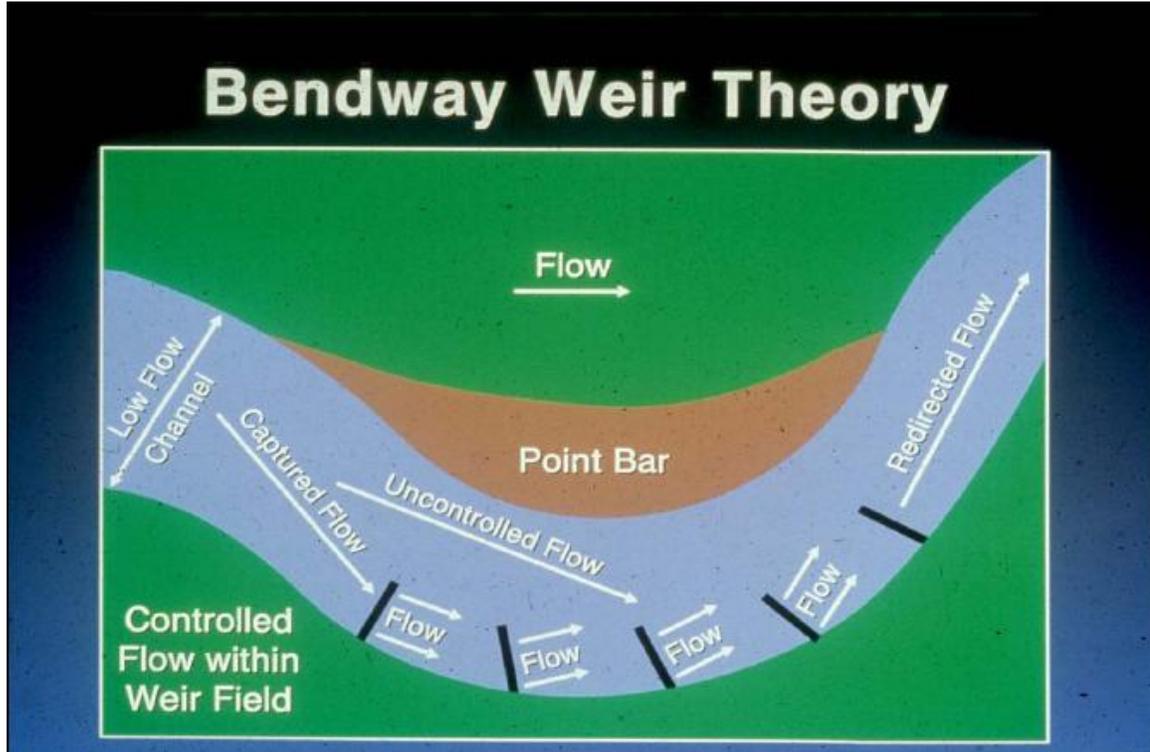
Figure 2-8. Bendway Weir Theory.

As water passes over a bendway weir, it is redirected downstream perpendicular to the structure as illustrated in Figure 2-8. (Freeman 2005²).

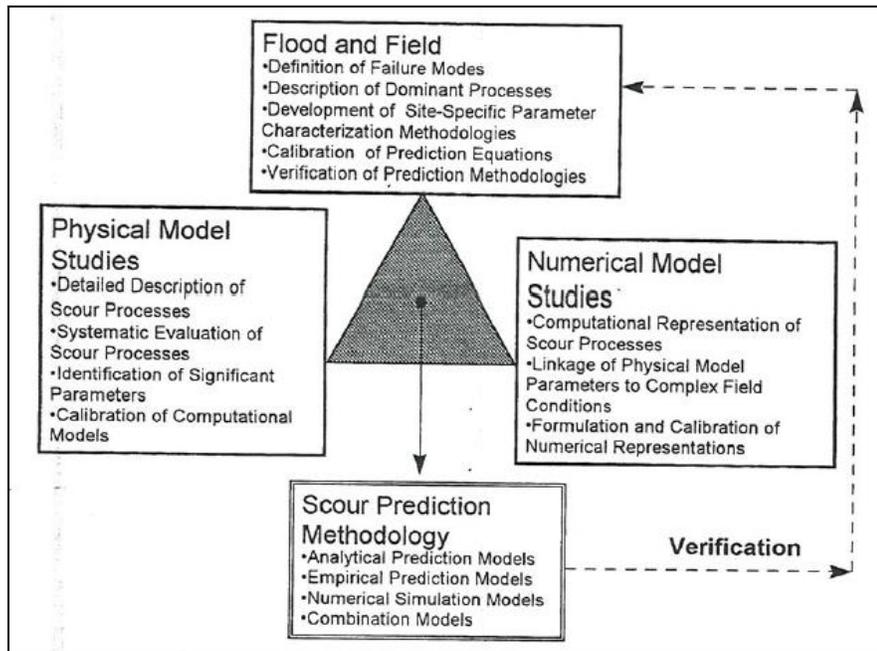
Figure 2-11. Balanced Research Approach Model.

As the literature was surveyed for studies conducted on structures comparable in composition and relative size, components of a balanced approach methodology were scattered throughout the literature. Shea and Ports (1997) asserted that a balanced approach to evaluation of scour at bridge crossings can produce cost savings with a high degree of reliability. Figure 2-11 shows an illustration of the balanced approach methodology for evaluation of scour at bridge crossings (Parola et al. 1997).

Failure modes are a key component of a balanced research approach (see Figure 2-11) for evaluating scour. Johnson et al. (2004) describes failure mode analysis:

Siting or “...structure placement relative to natural channel features and fluvial patterns...” may increase the reliability of scour countermeasures (URMCC 1995). Recommended structure siting is given in *Stream Habitat Improvement Evaluation Project* (URMCC 1995) in Table 4.48, *Bridge Scour and Stream Instability Countermeasures – Experience, Selection and Design Guidance* (Lagasse et al. 2001) in Table 2.1, *Using Technical Adaptive Management to Improve Design Guidelines for Urban Instream Structures* (Johnson et al. 2002²) in Tables 1 and 2., and class notes sections five and nine of the *2005 Stream Investigation, Stabilization and Restoration Conference* held in Niagara Falls, Ontario (Freeman 2005^{1,2}). Being familiar with common siting practices will enable more consistent monitoring during flood and field studies. See Figure 2-11 for elements of flood and field studies components.

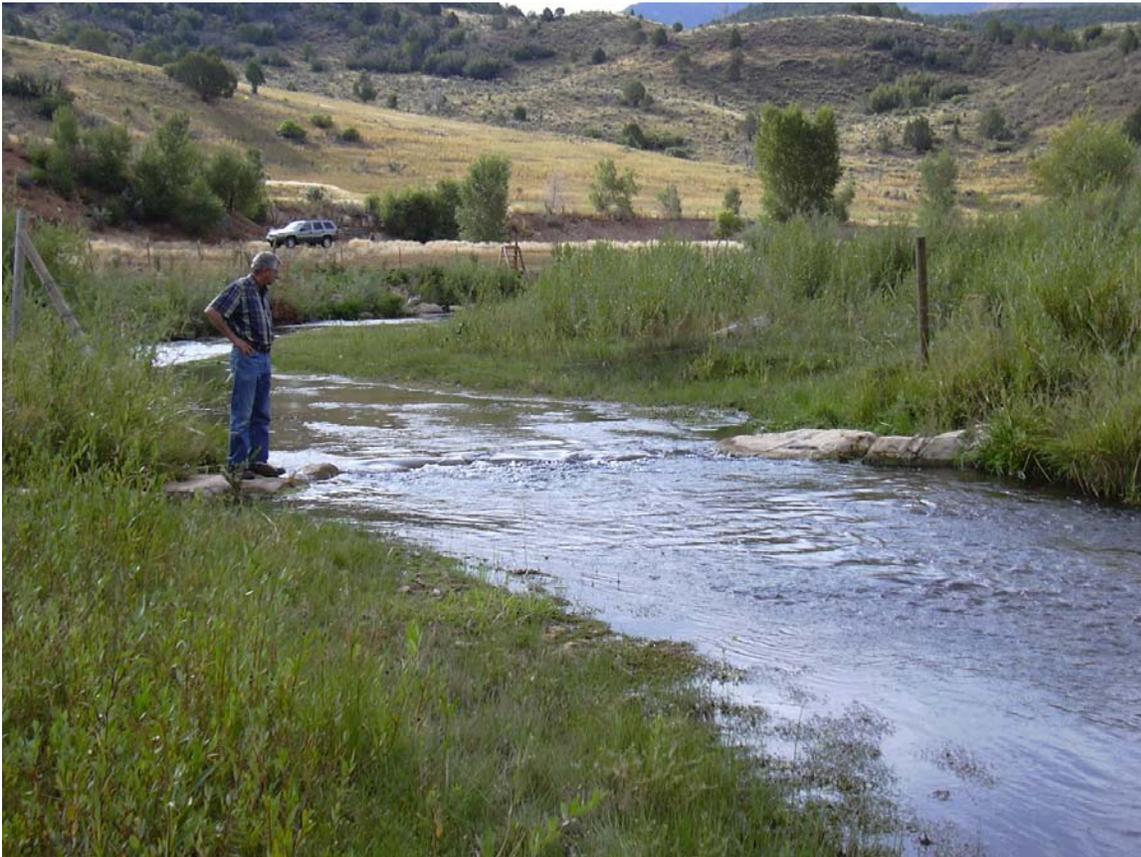
Figure 3-3. Cross-Vane Structure Observed and Modeled.

The site chosen for modeling includes many structures including: two cross-vanes, one j-hook and a number of vanes. Figure 3-3 shows the cross-vane modeled. Note the flow approaches the structure mostly on the right side of the channel and moves across the structure. This is reflected in the results of the numerical model.

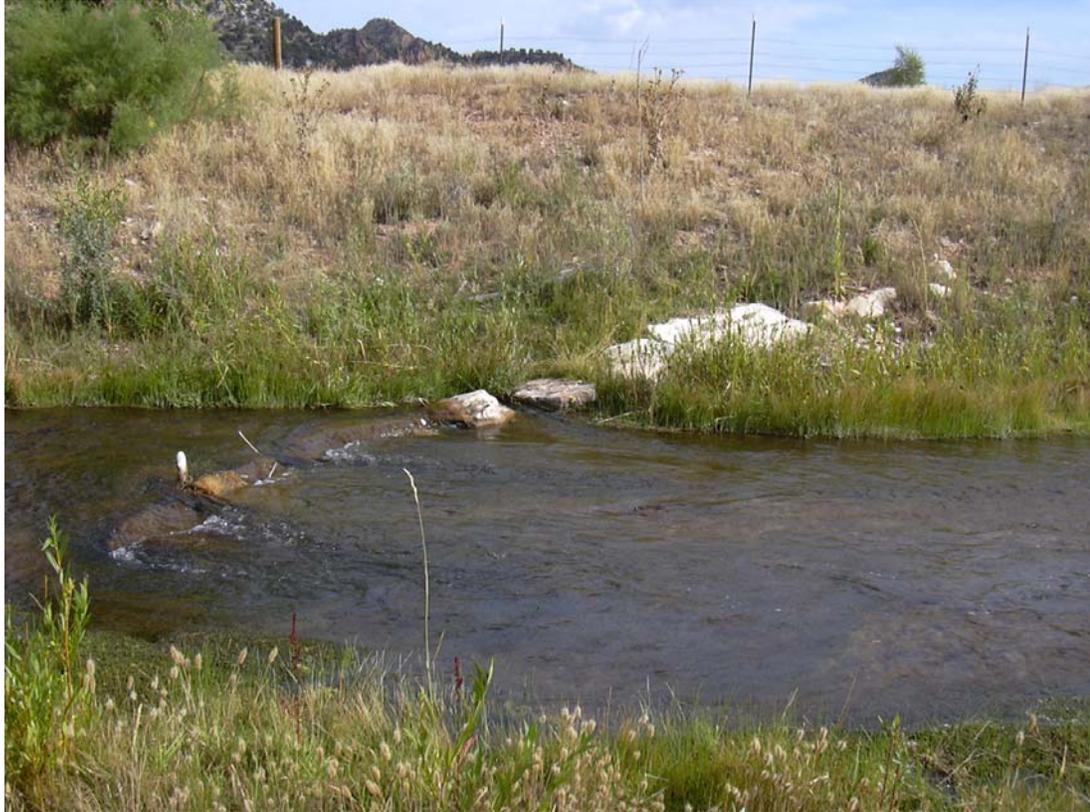
Figure 3-4. J-Hook Structure Observed and Modeled.

Figure 3-4 shows the j-hook structure modeled. Flow is from left to right in the picture. This structure is just downstream around a meander bend from the cross-vane. There is another cross-vane between these two structures on the meander bend. This is part of an ongoing restoration after the mudslide near Thistle, Utah. Also of note in this area is one of four experimental installations (in the study group for this paper) of SFS at bridges. The existing installation is located at Utah County State Park upstream of the Spanish Fork River and Diamond Fork confluence. SFS are installed upstream of a pedestrian-trafficked bridge. Figure 3-5 and Figure 3-6 show the relationship of a j-hook being constructed next to this footbridge.

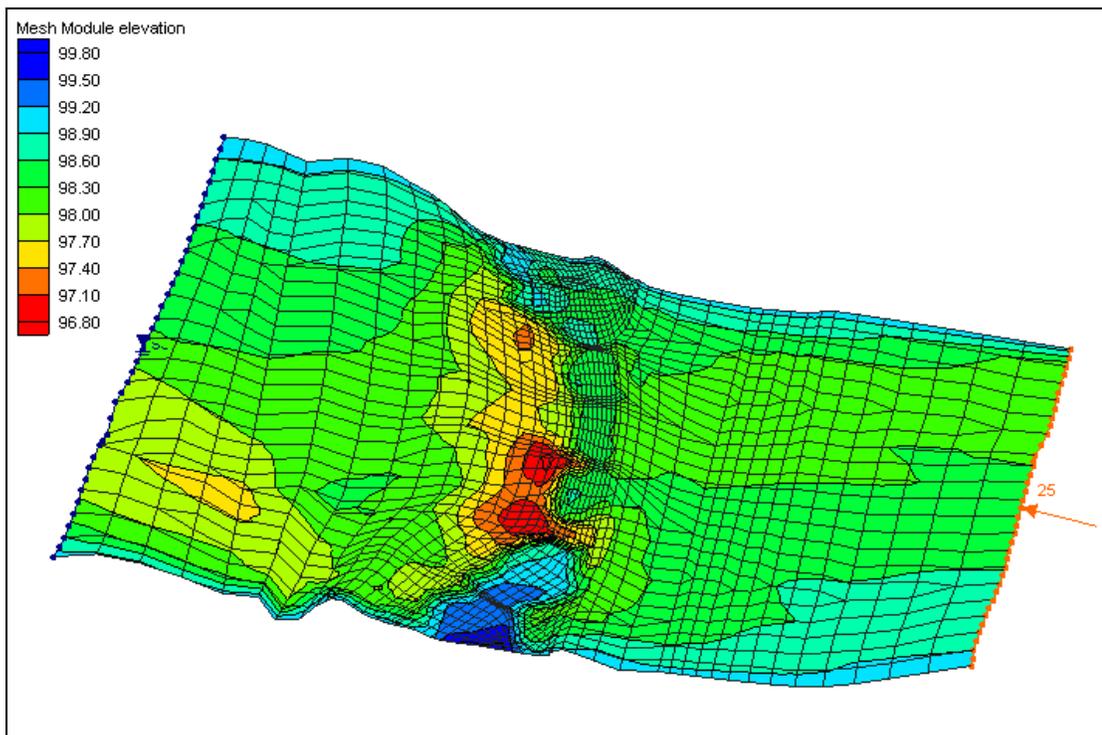
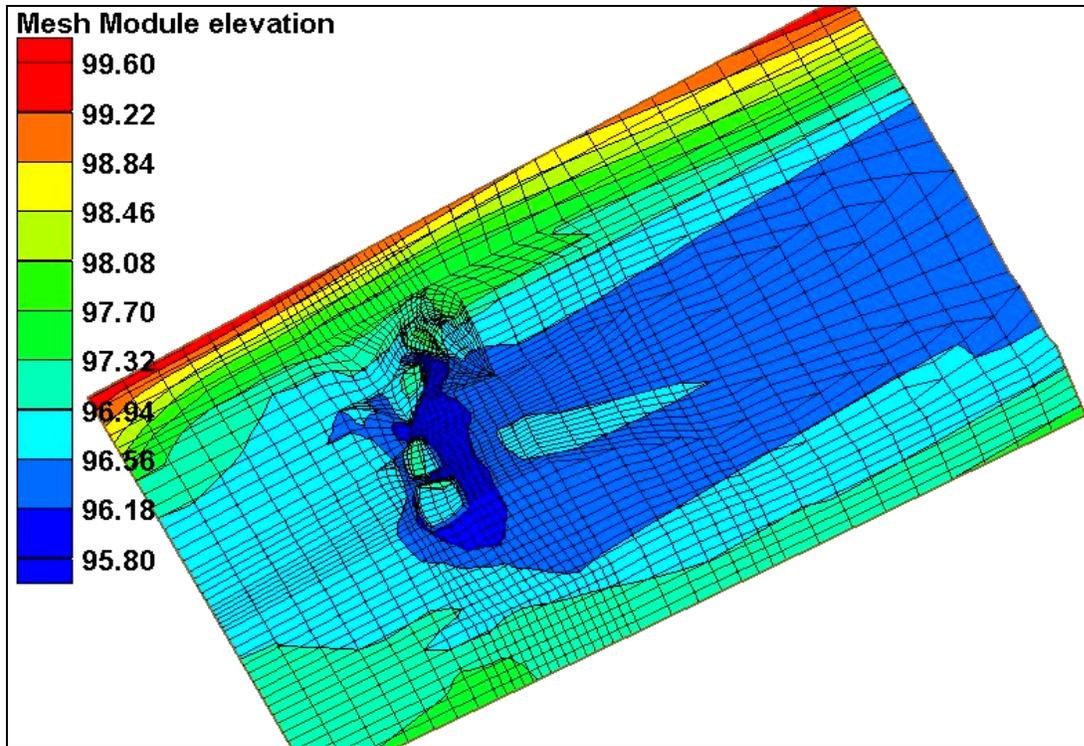
The Thistle Creek site modeled includes two separate finite element meshes. They represent two reaches of the stream that are very close together. The first includes a cross-vane structure and the second includes a j-hook. Figure 3-7 and Figure 3-8 show the meshes constructed around the cross-vane and the j-hook, respectively. The color keys in the upper left-hand corners indicate elevations. The resolution around the structure is very high, defining the elevation of each boulder, the elevation of the chutes between boulders and the pools upstream and downstream of the chutes are also illustrated.

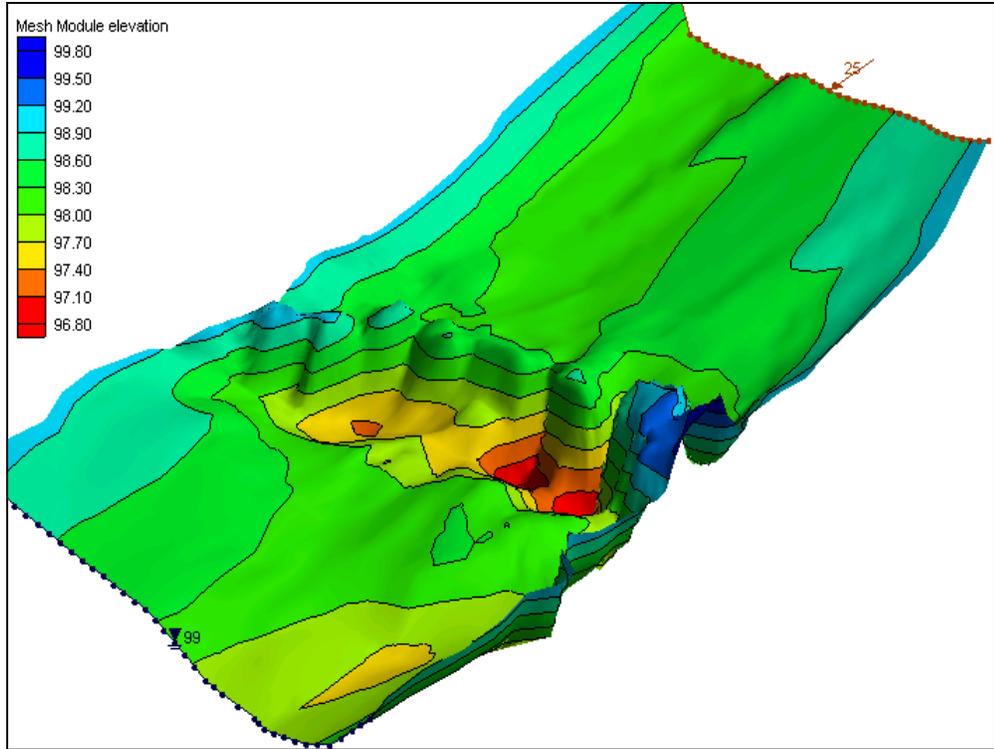
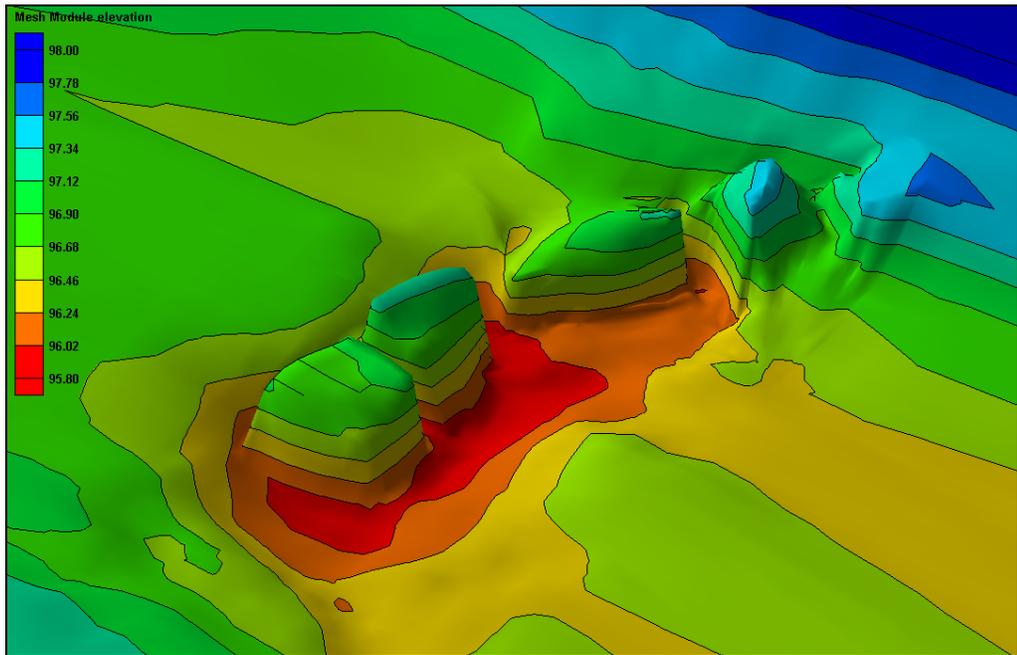
Figure 3-9 and Figure 3-10 show the geometry of the meshes from an oblique view. This view accentuates the scour holes that are developing downstream of the structures. Results shown later in this chapter illustrate additional scour has occurred during the year of phase one monitoring. Also note the scour occurring upstream on the j-hook. Field observations support that failure of SFS occurs not only by downstream scour, but also by an upstream erosion mechanism. The initial elevations came from the survey data that are displayed along with contours of the survey points in Figure 3-11 and Figure 3-12.

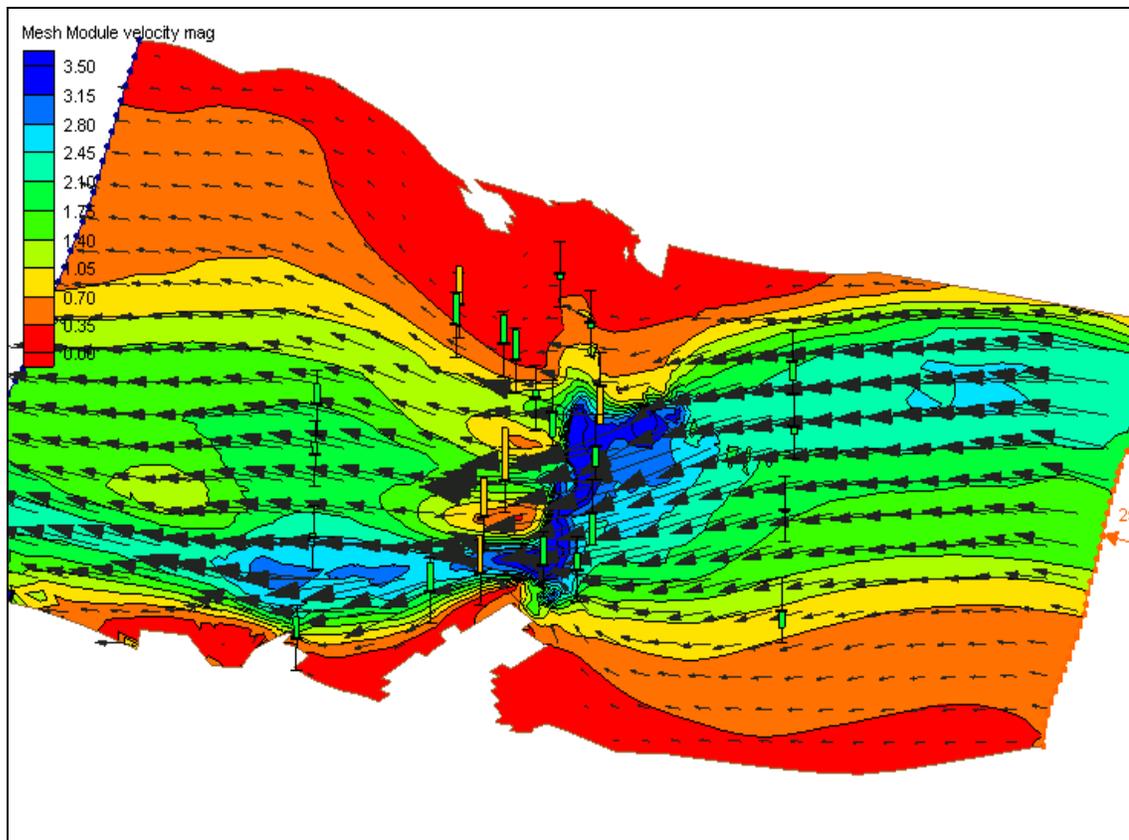
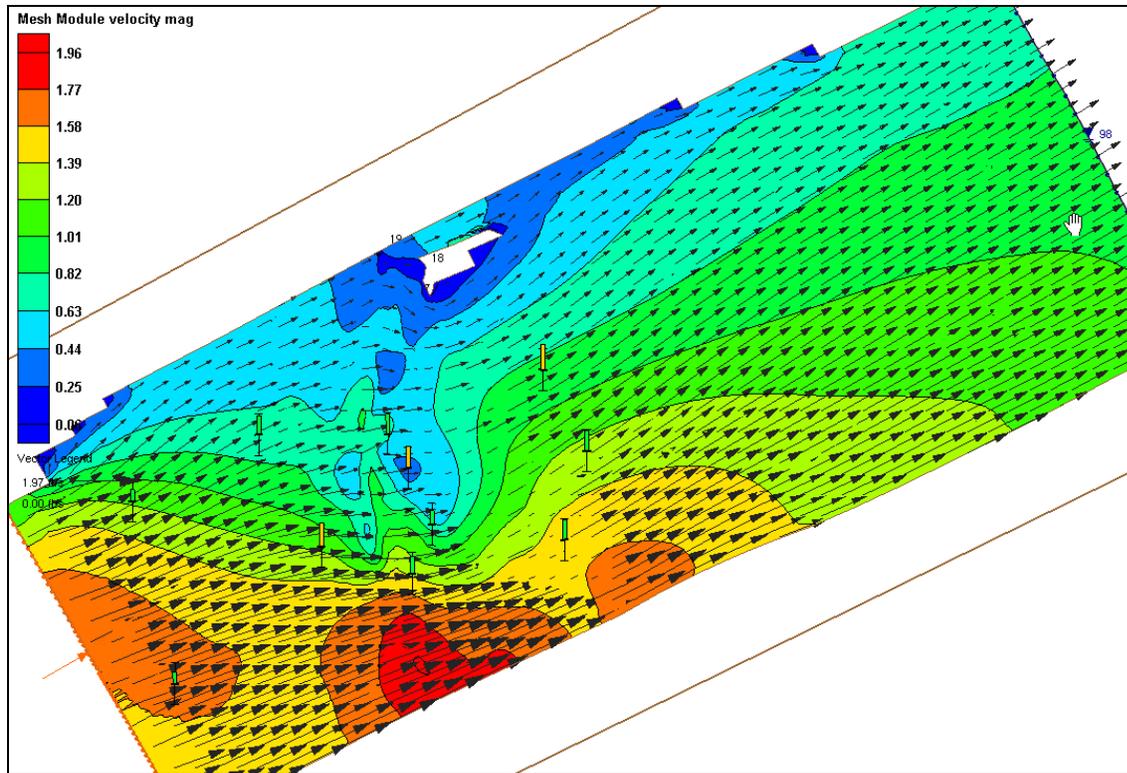
Initially, a flow of 25 cfs was simulated through the two meshes. This corresponds to the flow rate computed from the date when the original survey data was gathered. In addition to bathymetric data at 1-foot intervals, velocity samples were obtained across the cross section and at several points around the structure. The following images display the computed flow directions and magnitudes computed by the model. Note that the model has dried out portions of the rocks and reproduced the flow conditions coming from the right side of the channel and crossing over to the left at the structure.

Figure 3-13 and Figure 3-14 also show the calibration targets at various sample points. Any target showing a green staff indicates a computed velocity magnitude within .26 ft/sec of the measured value. A yellow staff indicates a computed value within .52 ft/sec of the measured value. The data sets were calibrated using the measured velocities and depths gathered at the site. Based on the calibration results and flow conditions observed during data gathering, it appears that the models are performing reasonably well to predict flow conditions. This includes water depths and flow velocities from which scour forces can easily be computed.

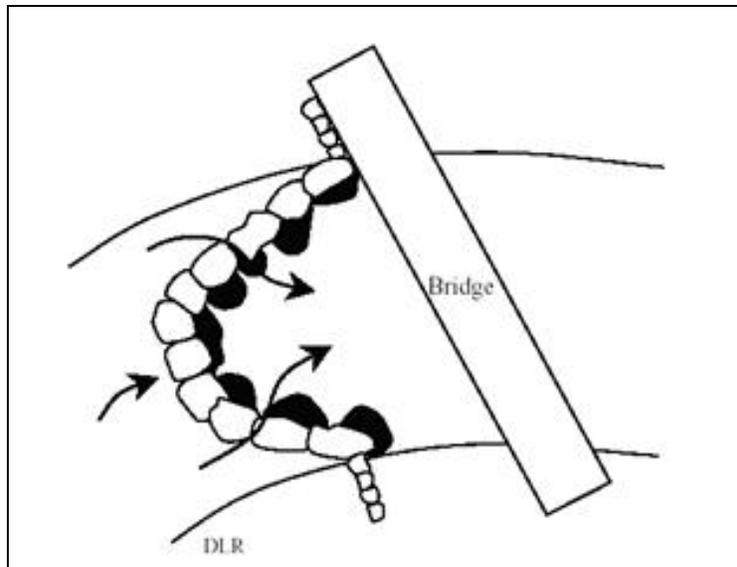
Figure 3-15. Proposed Design Methodology for Cross-Vane Installation at a Bridge.

See Figure 3-15 for Rosgen’s (2001) proposed cross-vane installation upstream of bridges.

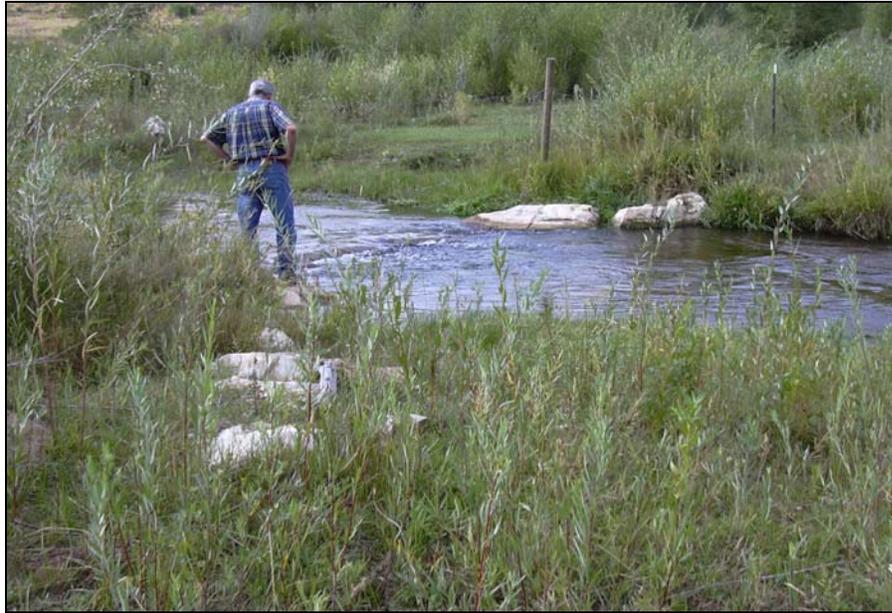
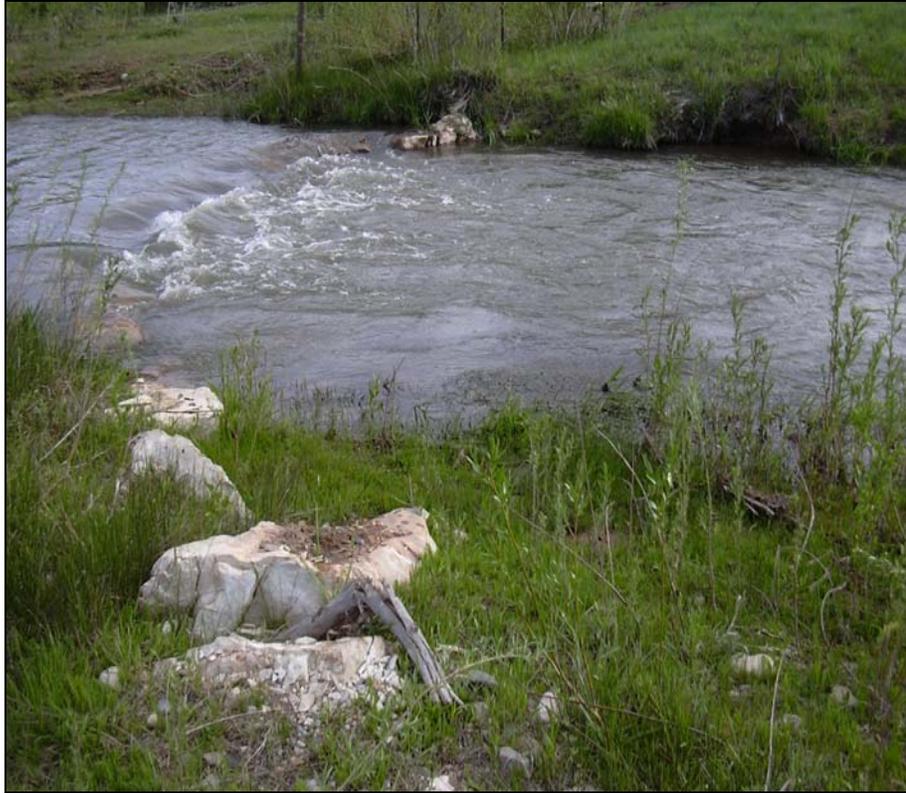
The asymmetrical cross-vane also has erosion problems illustrated in the photos taken in the fall of 2003 and the summer of 2004 during spring runoff (Figure 3-16 and Figure 3-17). In Figure 3-16, two large boulders are visible on the far bank. Figure 3-17 illustrates that due to erosion around the boulder, the left of the two boulders on the bank has shifted and broken. That is why the boulder is not visible in this figure. The erosion is caused by the water moving across the structure from the upstream (north) to the downstream (south) side. The velocity of the water is increased as it runs over the structure and is redirected to the south bank as seen in Figure 3-13.

Rock decay was also observed during the study. As noted above, one of the main boulders broke after shifting due to erosion. The crumbling rock in the foreground of Figure 3-17 illustrates the inferior quality of these materials.

This hydraulic condition was observed during the initial survey and appeared to be aggravated after spring runoff as the bank began to fail after spring runoff in 2004 as seen in Figure 3-16 and Figure 3-17. The cross-vane, rather than redirecting the thalweg to the center of the stream channel to reduce bank scour, is in fact redirecting it toward the bank and inducing scour during base flow conditions.

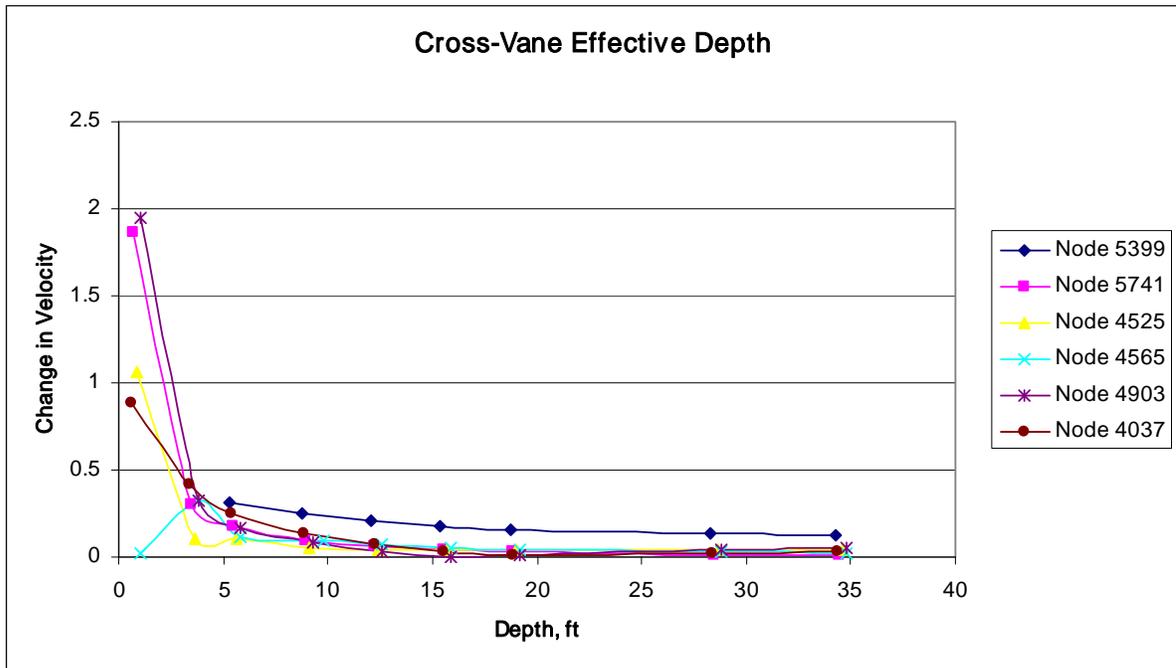
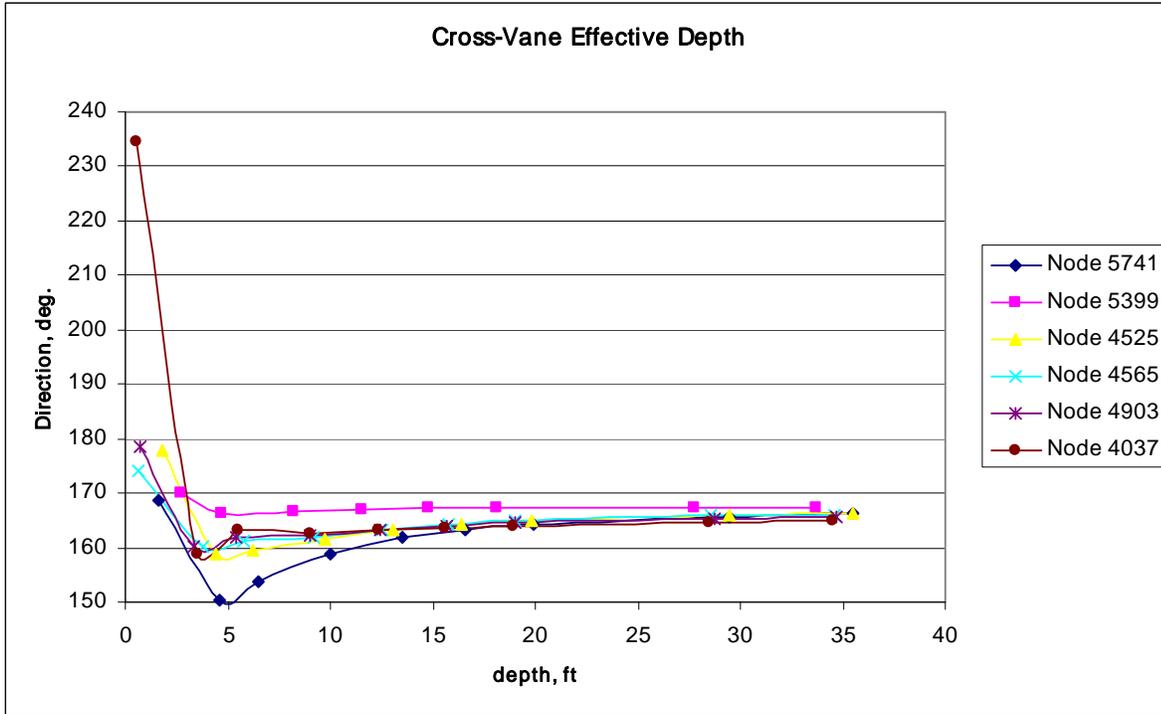
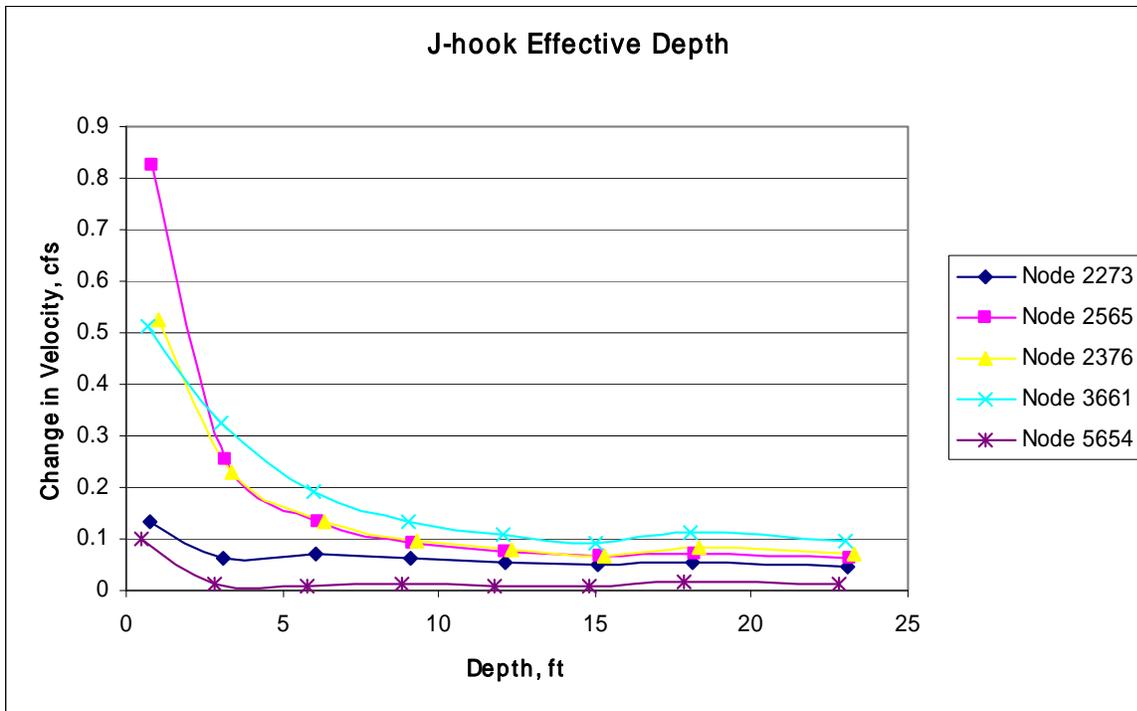
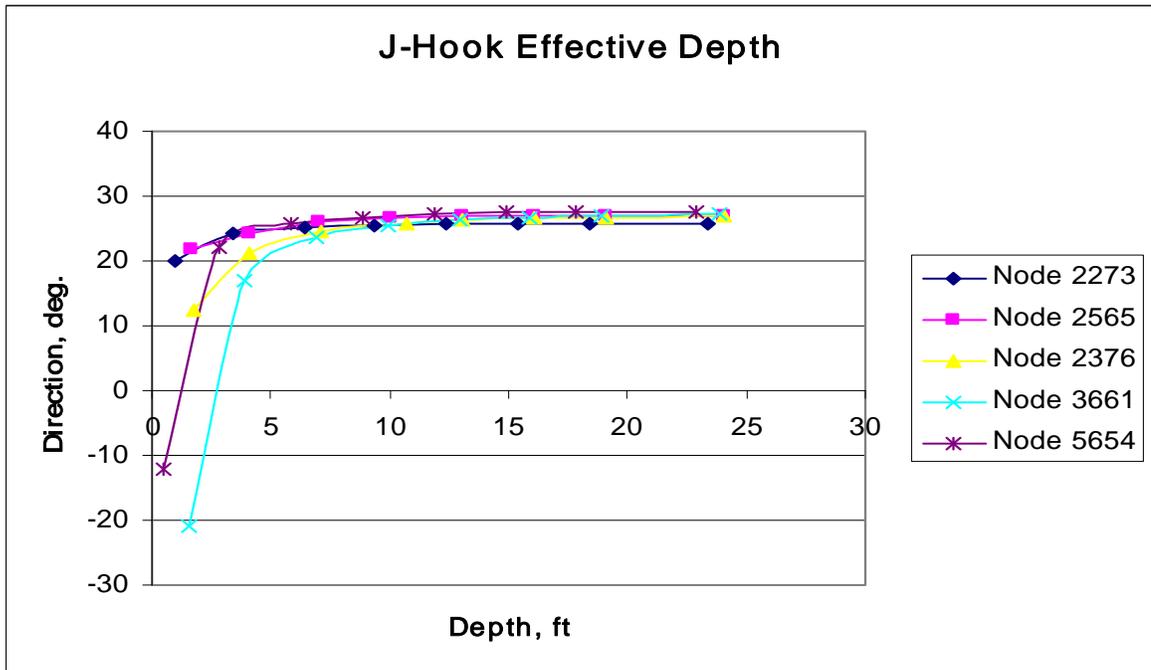
To view the depth verses flow direction, data points were selected across the structure. The depths and directions at that point were recorded for each flow rate. The results are presented in Figure 3-19 and Figure 3-21. To view the change in velocity versus depth, an additional data point was chosen just upstream to correspond with each of the points along the structure. The depth of the upstream point was plotted against the change of velocity between the upstream and downstream points. The results for the second set of data are illustrated in Figure 3-18 and Figure 3-20.

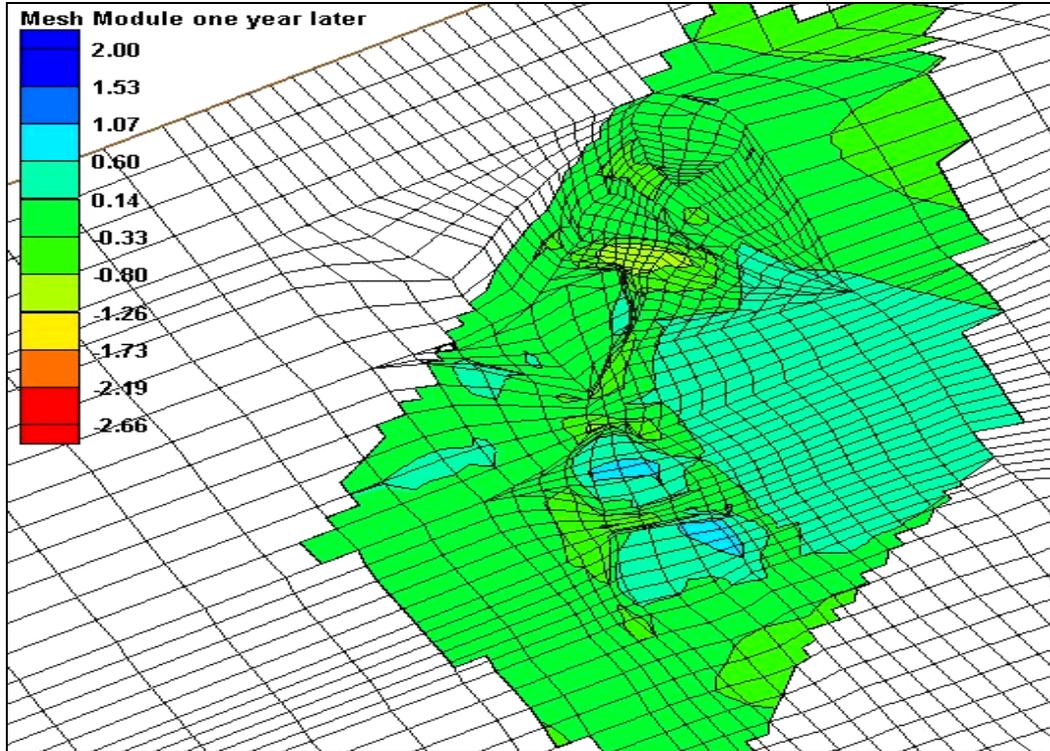
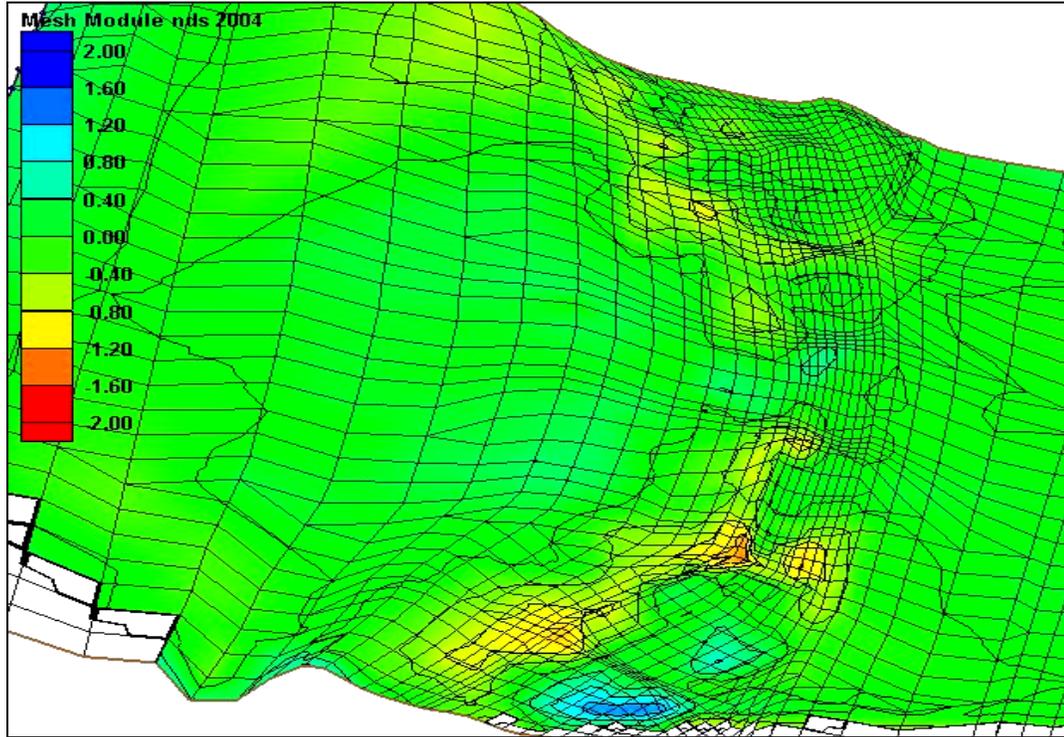
A fourth observation can be made by evaluating the erosion that took place over the year of monitoring at this site (2003-2004). To do this, bathymetric data from the fall of 2003 is compared to post spring runoff measurements in 2004. The results are shown around the vicinity of the structures themselves.

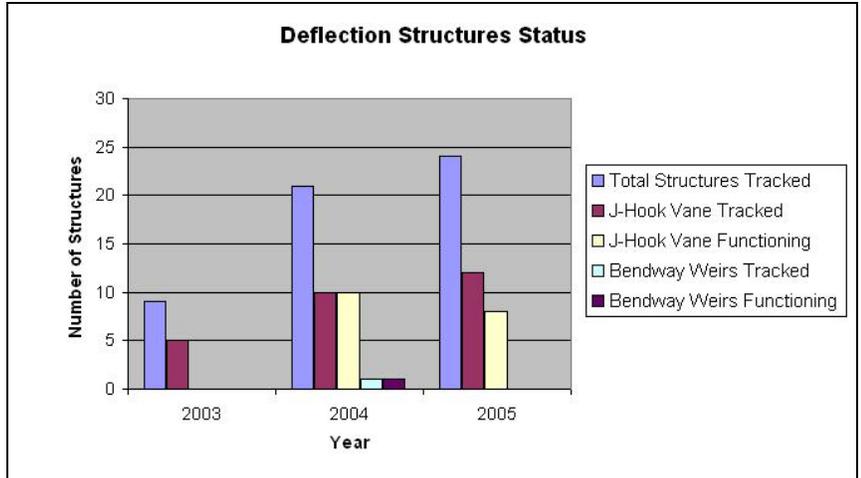
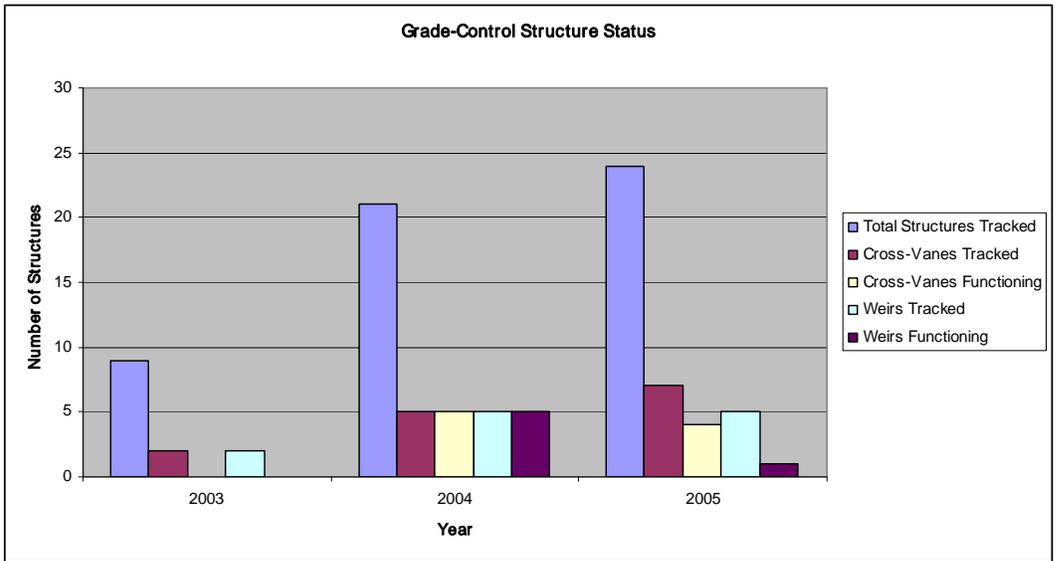
The year 2005 was an average-water year and mixed results were found for the 24.5% of the monitored structures. In 2005, a total of seven cross-vanes were monitored. Only four were still functioning as designed after spring runoff for a 57.1% success rate. There were a total of 12 j-hook vanes, of which eight were still functioning as designed after spring runoff for a 66.7% success rate. There were a total of five weirs of which one was still functioning as designed after spring runoff for a 20.0% success rate. Overall 54.2% of the structures monitored in 2005 had not failed during that year.

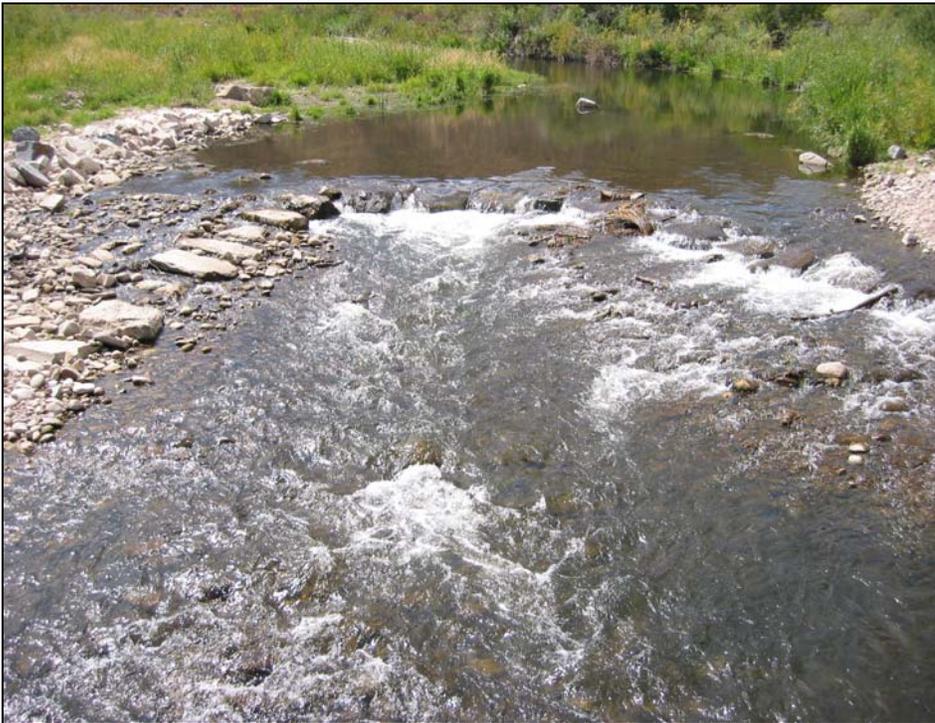
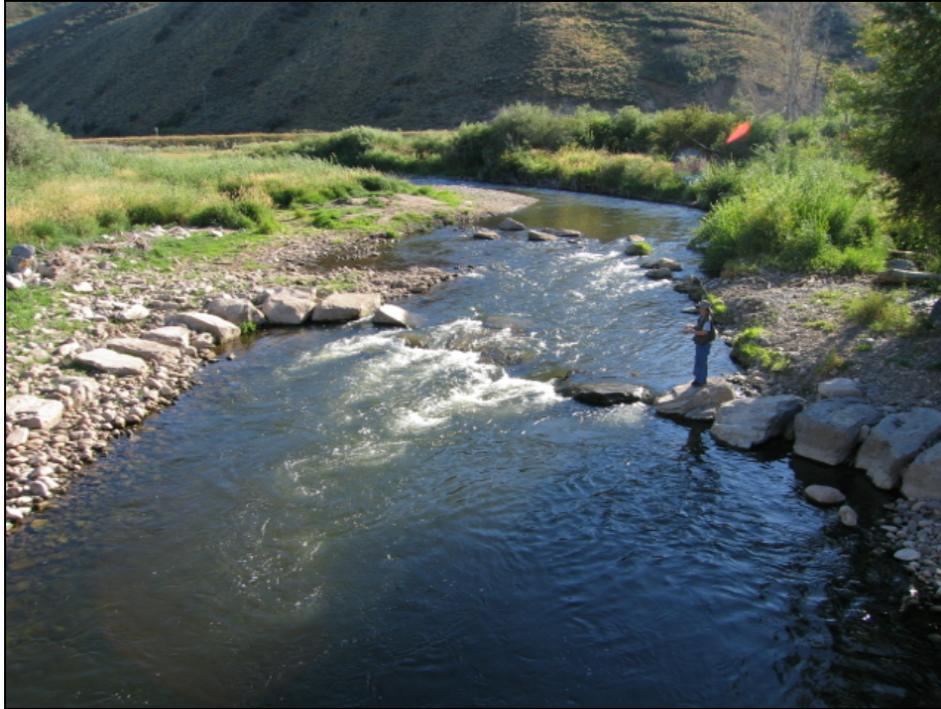
One structure was placed upstream of the bridge at Rockport State Park on the Weber River as shown in Figure 4-25 and Figure 4-26. The structure is a cross-vane placed just upstream of the bridge. The installation did not conform to Rosgen Design Methodology, which dictates the vane arms slope down at a slight angle upstream. In this installation, the vane arms were installed at a slight upstream angle.

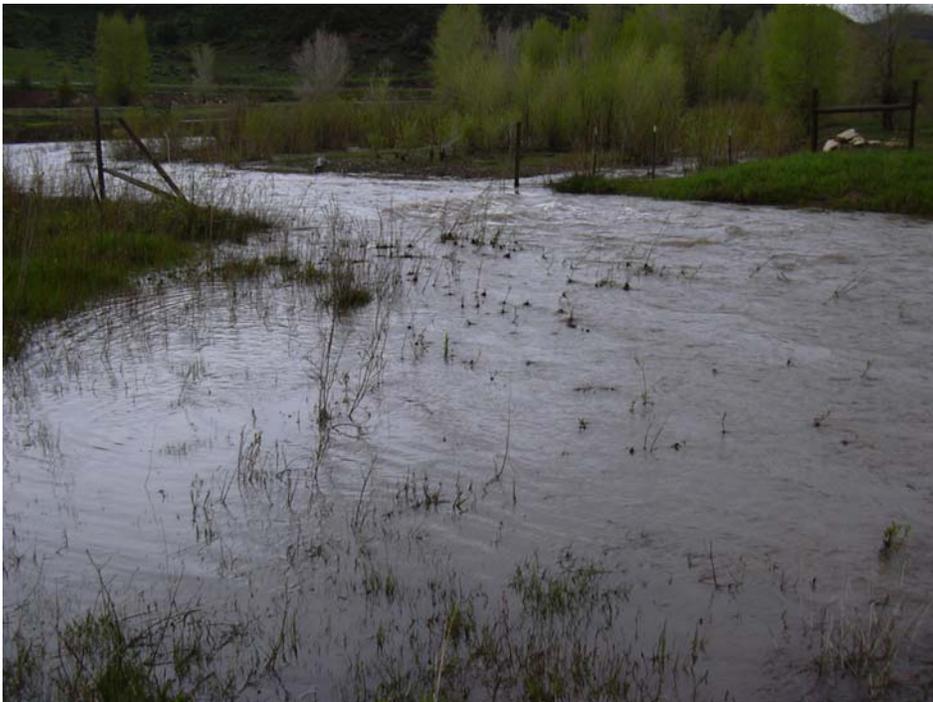
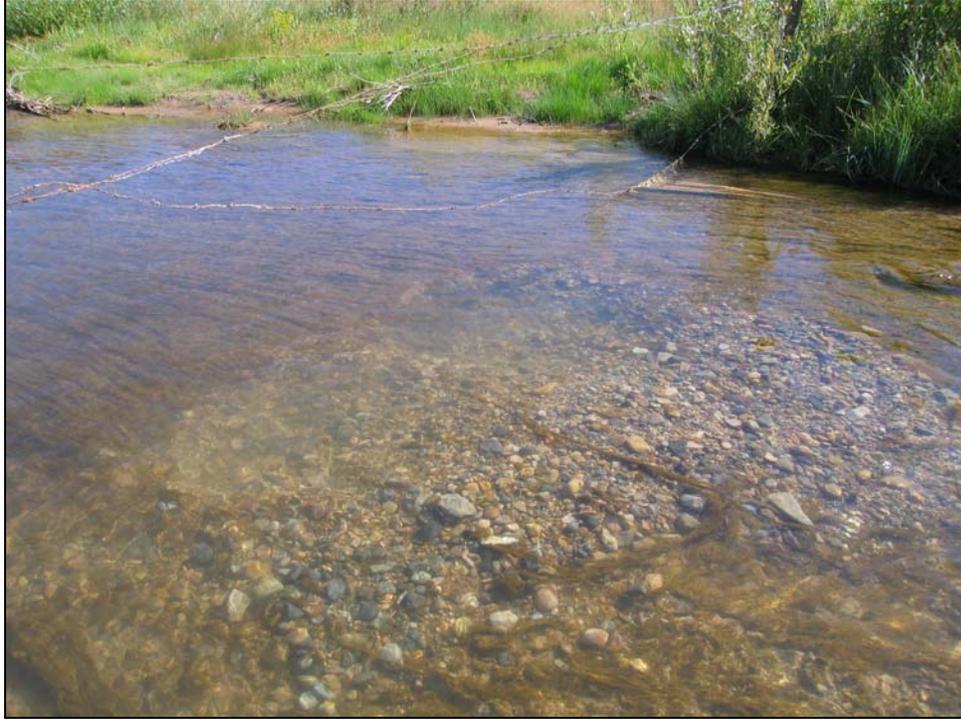
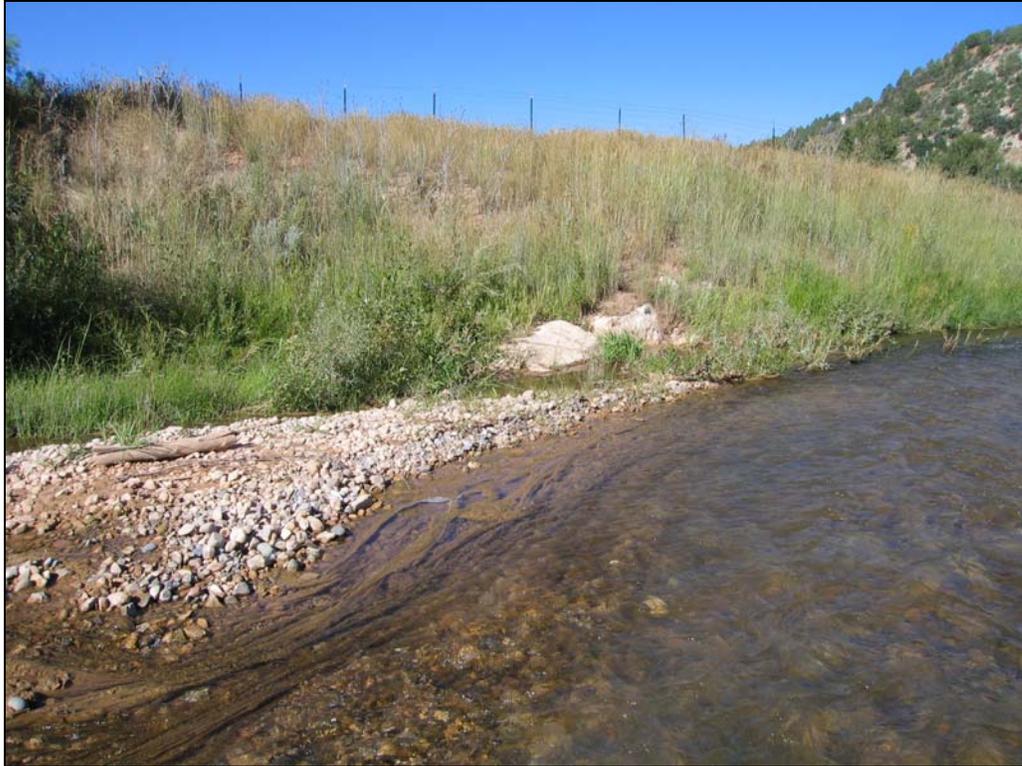
The response of the j-hook and cross-vane was unremarkable under normal flow conditions as compared to spring flows of 2005. In 2005, under average spring flows, both structures were active as water was breaking over the top of them. See Figure 4-27 for cross-vane during 2005 spring runoff. Figure 4-28 and Figure 4-29 were photos taken after 2005 spring runoff.
