Report No. UT-08.04

## **EVALUATION OF ADVANCE WARNING SIGNAL INSTALLATION**

Phase II: Long-term Monitoring

Utah Department of Transportation  
Research Division

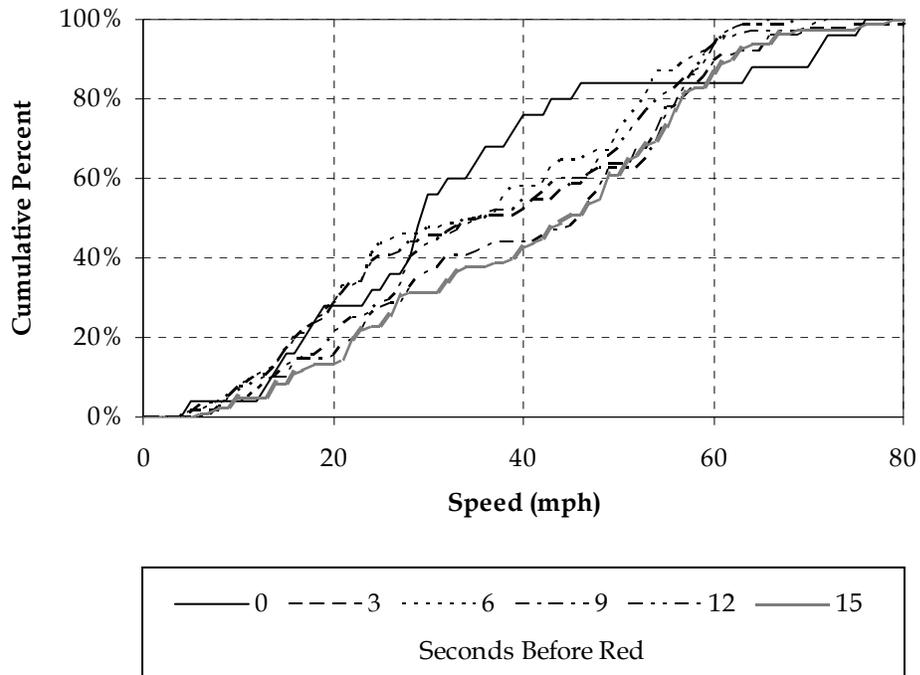
**Figure ES-1. Cumulative distribution plot for northbound AM peak speeds at the 100 foot detection zone before the AWS system was installed.**

The cumulative speed distribution plots show the change in the speed distribution for the analysis period. Figure ES-1 shows the speed distribution before the AWS system was installed. Figure ES-2 and Figures ES-3 show the speed distribution immediately after and approximately eight months after the installation of the AWS system. Figure ES-4 shows the speed distributions immediately after the change in lead flash timing to 4 seconds. Figure ES-5 shows the speed distribution approximately two years after the installation of the AWS system.

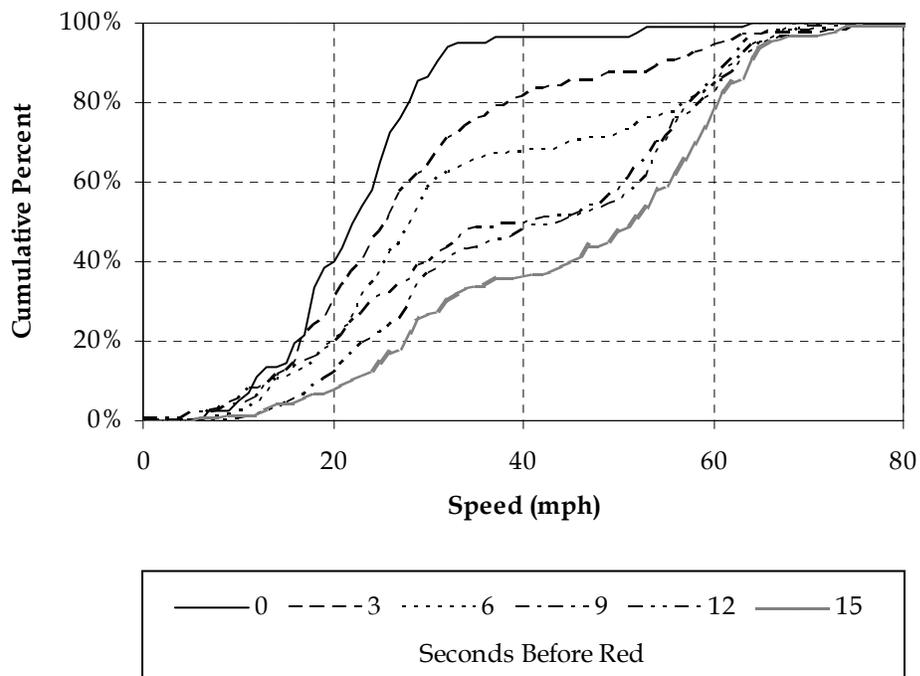
**Figure ES-2. Cumulative distribution plot for northbound AM peak speeds at the 100 foot detection zone immediately after installation of the AWS system.**

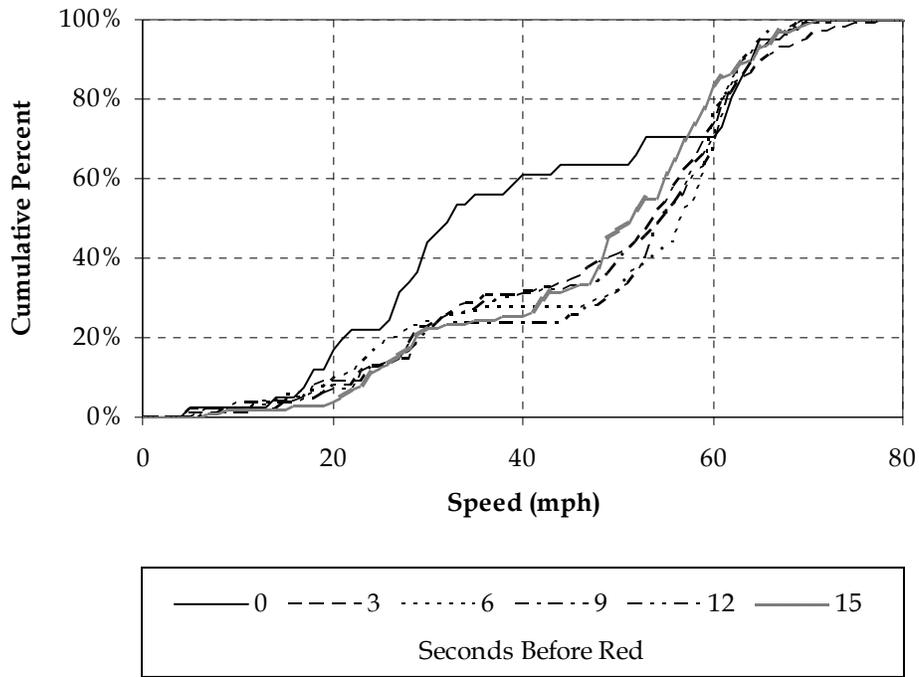
**Figure ES-3. Cumulative distribution plot for northbound AM peak speeds at the 100 foot detection zone eight months after installation of the AWS system.**

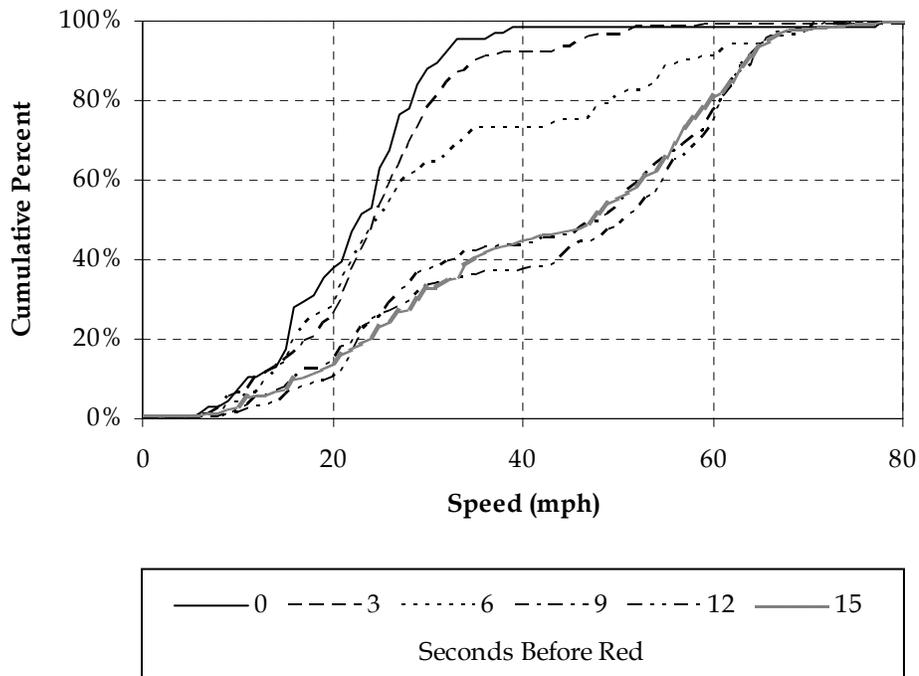
**Figure ES-4. Cumulative distribution plot for northbound AM peak speeds at the 100 foot detection zone immediately after adjusting the lead flash to 4 seconds.**

It was found that the lowest 85<sup>th</sup> percentile speeds decreased from 62 mph to 31 mph immediately after the reduction in lead flash timing then increased to 52 mph two years later, which is 3 mph lower than the lowest 85<sup>th</sup> percentile speed before the installation of the AWS system. Although in general speeds decreased, they also became more variable, as illustrated by the fact that median speeds decreased more than did the 85<sup>th</sup> percentile speeds, which stayed about the same or, in some instances, increased. These trends suggest that the lead flash timing of 4 seconds resulted in lower speeds, which may lead to increased safety at the intersections, but that more variable speeds also resulted, which may have a negative impact on safety.

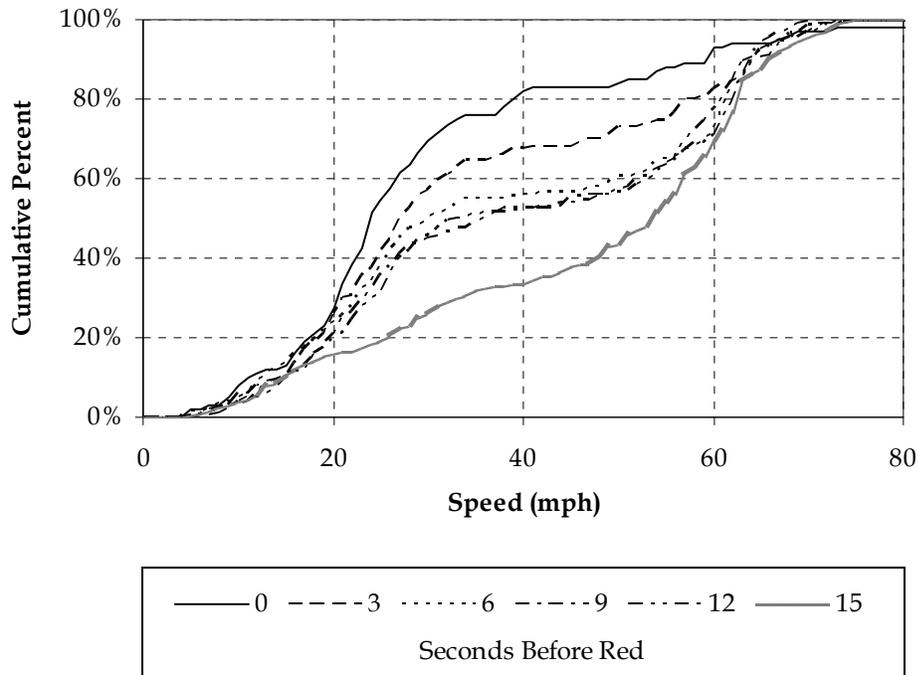
**Figure ES-5. Cumulative distribution plot for northbound AM peak speeds at the 100 foot detection zone two years after installation of the AWS system.**

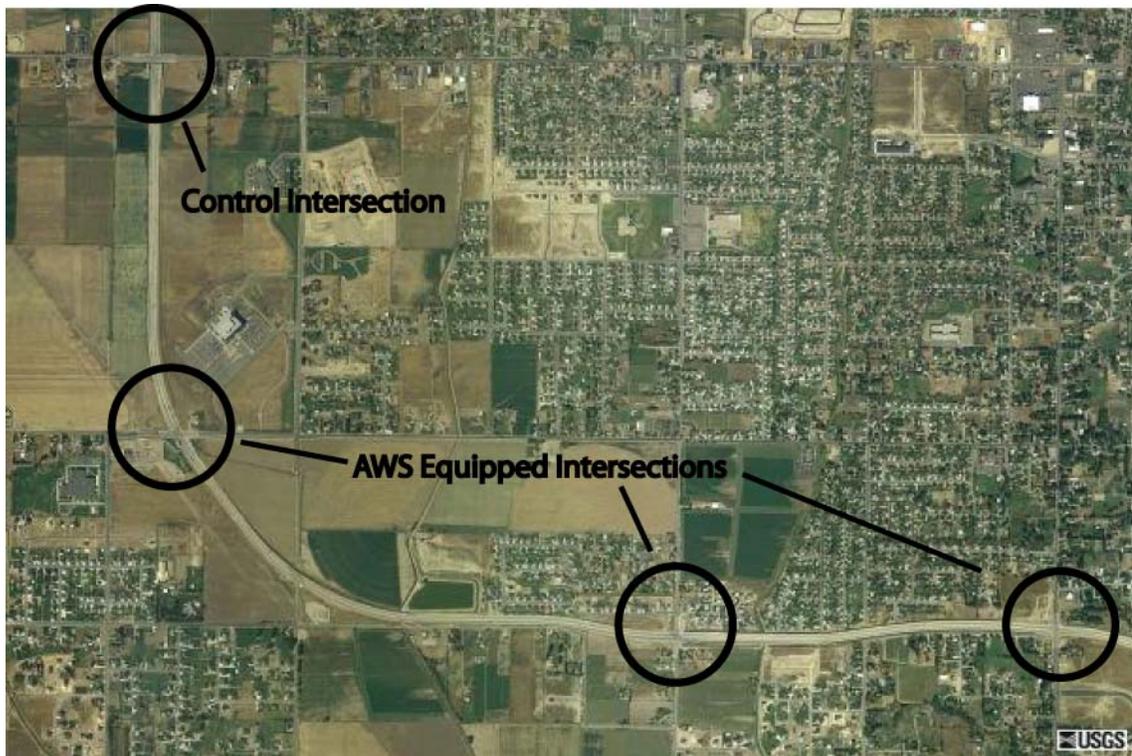
**Figure 3-2. Study and Control Intersections Aerial Photograph (13).**

Bangerter Highway is a divided suburban and rural multilane facility, with a posted speed limit of 60 mph. At the start of the study period, it had two lanes in each direction, but by the end of the study period an additional lane was added in each direction through a re-striping project. Bangerter Highway has limited access, with intersections spaced about one mile apart in the study area. The land uses surrounding Bangerter Highway in the study area include suburban development and rural open areas, with commercial and residential developments concentrated around each intersection, as shown in Figure 3-2 (7).

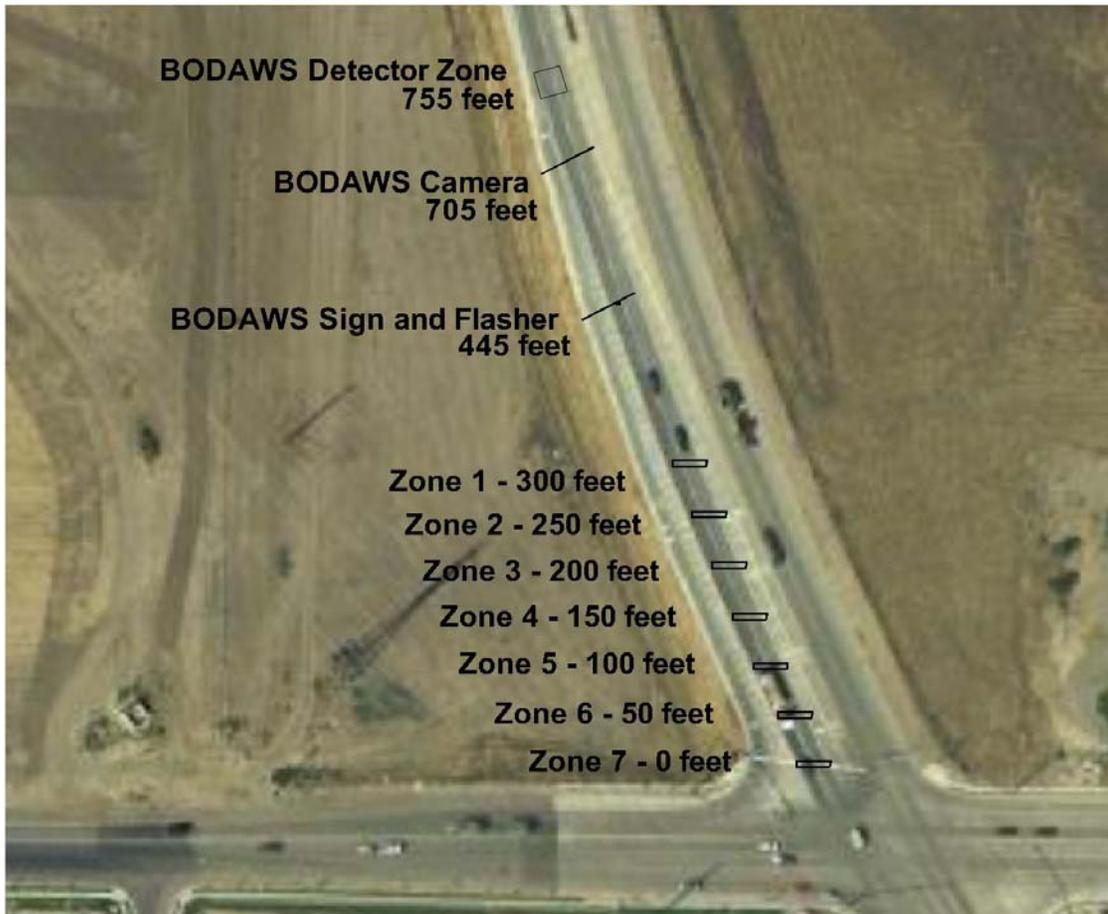
**Figure 5-2. Sensor zones and detection equipment layout (7).**

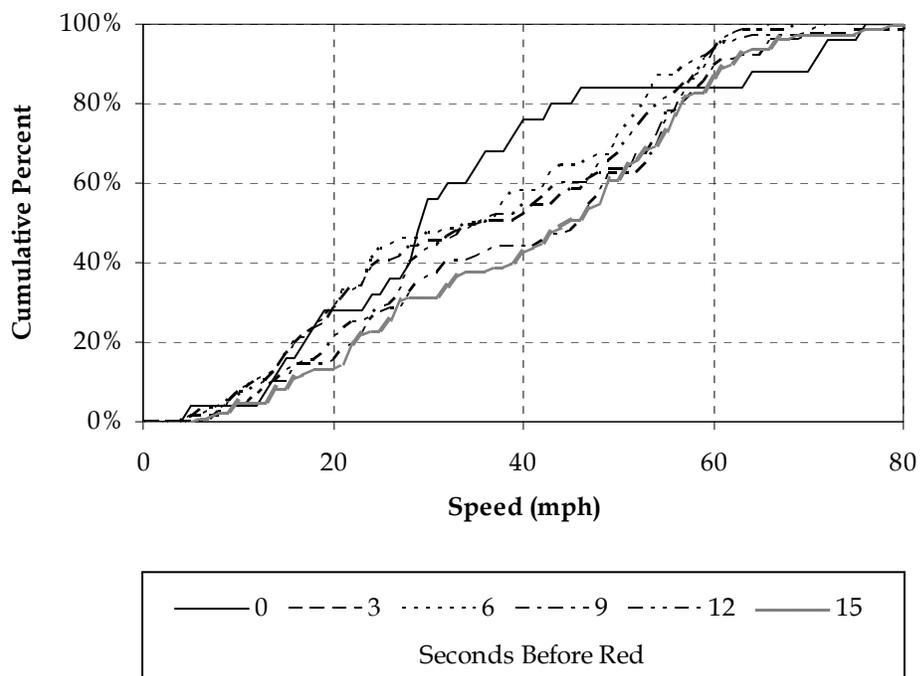
**Figure 5-3. Cumulative distribution plot for northbound AM peak speeds at the 100 foot detection zone for P1.**

The cumulative speed distribution plots show the change in the speed distribution for each analysis period. Figure 5-3 shows the speed distribution before the AWS system

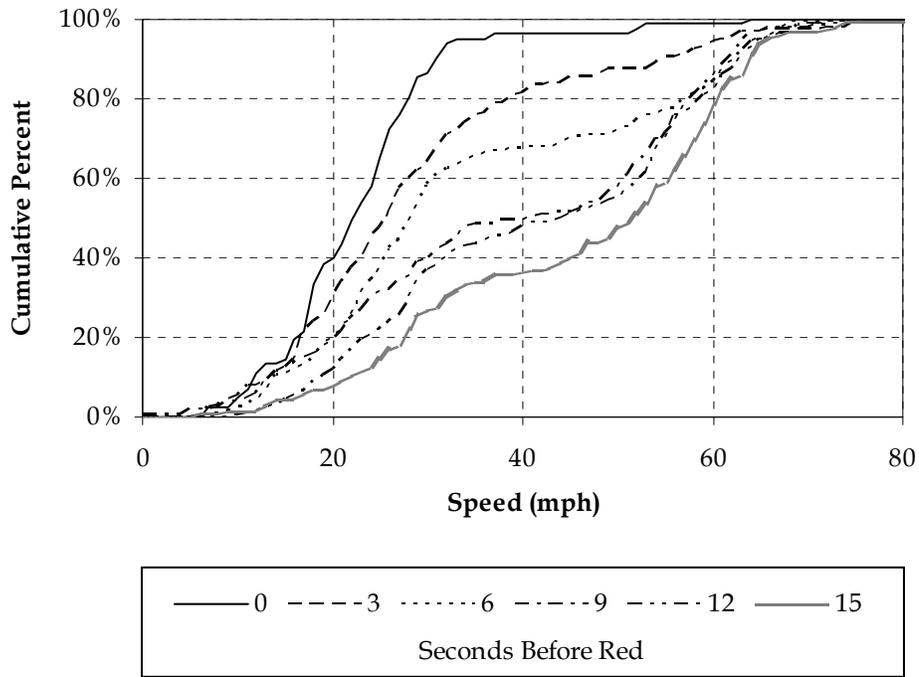
**Figure 5-4. Cumulative distribution plot for northbound AM peak speeds at the 100 foot detection zone for P2.**

was installed (P1). Figure 5-4 and Figure 5-5 show the speed distribution immediately after and approximately eight months after the installation of the AWS system (P2 and P3). Figure 5-6 and Figure 5-7 show the speed distributions immediately after the change in lead flash timing to 5 seconds and 4 seconds (P4 and P5), respectively. Figure 5-8 shows the speed distribution approximately two years after the installation of the AWS system (P6). The lowest and highest 85<sup>th</sup> percentile speeds for the plots are summarized in Table 5-2.

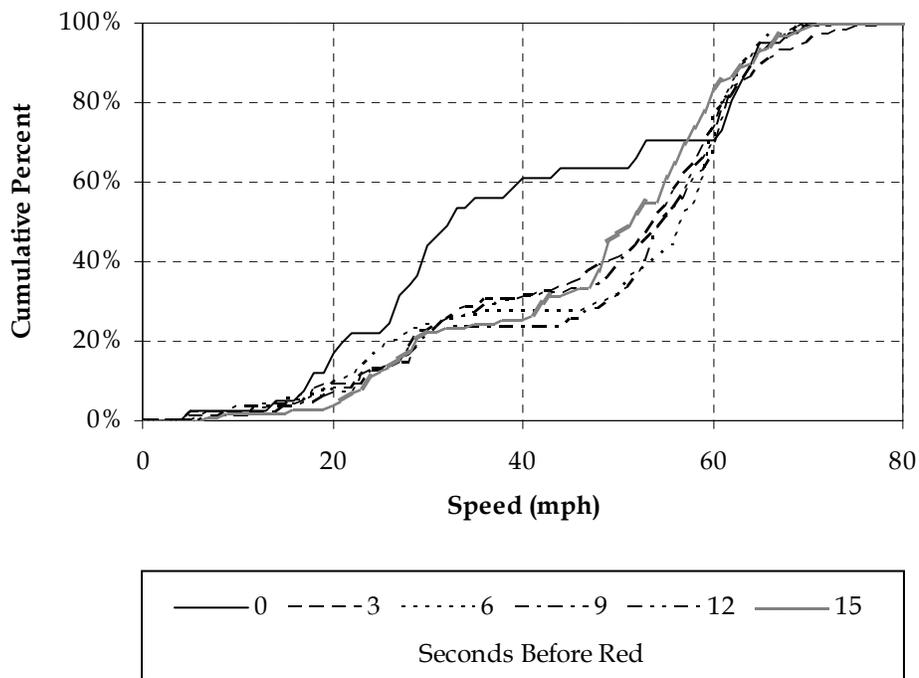
**Figure 5-5. Cumulative distribution plot for northbound AM peak speeds at the 100 foot detection zone for P3.**

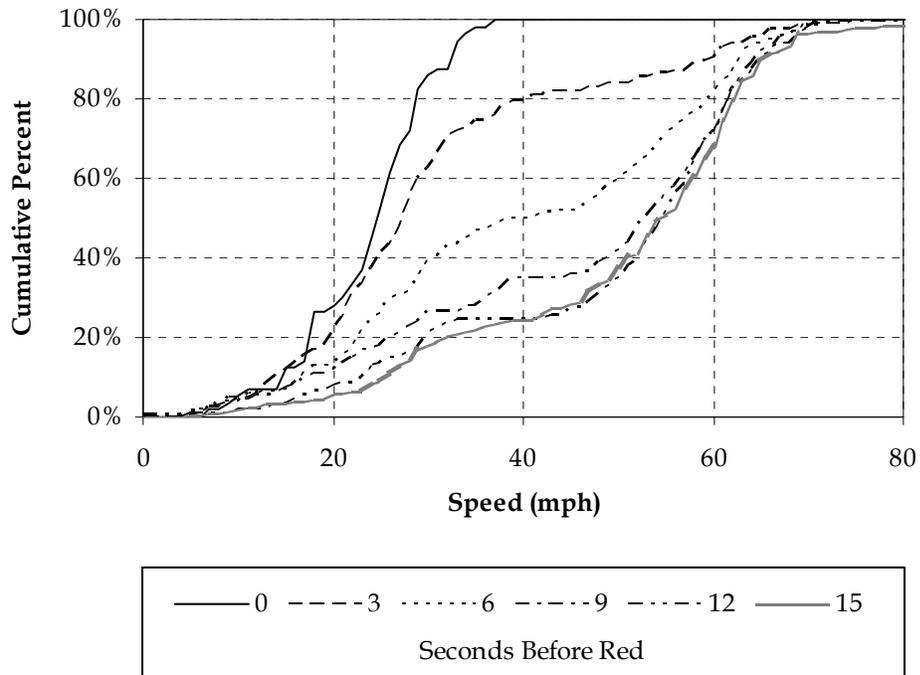
**Figure 5-6. Cumulative distribution plot for northbound AM peak speeds at the 100 foot detection zone for P4.**

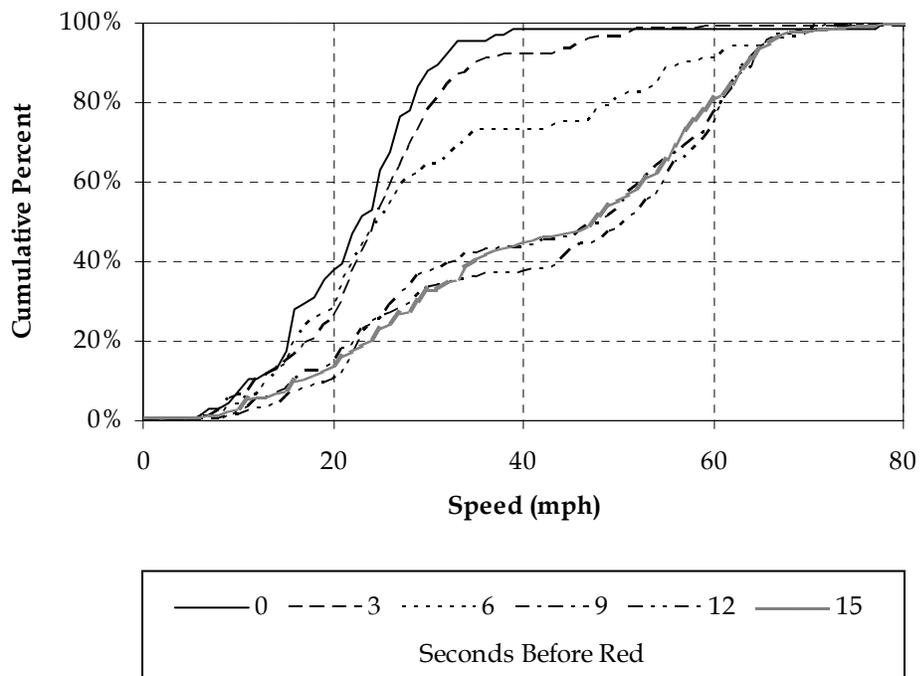
**Figure 5-7. Cumulative distribution plot for northbound AM peak speeds at the 100 foot detection zone for P5.**

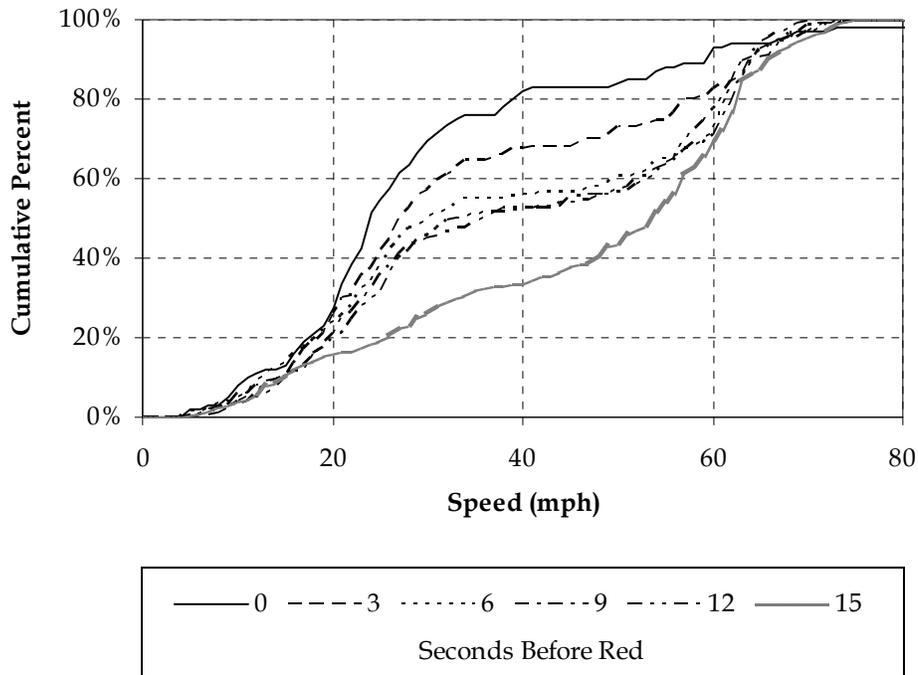
**Figure 5-8. Cumulative distribution plot for northbound AM peak speeds at the 100 foot detection zone for P6.**

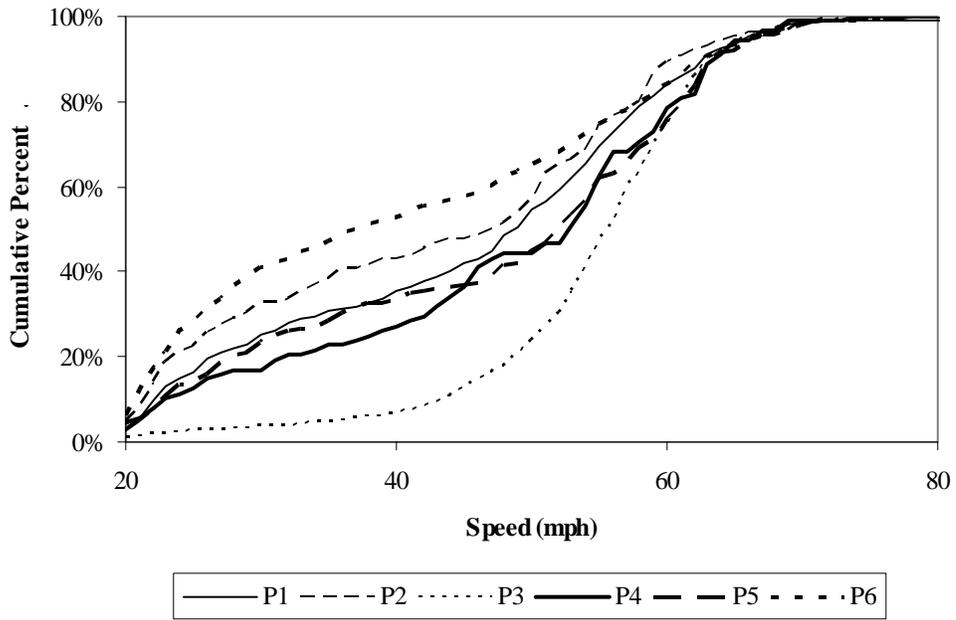
Figure 5-12. Northbound red light running speed distribution

Figure 5-12 shows the speed distribution for vehicles that ran the red light at speeds greater than 20 mph at less than 4 seconds into the red interval. The RLR speeds for P2 and P6 are less than the RLR speeds for P1, and those for P3, P4 and P5 are greater than those of P1. The highest speeds were recorded during P3, which, like the RLR rates for P3, suggests that the lead flash during P3 may have been too long. Drivers may have felt that they had enough time to accelerate through the intersection when they saw the activated AWS sign. The lowest RLR speeds were recorded during P6, which may suggest that the 4 second lead flash was effective at encouraging lower speeds.

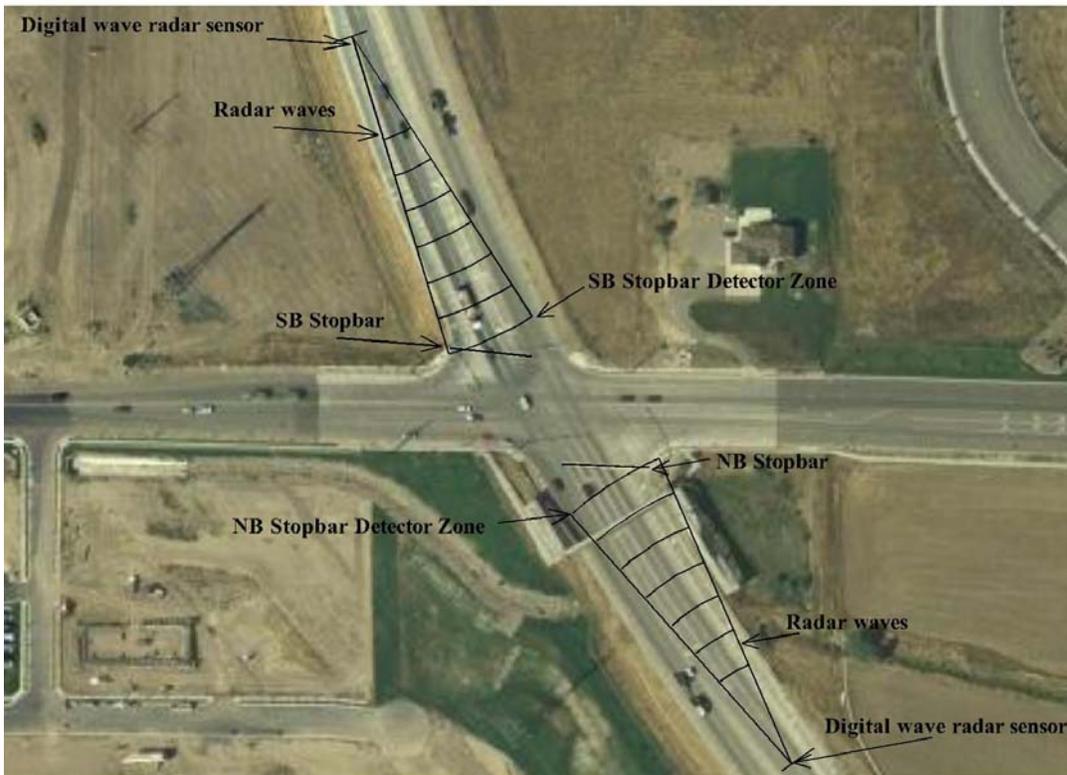
Figure 5-13. Spherical path of radar waves and skewed intersection geometry (7).

As indicated, the RLR rates and speeds may have also been affected by a number of other factors at the intersection. For example, over the course of the study, significant changes in land used were made around the intersection, including an empty field being developed into a Home Depot. The developments around the intersection likely increased the number of right-turning northbound bound vehicles, which may have been traveling greater than 20 mph as they made the right turn. The configuration of the Digital Wave Radar™ sensor may have also contributed to recording right-turn movements as RLR. Because the northbound approach to the intersection was curved, and because the radar waves emanated from sensor in a spherical pattern, the stop bar detection zone may have been in front of the actual stop bar, as illustrated in Figure 5-13 (7). As a result, right turning vehicles may have been recorded as running the red light when in fact they were turning after stopping at the stop bar.
