Report No. UT-05.07

Annual Experimental Features Report

Utah Department of Transportation
Research Division

June 2005

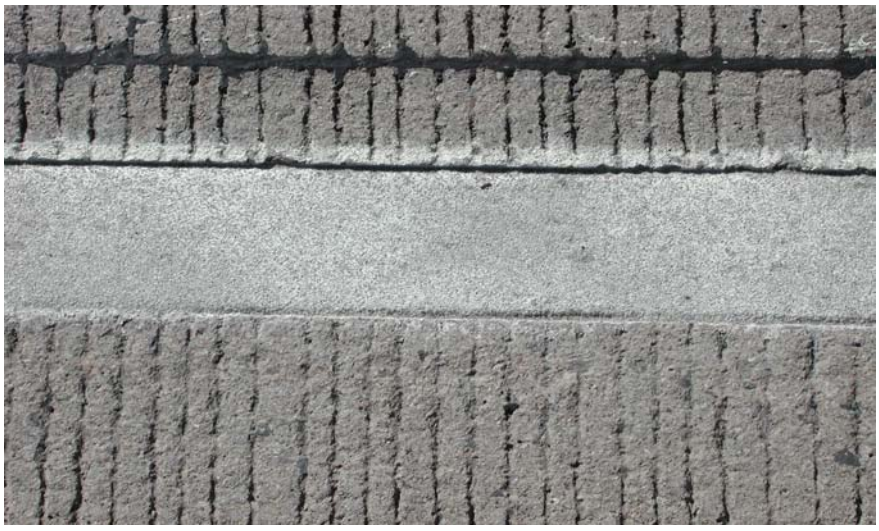
Soundings using a chain revealed one air pocket (or void) where a hairline fissure was visible and under which a concrete crack appeared (small, isolated edge failure; see Figures 2 and 3). No other surface deficiencies were apparent. An evenly cut groove on the existing PCCP provided good material and substrate adhesion, evidenced in the clean profile shown in Figure 4. Small air intrusions were occasionally manifested as small surface flaws, having no detrimental effects on bonding and adhesion (Figures 5 and 6).

Figure 2. LUMIMARK PAVEMENT MARKING NEAR SALT LAKE INT'L. AIRPORT

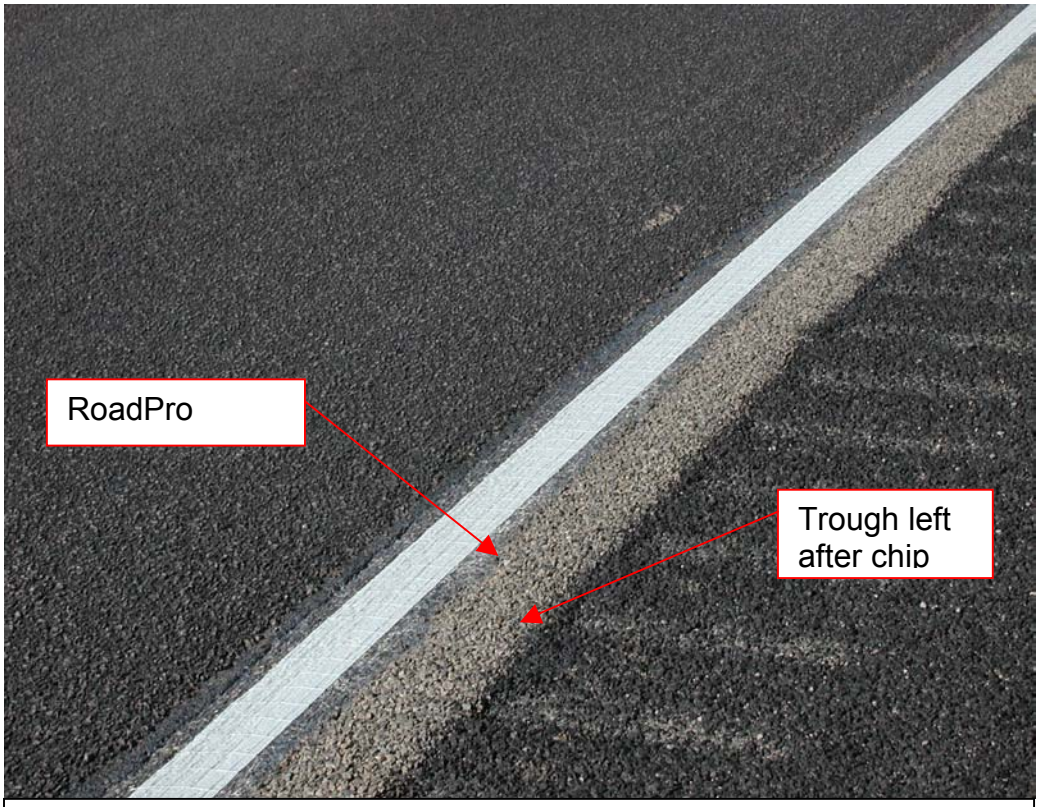
Figure 3-Installed tape on US-6

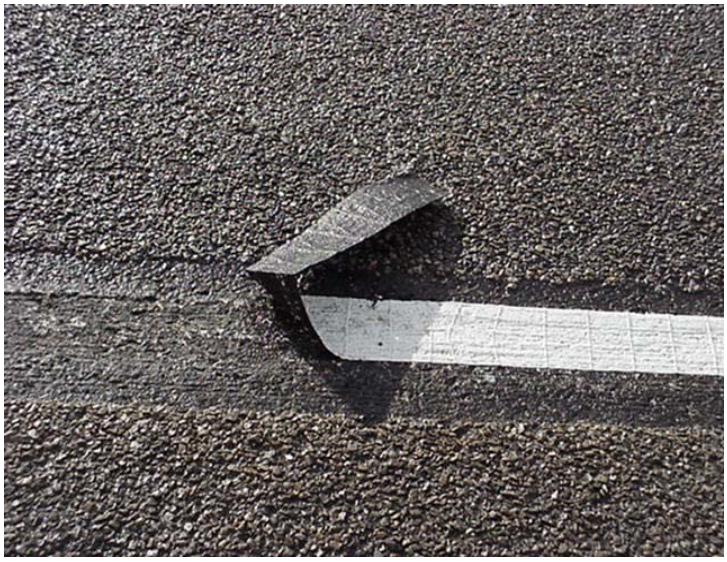
Failed tape on SR-6

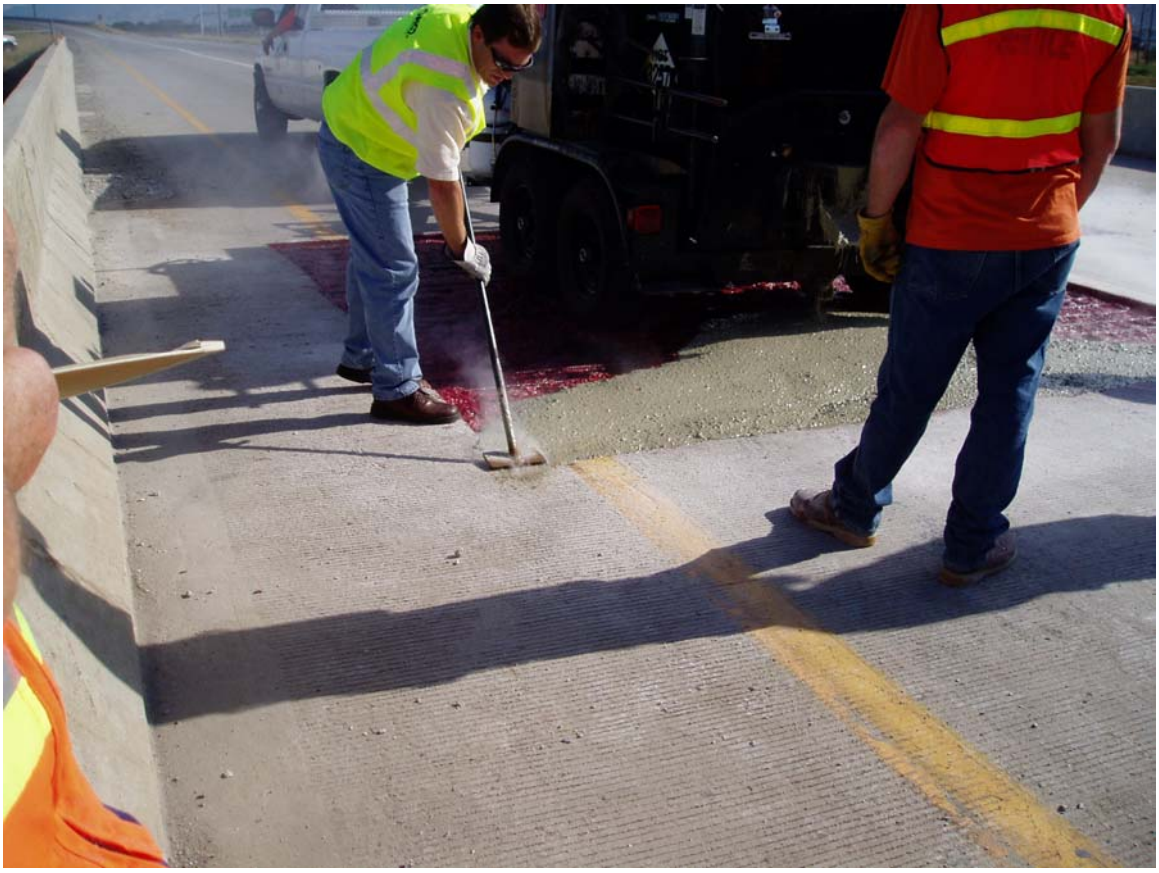
Heated spreaders were used to push the polymer into place where it began self-leveling.

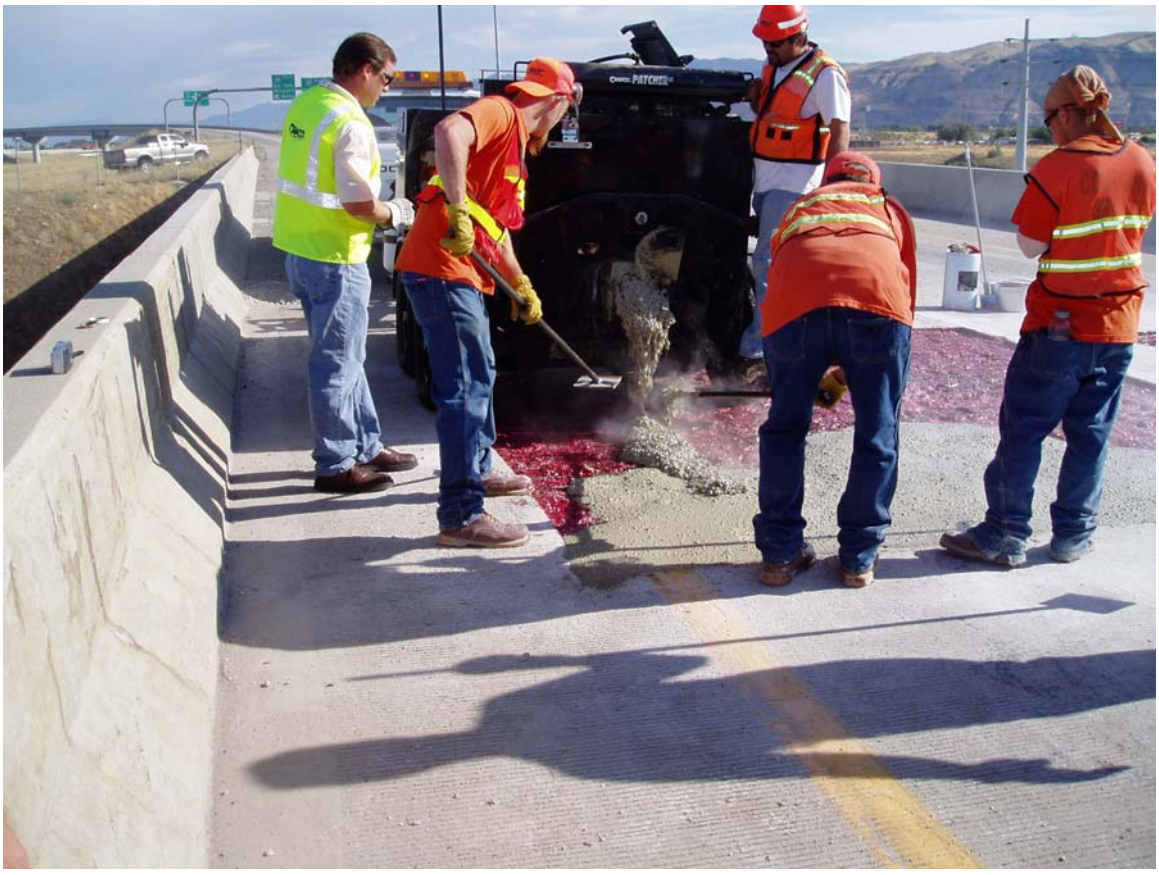
The corners of the patch area were worked into place.

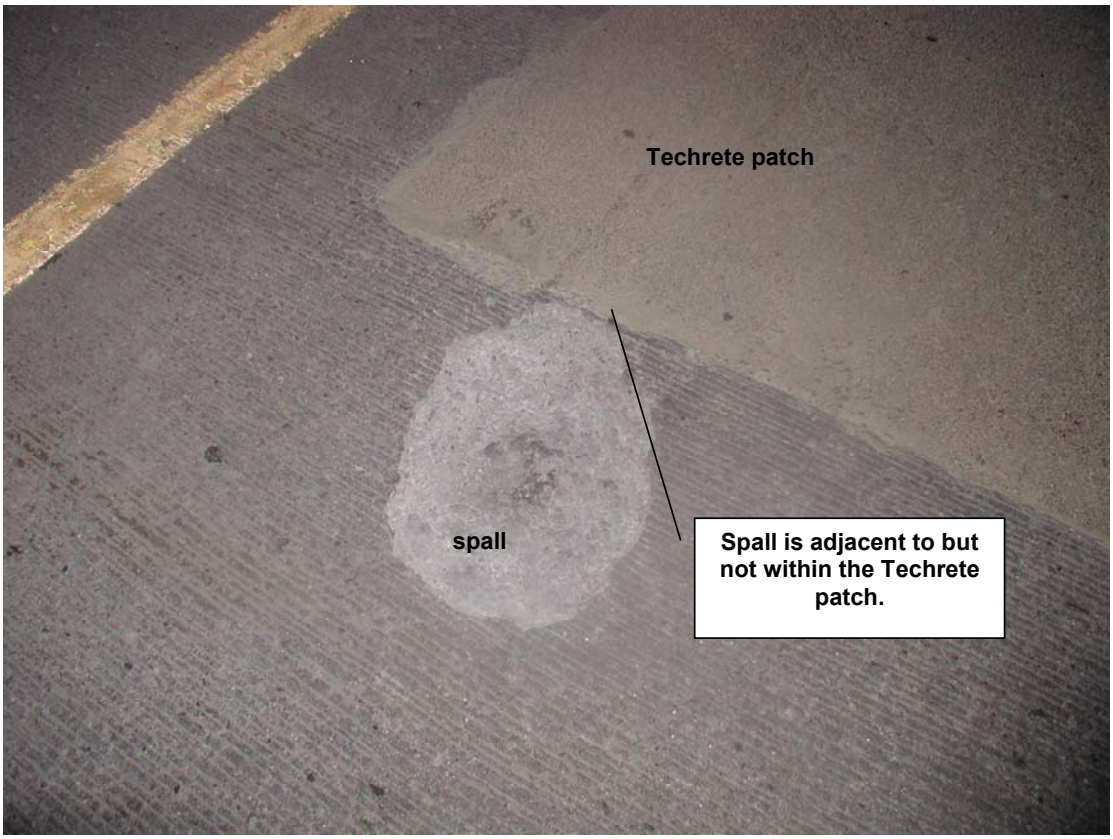
Techrete patch appears to be intact with no evidence of degradation
