Report No. UT-07.01

TIME DEPENDENT EFFECTS FROM MONITORING OF STATE STREET BRIDGE FRP COMPOSITE RETROFIT

University of Utah
Department of Civil & Environmental Engineering

December 2006

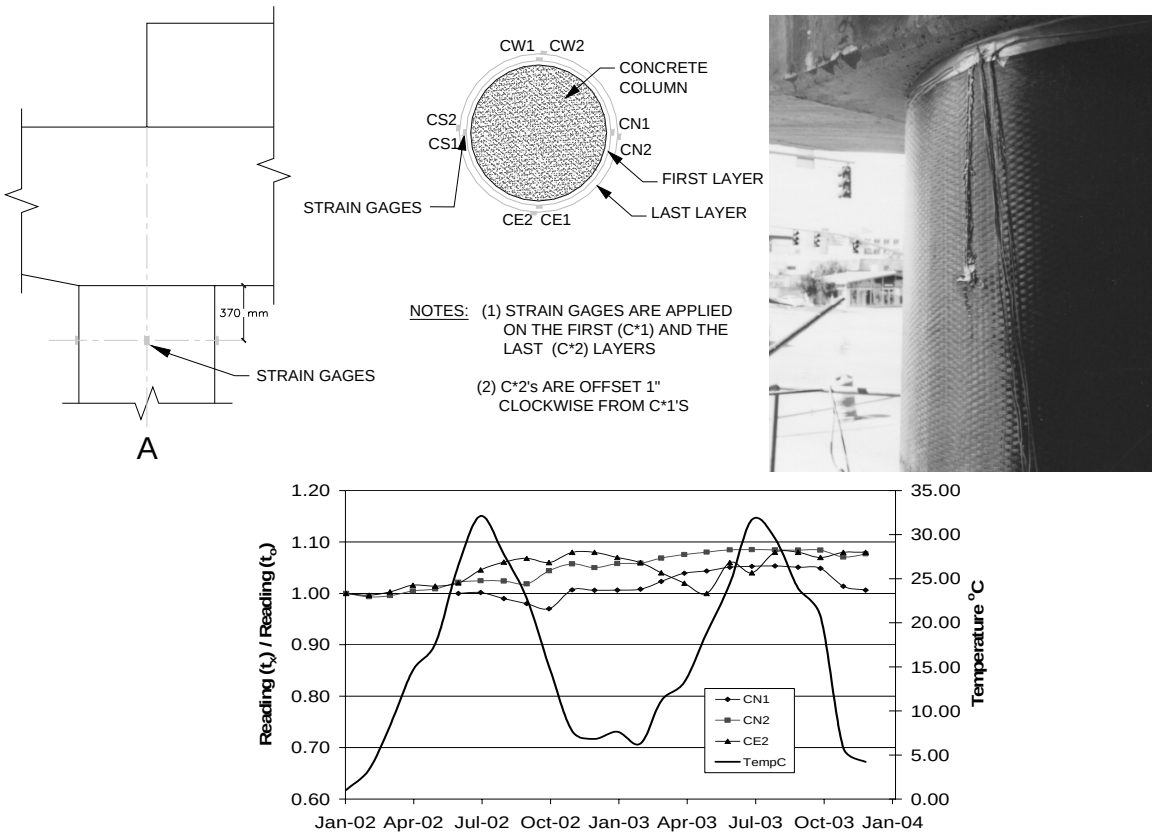
Figure 3. Location and readings of strain gauges on southeast column.

Temperature and traffic loads had a major effect on daily strain variations in the CFRP composite. Figures 3 and 4 show the average monthly strain measurements of several randomly chosen strain gauges, plotted with the average monthly temperature over a two-year period. For uniformity, all strains were normalized by the initial reading. Figure 3 shows that after two years there is a moderate increase in strain over time for the column strain gauges, independent of temperature; similarly, Figure 4 shows that for the cap beam gauges there is also an increase in strain; the same trend is followed by the strain gauges attached to the FRP at the cap-beam column joint, and the FRP U-straps. The cause of the variation and general increase in strain are not understood well; however, it was noted that a number of strain gauges stopped functioning after long periods of operation. Therefore, the strain gauges used in this project are not recommended for the purpose of long term monitoring. There are other devices that are now being developed for long term monitoring of FRP composite systems, such as fiber optic sensors.

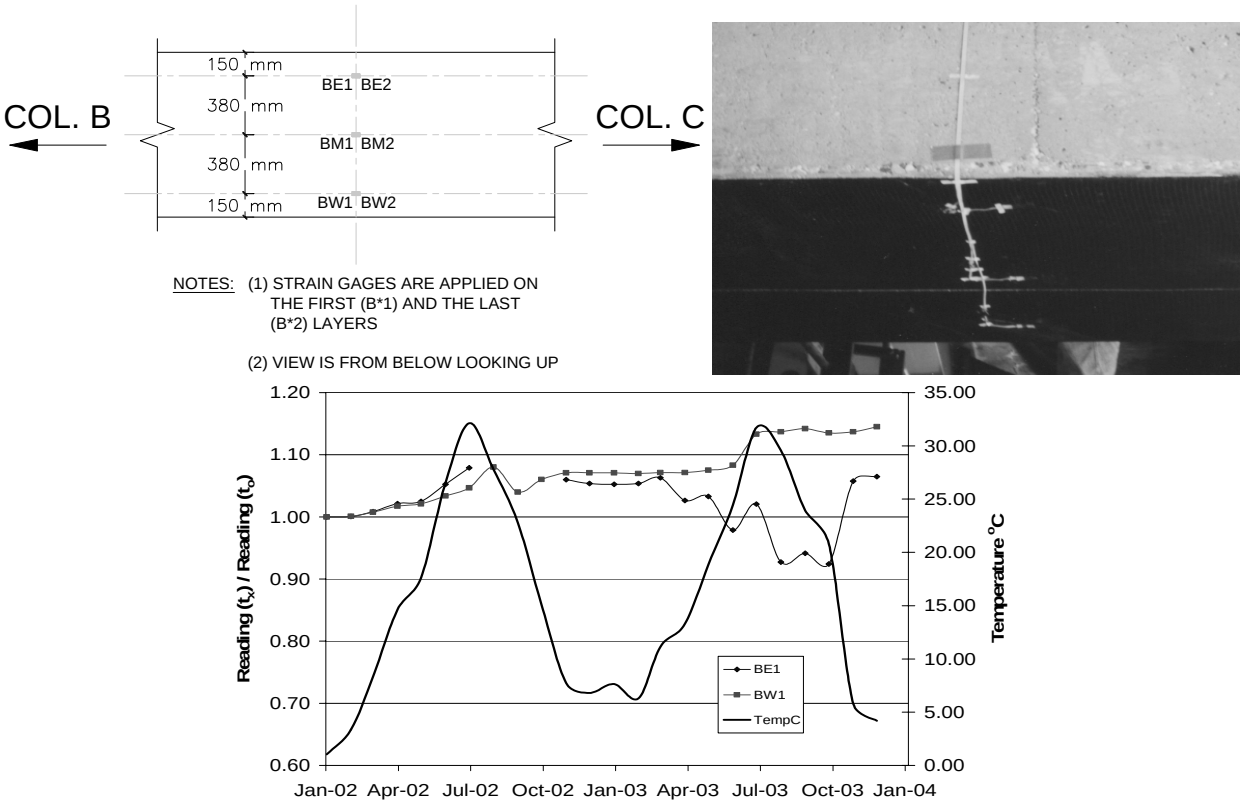
Figure 4. Location and readings of strain gauges on underside of cap beam.

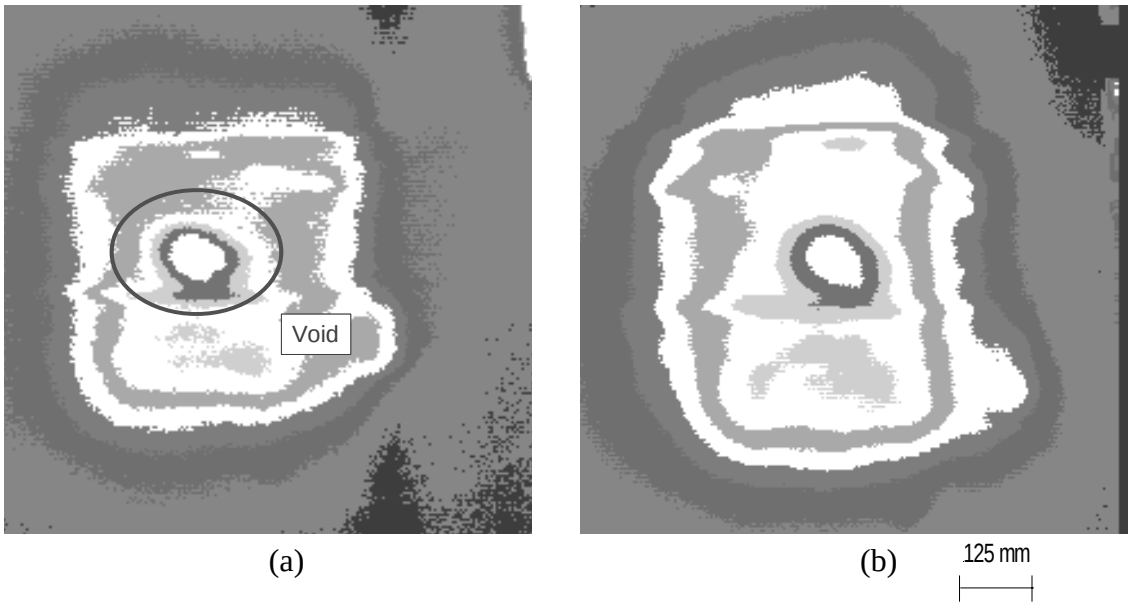
Figure 5 shows a thermographic image of a large void discovered on one of the columns, which clearly shows up within the heated area of the column. Image (a) was taken in June 2003 and image (b) was taken six months later in December 2003. The size of the oval shaped void in

Figure 5(a) was approximately 100 mm in the horizontal and 80 mm in the vertical direction. It appears that the size of the void has stayed relatively constant from June to December and that the void was probably created at the time of application of the CFRP composite. Quantitative evaluation requires more extensive measurements, and research in this area is currently ongoing (Starnes et al. 2003). No other voids discovered from images taken in June 2003 have shown any change or indication of bond degradation.

Figure 5. Thermographic images of void in column: (a) June 2003; (b) December 2003.

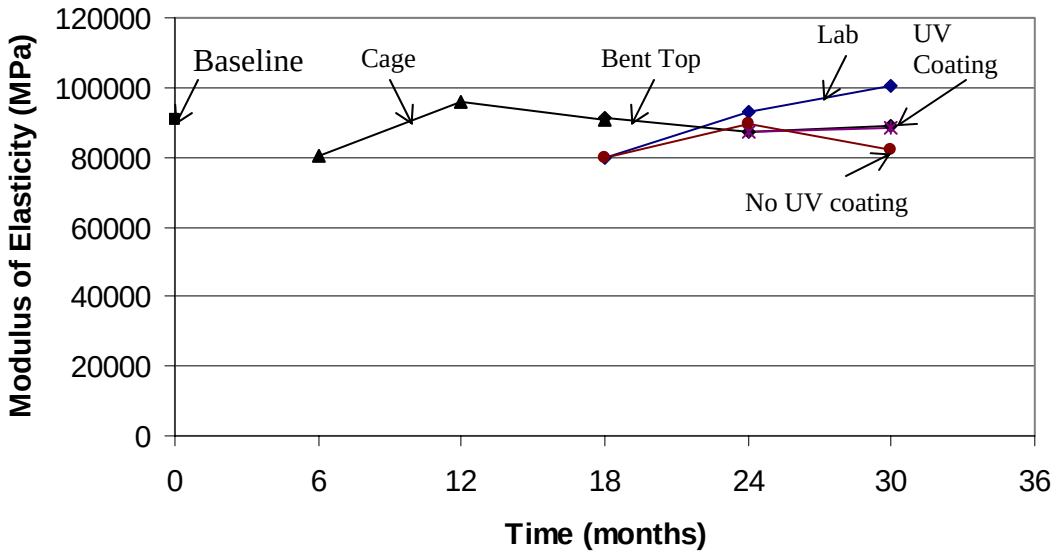
Table 7 shows the test results and compares them to the baseline specimens, which are the 415 tests carried out during construction, and shown in Table 5. The average of five specimens for each test is reported in Table 7. The results indicate that the ultimate strength capacity in every group, except the bent top, is increasing. The increase in ultimate strength capacity for the lab panels is 12%, and for the cage panels 9%; for the panels at the bent top there is an ultimate strength capacity decrease of 3%, and for the patches very little difference. The lab panels had an increase in elastic modulus of 11%, the cage panels had no significant increase, the bent top panels and painted patches with an UV coating had a decrease of 2%, and the patches not painted with an UV coating had a decrease of 9%. Thus, the elastic modulus of the patches not painted with the UV coating seems to be affected adversely by environmental exposure, as shown in Figure 6.

Figure 6. Modulus of elasticity of CFRP composite from tensile coupons.

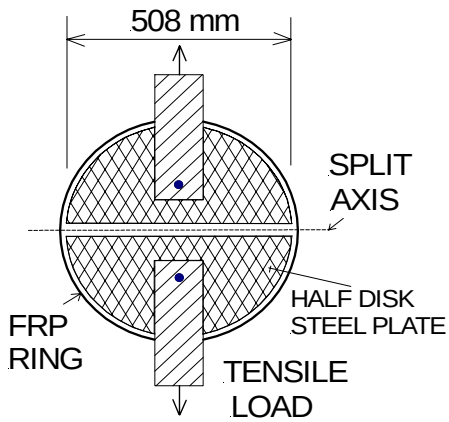
Figure 7. Split-disk fixture for testing CFRP composite rings.

The second type of test examined the hoop strength capacity of the CFRP composite. Throughout the construction phase in the summers of 2000 and 2001, CFRP composite cylinders were made by wrapping five CFRP composite layers around 508 mm diameter stainless steel drums. After the composite had cured, the cylinders were removed from the drums and taken to the three different storage locations. Tests were performed using the split disk method, according to ASTM D2290 (ASTM 2001b). The split disk ring test has a 25 mm-wide ring tested in the device shown in Figure 7. The CFRP ring is tested in tension so the direction of pull load is perpendicular to the split axis of the fixture; a displacement rate of 1mm/min was used. The test introduces high tensile stresses in the CFRP ring at the split line of the fixture, creating a line of pure tension, and the split disk test is easier to perform than the similar pressurized ring test.

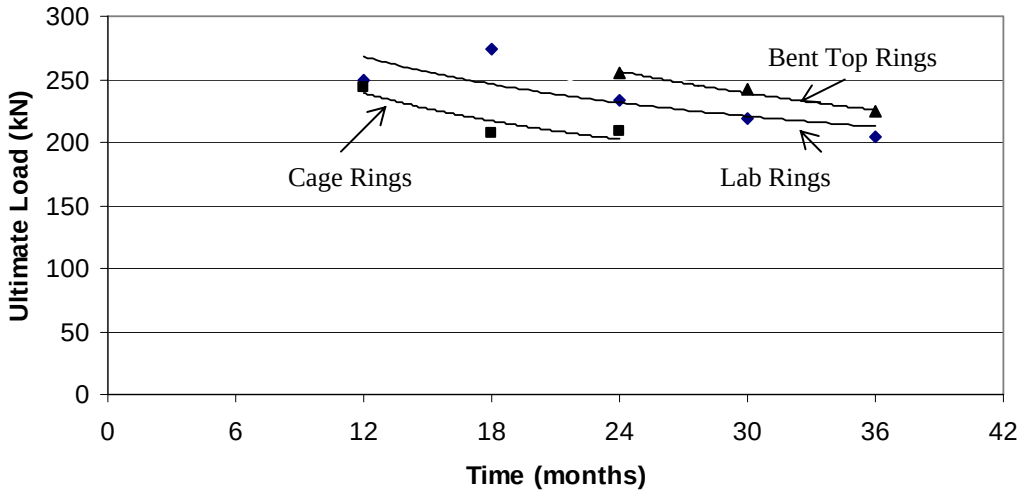
Figure 8. Experimental results for CFRP composite rings with split-disk fixture.

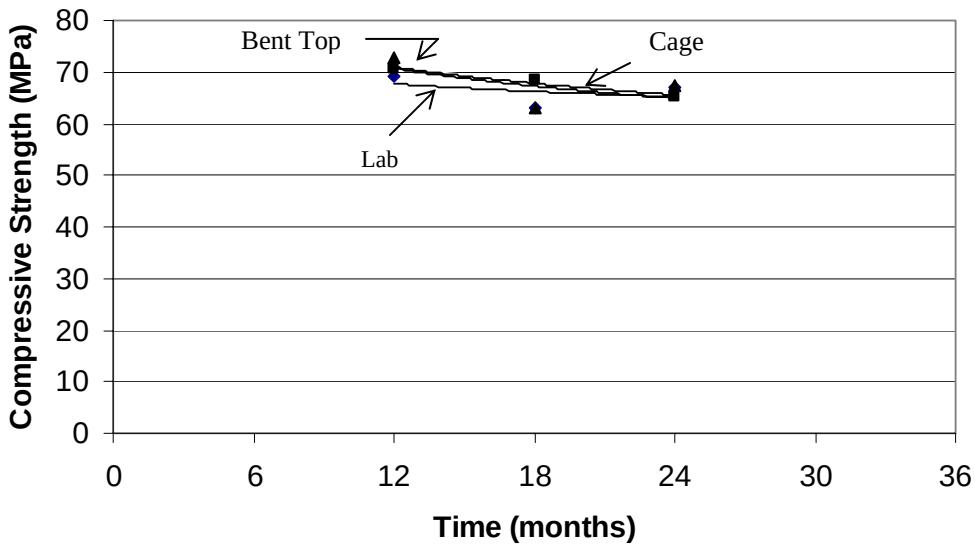
Figure 9. Experimental results for compressive strength of CFRP-confined concrete specimens.

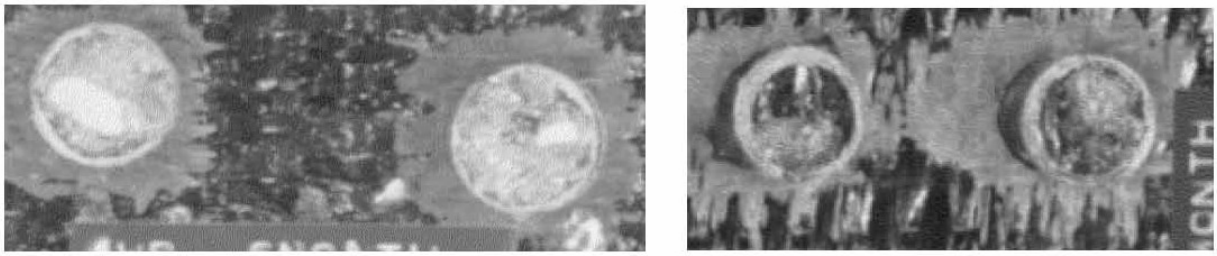
Table 10 shows that initially the average bond strength of the CFRP composite on the water-jetted side of the concrete block was 45% stronger than the wire-brushed side. After six months the water-jetted side showed a significant loss of strength, whereas the wire-brushed groups showed a smaller loss in bond strength capacity; there is no apparent reason for this behavior. Figure 10 shows that the 6-month block failures occurred only in the concrete, but the 12-month block failures occurred in the matrix-to-concrete interface. The water-jetted side continues to exhibit a higher average bond strength capacity than the wire-brushed side. The laboratory specimens generally performed better than field specimens, indicating that environmental factors, such as humidity and UV radiation variations affect CFRP composite-to-concrete bond strength. There has been no visual indication of damage to the concrete, or any steel reinforcement corrosion due to the application or presence of the CFRP composite. This is significant because one important reason for covering the entire surface of the bridge with CFRP composite jackets, as shown in Figure 2, was to encapsulate the reinforced concrete structure in order to eliminate or minimize any further steel corrosion degradation of the bridge.

Figure 10. CFRP composite-to-concrete pull-off adhesion test: (a) 6 months, (b) 12 months

Table 10 demonstrates that the drop in bond strength after three years for water-jetted specimens was between 20% and 35%; for wire-brushed specimens the drop was between 3% and 29%; there is no apparent reason for the greater drop in values for the water-jetted specimens as compared to the wire-brushed specimens; however, even with the bigger drop, the water-jetted bond strength is still higher after three years than the wire-brushed specimens from 9% to 20% because of the higher initial values. The drop in bond strength for specimens stored at the bridge for three years was higher than the drop observed for specimens stored in the laboratory.

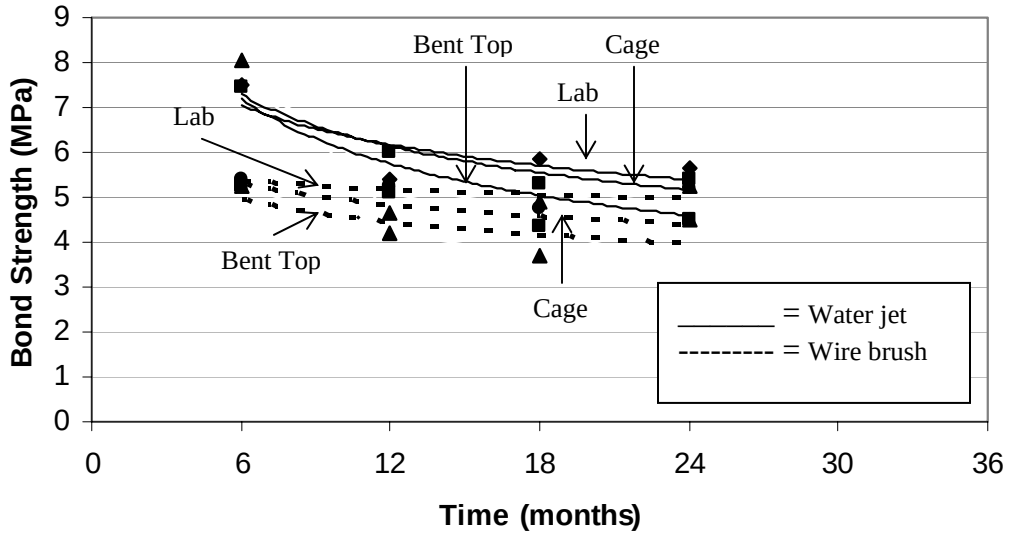
The bond between CFRP composite and concrete was investigated further and compared to previous results for similar type specimens (Pantelides et al. 2003a). In those tests, there were three types of specimens: (a) no surface preparation, (b) sandblast, and (c) water jet. The difference in bond strength was as follows: the sandblasted specimens were stronger compared to those with no surface preparation by 15%, and the water-jetted specimens were stronger compared to those with no surface preparation by 28%. Thus, it can be seen that the drop in bond strength due to environmental degradation, even though it is significant, it is within the range of variation which could occur from different surface preparation techniques. Moreover, as Figure 11 shows, it is clear that for both water-jetted and wire-brushed specimens, there is an asymptotic type of behavior, and that the bulk of the bond degradation with time had taken place by the end of the second year. Figure 11 also shows that at the end of two years, the water-jetted specimens still demonstrate superior performance compared to the wire-brushed specimens, with respect to the specific location of the specimens. It is recommended that more tests should be carried out for a longer time frame, which should extend to ten years; original specimens are still available for this purpose.

Figure 11. Experimental results for bond strength of CFRP to concrete.
