Report No. UT-08.12

Field Comparison of Five Pavement Marking Removal Technologies

FINAL REPORT

Utah Department of Transportation Research Division

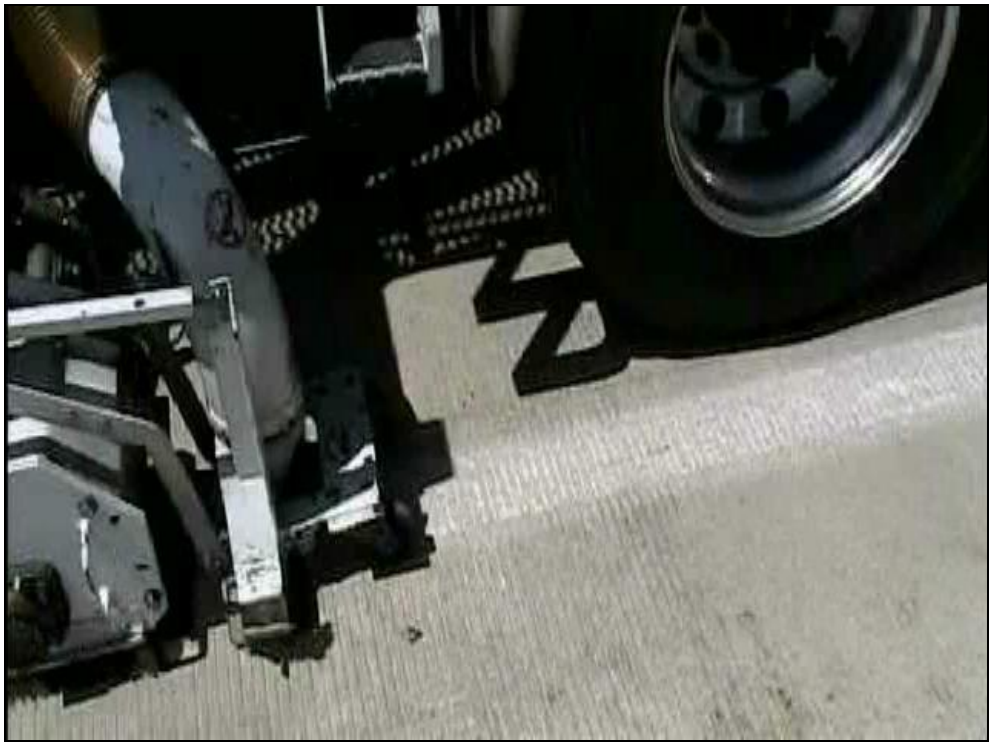
(Figure 5) Results of carbide grinding technique on concrete (note the marking material is partially removed and a shadow line still remains)
