Report No. UT-06.07

UDOT ROCKFALL HAZARD RATING SYSTEM: FINAL REPORT AND USER'S MANUAL

Utah Department of Transportation
Research and Development Division

Utah State University
Dept. of Civil & Environmental Engineering
Logan, Utah

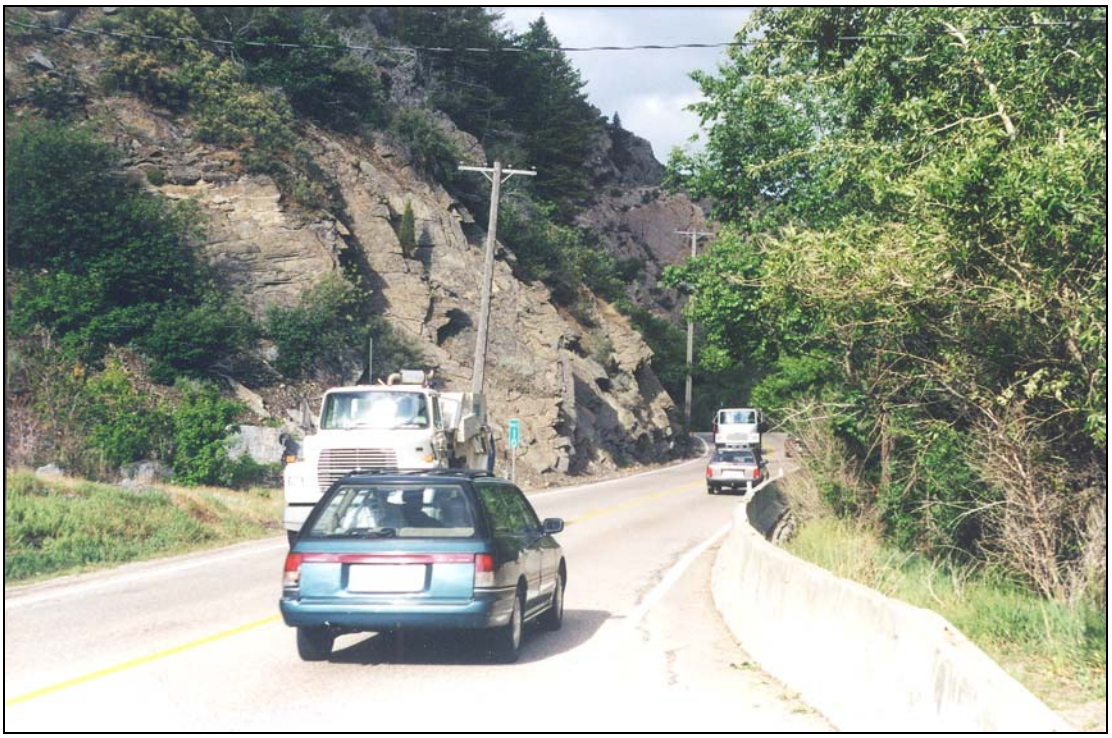
Figure 21. Photograph of Huntsville Site Number 1425-08.

The first site to be examined is in the Huntsville maintenance station jurisdiction and is located in Ogden Canyon. The site is east of the city of Ogden Utah along the south side of State Highway 39 and west of the Pineview Reservoir. Figure 21 shows that the site consists of a series of resistant ledges of altered carbonate and phyllite rock adjacent to a roadway with an average daily traffic volume of 8320 vehicles. The roadway is eight meters wide, and has two lanes, with a drop-off to a stream on the north side bordering the westbound lane. Because of the height of the cliffs (10 meters) south of the road, rockfall hazard exists in both lanes. General site dimensions and characteristics are listed in Figure 17, which is a copy of the field sheet generated during the summer 2002 survey.

In order to understand the sensitivity of the site to different repair methods, a spreadsheet containing the hazard calculations was created for easy reference. Figure 22 is the score calculation sheet for the form given earlier as Figure 17. The total score for this site untreated is 618 and ranks 15th in the state at 37% of the maximum score. For this site, the most obvious problems exist with the Geologic Factor and Section Factor. The photograph bears this out, as there is an obvious series of outcrops immediately adjacent to the road with little or no catchment. The Human Exposure Factor is largely driven by the high traffic volume and minimal measured stopping site distance (Figure 17). While the stopping sight distance can be increased with the removal of vegetation and a recut of the slope, traffic volume cannot be altered.

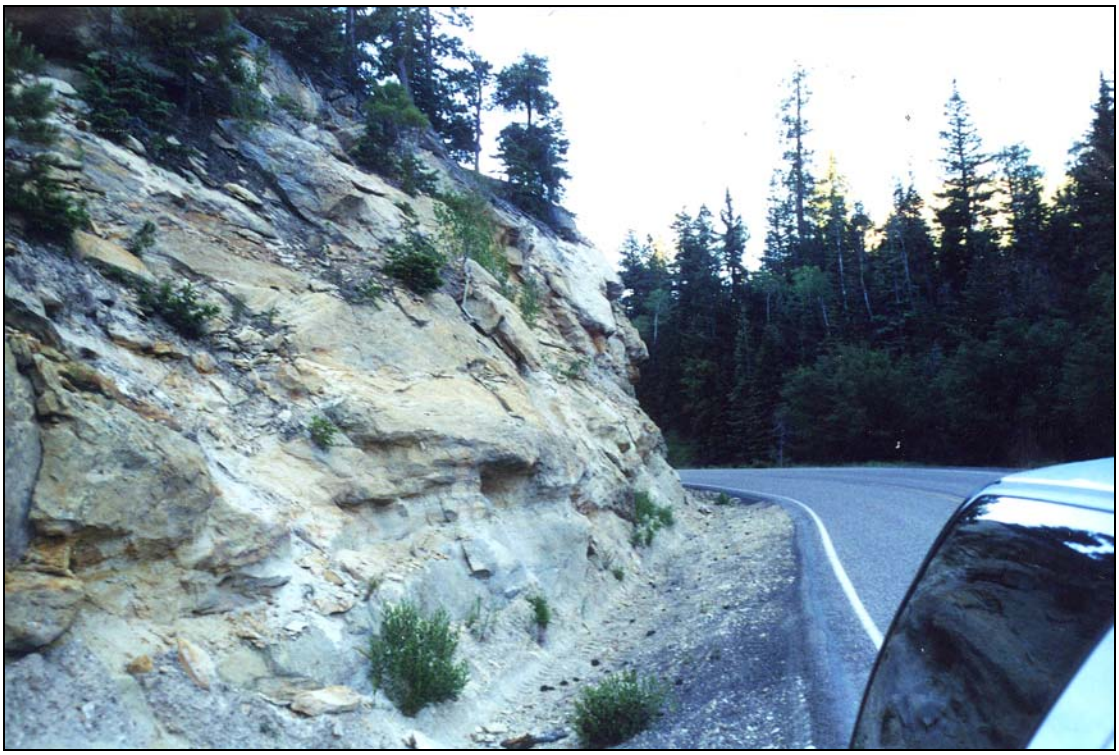
Figure 23. Site Number 4524-25 located on State Highway 143 northwest of the Brian Head ski area and southeast of the town of Parowan.

Examination of the site characteristics using the NYDOT system indicates that the initial (before remediation) score is driven largely by the Geologic and Human Exposure Factors (Figure 24). By focusing on the Human Exposure Factor, some improvement in the sight distance could be gained by a relocation of the roadway 3 meters to the south. This conservatively increases the sight distance by 10 meters, lowers the Human Exposure Factor from 6.8 to 5.2 and gains a 126-point or 26% reduction in overall score. In addition, the treatment would generate an increased ditch width of 3 meters that reduces the Section Factor from a value of 5.2 to 1.3. The overall effect of this road improvement, including the combined effects on the Section Factor and Human Exposure Factor results in a reduction of 413 points or 77%.

The most imposing feature at this site is the long backslope with the presence of rounded boulders on the cliffs above. The most obvious treatments are those that would reduce or contain backslope falls that use the immediate roadside cliffs as a launch ramp. Treatment of the upslope source area is not feasible due to the steepness of the backslope and the wooded terrain. Damaging the tree cover immediately above the roadway to access the upper slope would increase the danger as the trees act as a natural catch fence for the material rolling down slope. The construction of a catch fence near the top of the lower cliff, though labor intensive, would provide a means of stopping the vast majority of fall material from reaching the roadway. A catch fence can conservatively be modeled by a reduction in the backslope condition from 81 points to 27 points, a one step reduction. The overall effect is a drop of 192 points or 36%. The maintenance of 100 meters of catch fence from year to year would likely be difficult and as previously mentioned, initial installation costs would be high.

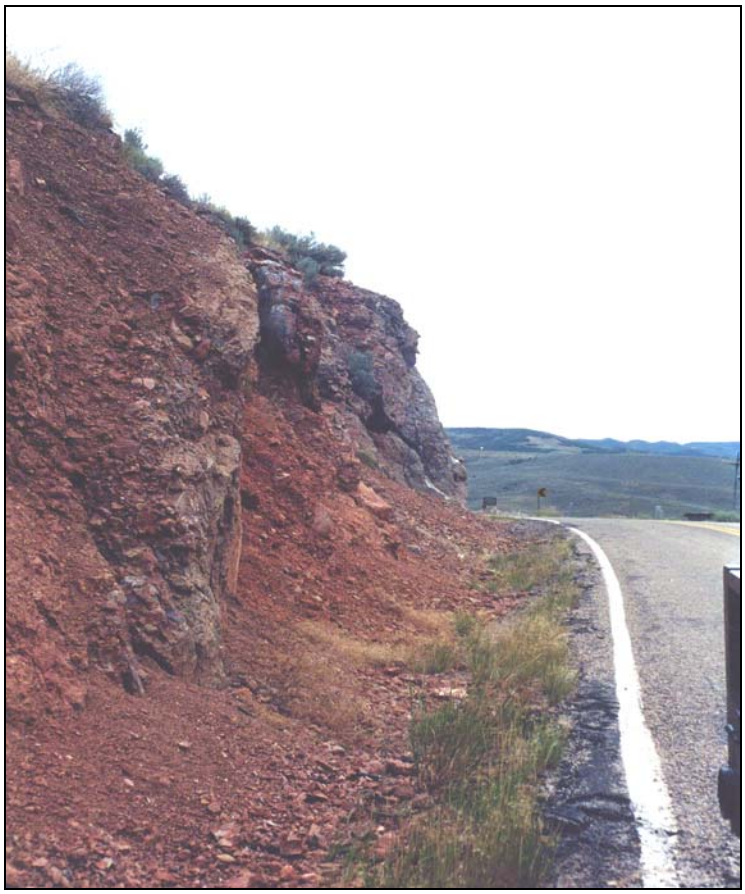
Figure 28. Site 1425-15 located 13 miles south of the city of Morgan Utah adjacent to State Route 66.

This site was chosen in part because it allows for the illustration of several different combinations of repair activities. Due to the overall site length of 250 meters and at least 100 meters of ditch that could be cut, other repairs might be considered along with ditch improvement. Though not covered by the NYDOT System description, ditch improvements should reflect the size of the boulders that the ditch needs to catch. In this case, 1 meter plus sized blocks could be expected. Thus a substantial ditch improvement is required to be effective. The measured sight distance for this section of road is only 25 meters, which is the result of a sharp corner on the southern margin due to an isolated 20 meter long section of massive conglomerate creating a pillar on the inside of the curve. Removal of the pillar, which is approximately 1200 cubic meters in volume, would conservatively double the measured sight distance on the curve from 25 to 50 meters. The net score improvement for the removal of this portion of the cliff reduces the HEF from 9 to 3.34 and the overall score by 327 or 63%. This site improvement could be achieved with several controlled blasts over a relatively short period of time.

The final repair action to be discussed is the application of scaling activities. The vegetation covering this site is primarily grass with scattered sage and presents easy access for a large excavator operating near the roadway level. Scaling activity from the roadway area could cover the majority of the cliff area but upper slopes could not be accessed and, in order to completely scale the entire site, access would have to be established from upslope. A scaling operation might be considered as a one-step reduction in the block size reducing the category value from 27 to 9 and the Geologic Factor from 9 to 6.6. The net effect of this repair is an overall reduction in the site score from 521 to 410 or 21%.
