Report No. UT-06.05

DEVELOPMENT OF AN INDEX FOR CONCRETE BRIDGE DECK MANAGEMENT IN UTAH

Final Report

Brigham Young University
Department of Civil and Environmental Engineering

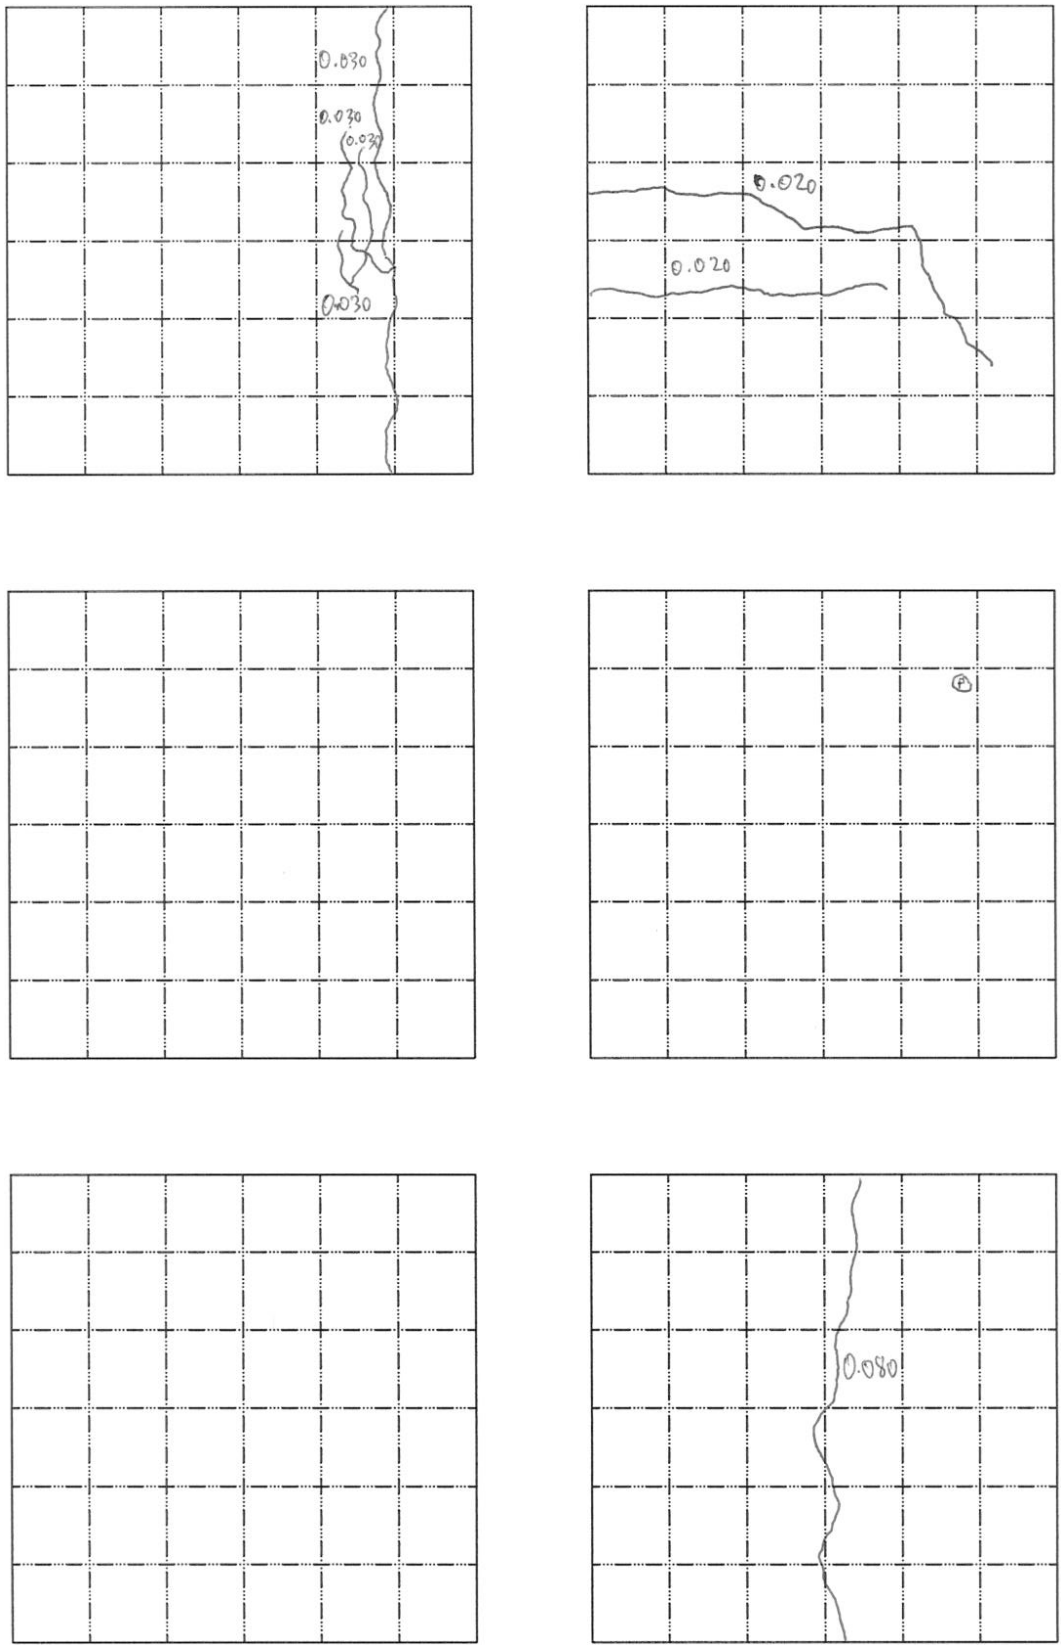
FIGURE 4.1 Distress survey for deck C-438.

Deck ID	Crack Width (in.)		Crack Severity	Crack Density (ft/yd^2)
	Average	Std. Dev.		
C-438	0.034	0.021	Wide	1.07
C-460	0.013	0.006	Medium	1.85
C-688	0.017	0.009	Medium	2.01
C-698	0.017	0.006	Medium	1.99
C-699	0.016	0.009	Medium	1.83
C-726	0.029	0.016	Medium	5.25
C-736	-	-	-	-
C-752	-	-	-	-
C-759	-	-	-	-
C-760	0.019	0.009	Medium	3.69
C-844	0.036	0.011	Wide	2.47
C-919	0.019	0.012	Medium	5.37
F-500	0.029	0.019	Medium	1.92
F-504	0.033	0.021	Wide	1.66
F-506	0.029	0.012	Medium	4.72
