Report No. UT-12.07

DETERMINING WILDLIFE USE OF WILDLIFE CROSSING STRUCTURES UNDER DIFFERENT SCENARIOS

**Final Report
May 2012**

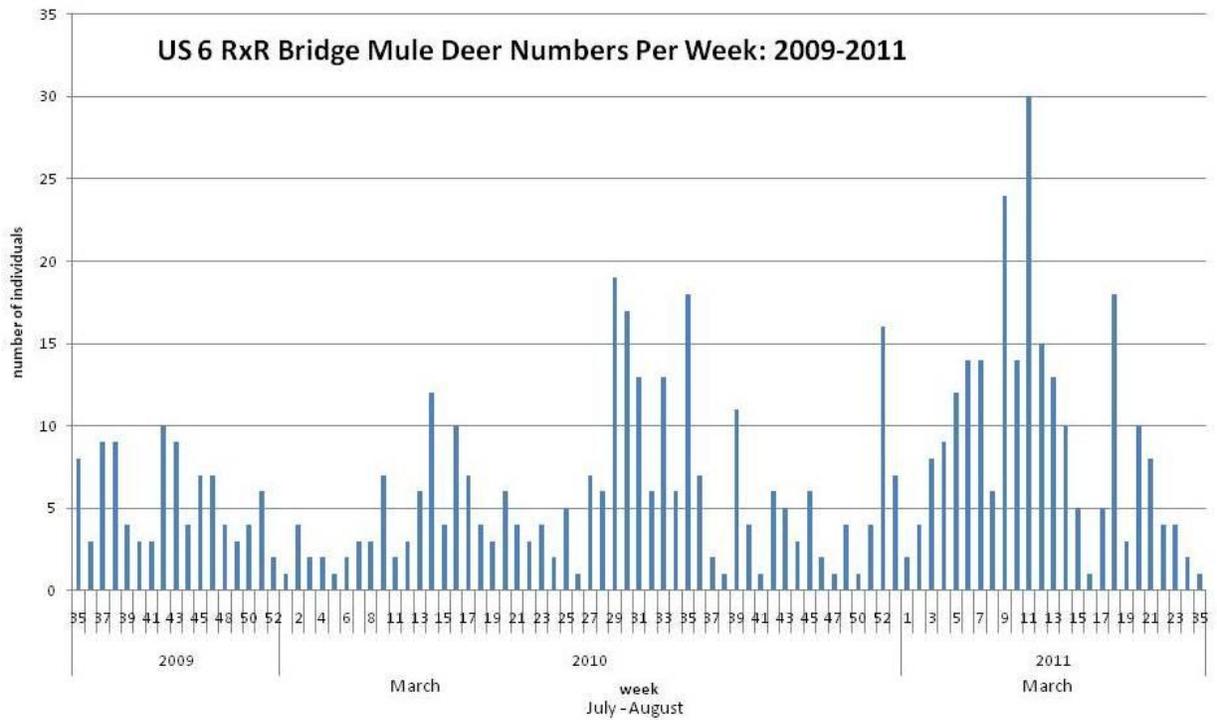
Unfortunately, the crossing does not pass other wildlife. This may be due to the fact it is open and devoid of vegetation, which is important to some species of wildlife needing hiding cover. Ongoing analyses of vegetative characteristics of the most successful crossings were conducted by the project graduate researcher during the writing of this report. Vegetative characteristics favorable to both mule deer and other species may be contradictory, and it is best to wait on making recommendations. If stumps, logs, and boulders could be placed in a line going into and through the crossing, they could increase use of the crossing by small and meso mammals, which would not adversely affect mule deer use. This approach has been taken at wildlife crossings in Oregon and Vermont (Bellis 2008). The bridge is a success for passing mule deer. It is not a success, at this time, in passing elk, and other wildlife.

Figure 35. Mule deer use of the US 6 Rail Road Bridge at MP 200.7 per week.

Prescription for Improvements: This bridge only passes mule deer. Elk are known to be in the area, both through camera evidence and wildlife-vehicle accidents and wildlife-train accidents. Elk are wary of changes to their environment and are reluctant to use structures. Perhaps if additional vegetation near the entrances to the bridge area were planted and maintained, the area would appear more natural and therefore more appealing to elk. These actions would probably help make the crossing more attractive to other wildlife such as moose, bobcat, coyote, and meso-mammals. A latent problem at this site is the inability of those accessing the railroad at gates to the east to close those gates, in spite of UDOT signs placed on those gates asking the users to close them for wildlife. Perhaps UDOT utilities and rail coordinators could work with the rail line workers on informing them of the importance of closed gates. Figure 36 demonstrates the potential results of opened gates.

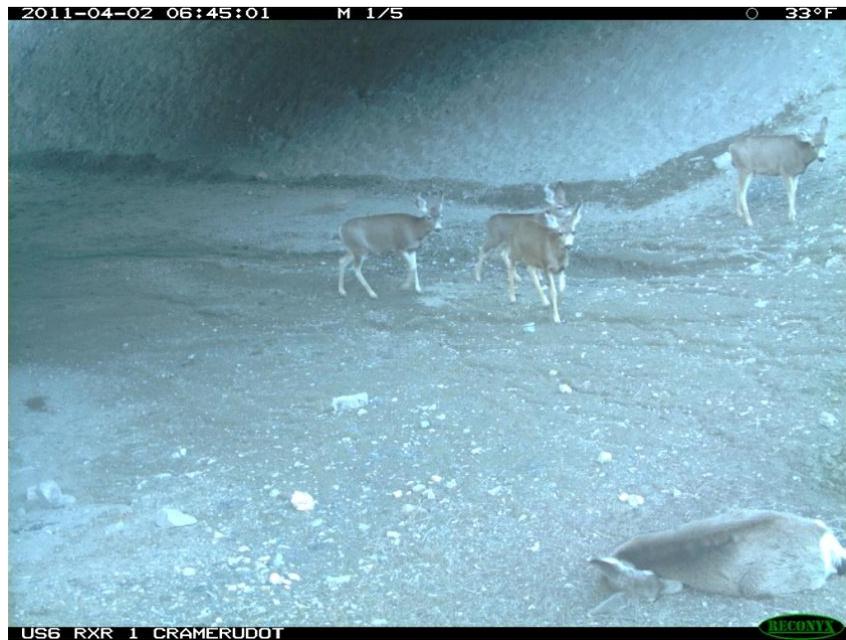
Figure 36. US 6 MP 200.7 Bridge: mule deer herd approached a mule deer carcass that appeared just 4 minutes earlier. It is hypothesized that the deer was hit by a vehicle on the bridge above and this was her herd.

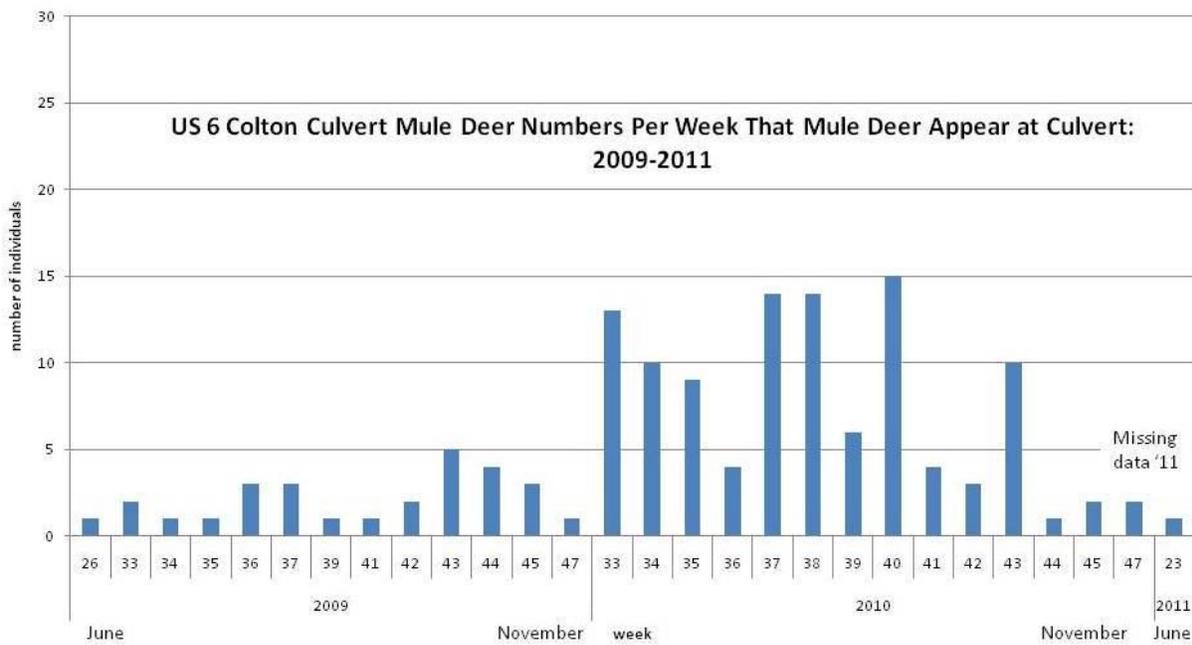
Figure 40. Mule deer use of Colton Culvert under US 6 by week. Missing weeks are times when no mule deer were at the culvert, typically December through April.

Prescription for Improvement: Vegetation is lacking for dozens of meters to the north and south of this structure. Vegetation such as sage brush provides cover for wildlife wary of predators or humans. Without vegetation, the approaches to the structures are less “inviting” to individual animals, and are more risky for wildlife than if they had some hiding cover. Planting of sagebrush or other types of vegetative cover is recommended. The wildlife fencing is substandard; it is lower than the required 8 feet (2.4 m). Moose tracks in the snow have been observed on the right-of-way side of the fence. If there is any possibility of increasing the height of the fence, it would help increase wildlife use of this and nearby crossings and bridges.

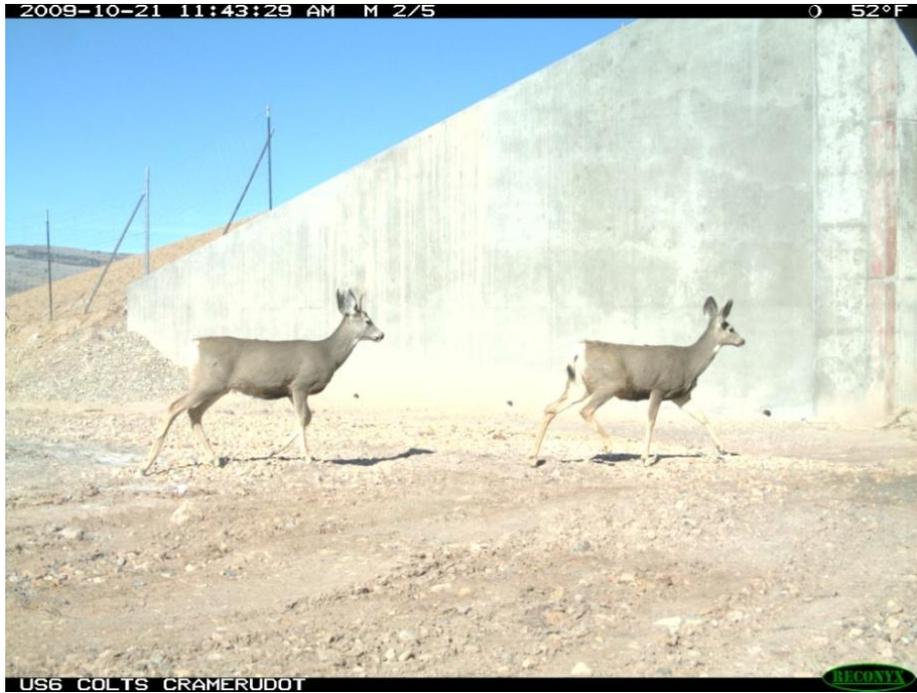
Figure 41. Mule deer doe lead buck through Colton Culvert under US 6.

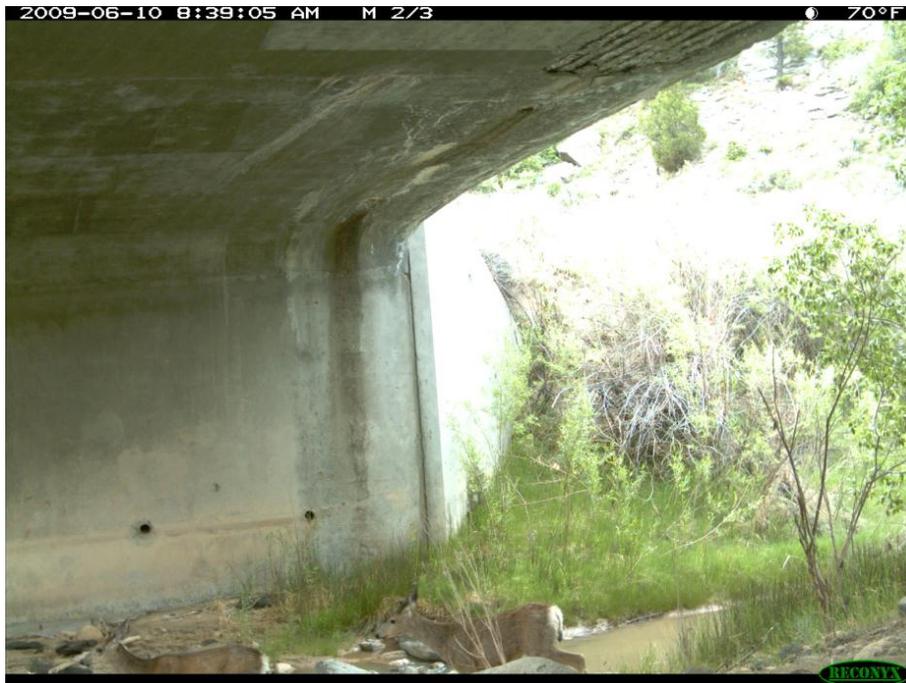
There was a pair of bridges at this location that accommodated the two directions of I-70 traffic, and a third bridge that accommodated the unpaved frontage road running parallel to the interstate. There was no wildlife-proof fencing along this stretch of highway. The area along Ivy Creek had very large boulders all along the creek, making even human passage difficult. This site was monitored with two cameras to determine if mule deer and other wildlife were attempting to cross under the interstate at this site and if their attempts were successful. In 375 days of monitoring, ten mule deer approaches to the bridge were recorded, and the cameras recorded four successful mule deer passages (Table 10). The mule deer traversed the passage in the middle of the stream (Figure 53). All other deer were recorded turning away from the passage.

Figure 53. Mule deer bucks used Ivy Creek stream bed to cross under all three Ivy Creek Bridges.

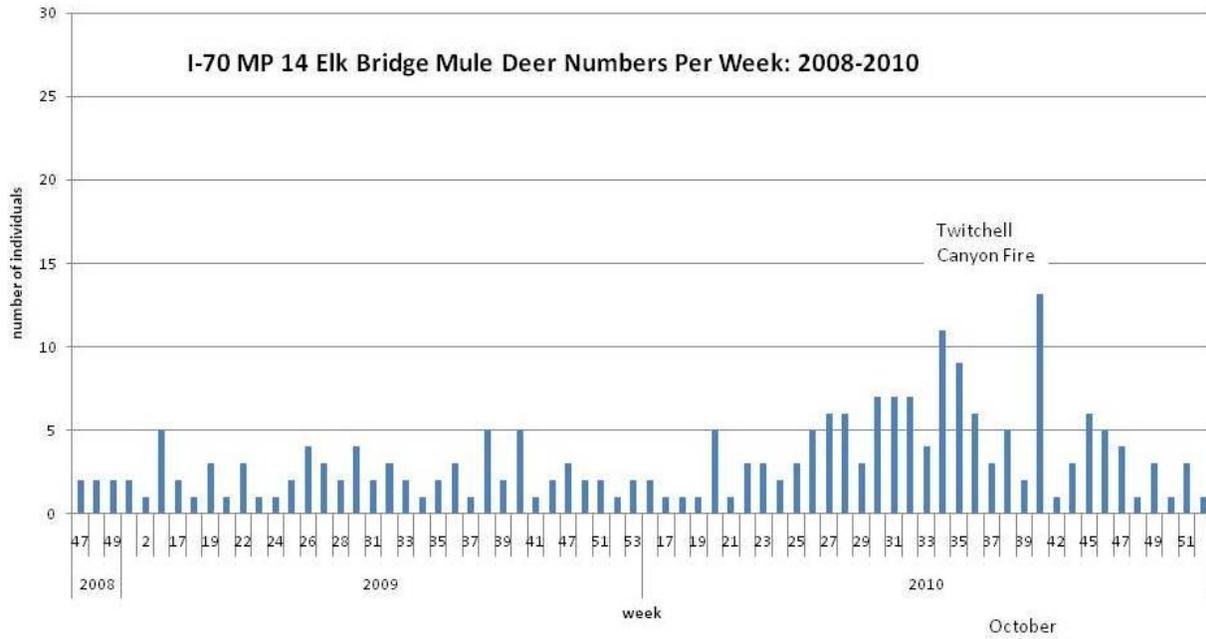
An important observation was made when the data was tabulated for the number of deer using the structure plotted per week for the monitoring period (Figure 54). The Twitchell Canyon fire occurred in the late summer through October in 2010 on the public lands south of the site. The fire came to within 300 meters of the crossing and crossed the interstate. During the period of time when the fire was closest to the crossing, in late September into October, mule deer use of the crossing increased to the highest levels recorded at this site. These results support the idea that wildlife crossing structures and existing bridges and culverts are important conduits for wildlife movements during times of natural and human caused disturbance events such as fire, floods, and land use change. These structures help to keep wildlife off the road during these turbulent times.

Figure 54. Mule deer use by week of the I-70 MP 14 Elk Bridge for 2008 – 2011. Note jump in use in the fall of 2010 when the Twitchell Canyon fire was near the bridges.

Prescription for Improvement: Reduction in vehicle use is the only change that would be necessary to increase wildlife use. Even if night time vehicle use could be reduced, it would assist the wildlife trying to use the structure.

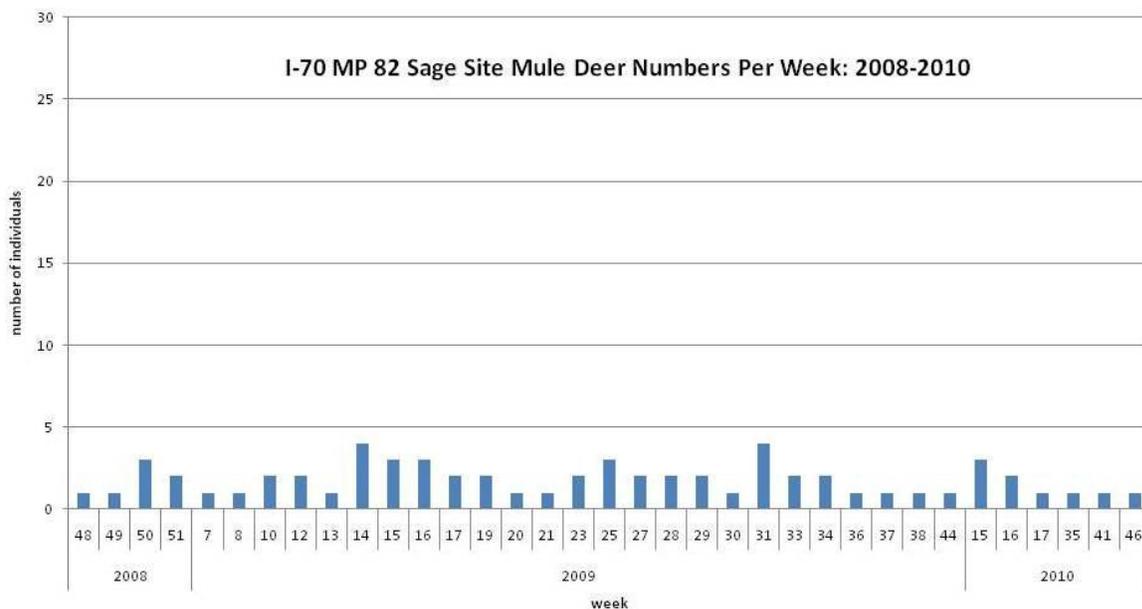
Two cameras were placed in the wild lands on the north side of I-70 near MP 82.3 as a potential new crossing site, which has no wildlife fencing at this time. The goal was to record the wildlife species in the area and their numbers. Catching wildlife in the camera field of view ranges was difficult because there was no restricted space that animals had to pass through to cross the road or return to the wild area. Nevertheless, in 759 days of monitoring, there were 171 mule deer observations, and 208 elk observations. Two-hundred of these elk observations occurred in the winter months. Mule deer were observed uniformly throughout the year (see Figure 56 below).

Figure 56. Mule deer observations at the north side of I-70 at MP 82.3 at the site called Sage, a potential future wildlife crossing site.

Prescription for Improvement: Installation of a bridged wildlife crossing would greatly facilitate the movement of mule deer, elk, and other wildlife under the highway. The bridged crossing should remain free of any roads. Wildlife-proof fencing should be placed for at least one-half mile (0.8 kilometers) in both directions from the crossing, on both sides of the road.

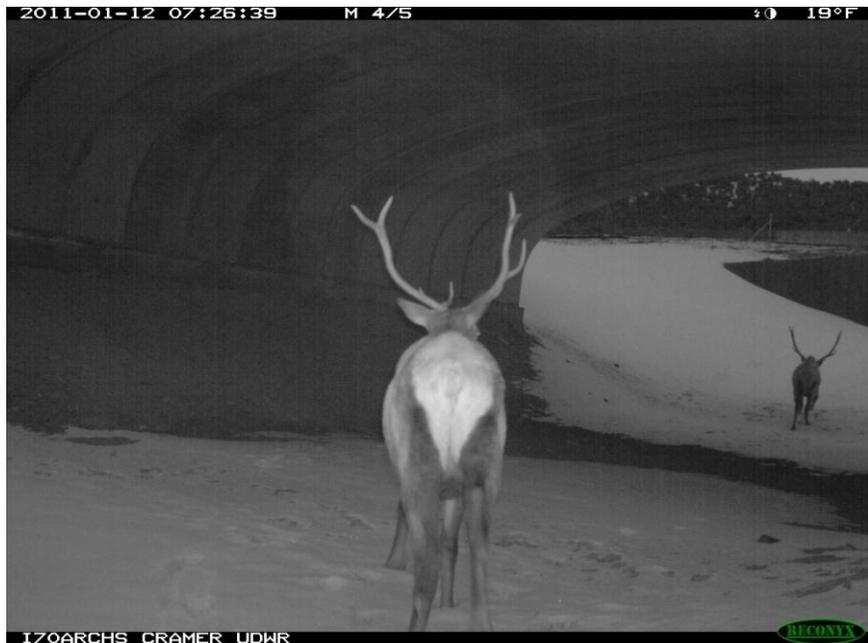
Figure 58. First elk to use new arch bridge crossing on I-70, MP 5.3.

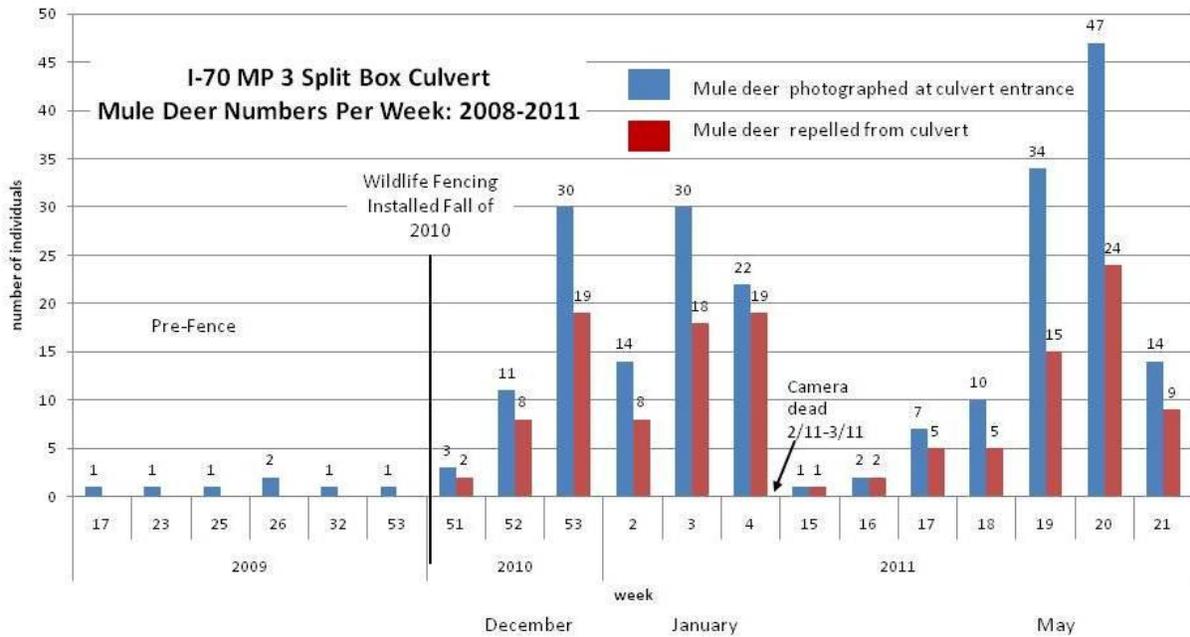
Figure 60. Mule deer appearances at the entrance to I-70 MP 3 split box culvert by week, in blue, and number of repels the same week. Note: all pre-fence approaches resulted in repels.

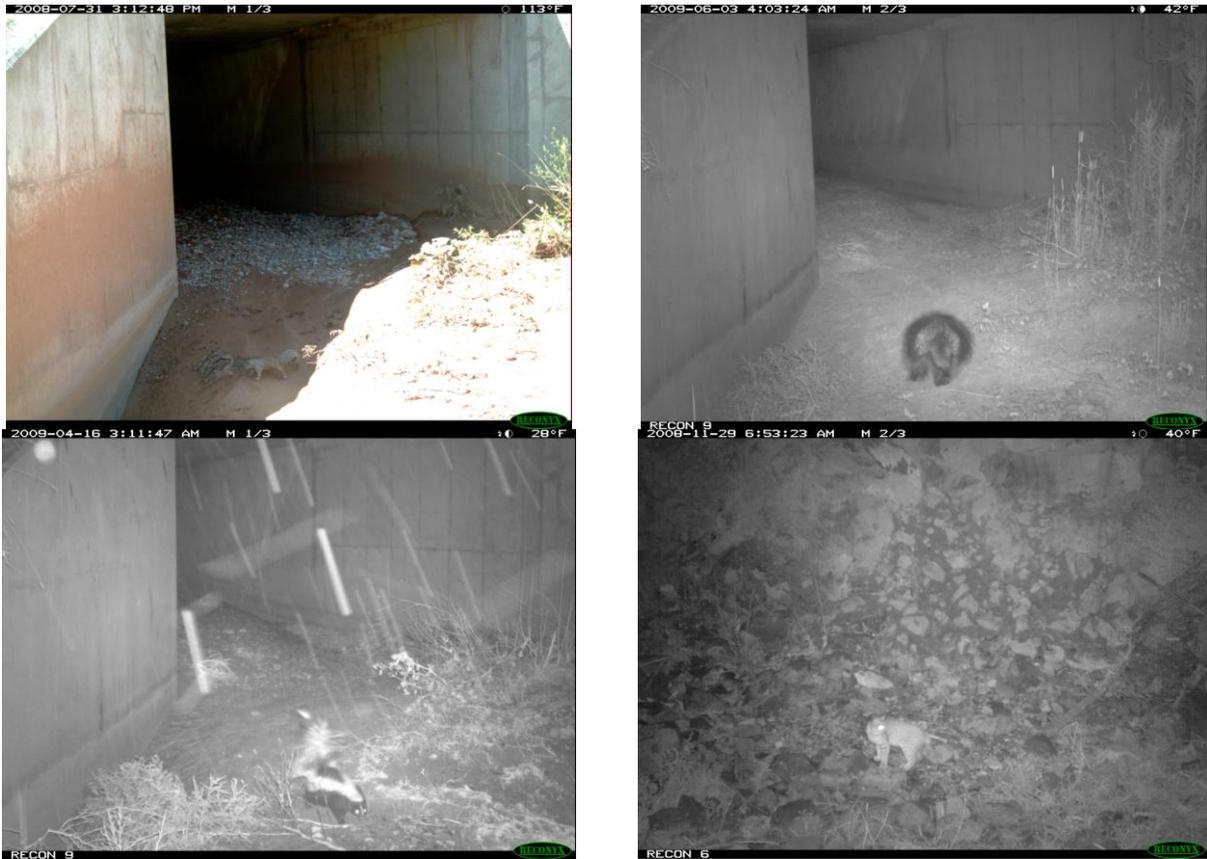
There was a diversity of other wildlife species that used the Ash Creek and Camp Creek South culverts, including: grey fox, bobcat, spotted skunk and striped skunk, ringtail, ground squirrel jackrabbit, cotton-tail rabbit, and raccoon (Figure 88).

Figure 88. Meso mammals (medium mammals) used I-15 box culverts: clockwise from upper left: ground squirrel at Camp Creek North culvert, porcupine at Camp Creek North culvert, Bobcat at Ash Creek culvert, and skunk at Camp Creek North culvert.

Prescription for Improvements: If sky lights could be punched into the middle of the Camp Creek culverts in the median of I-15, this may improve the conditions of the culverts for wildlife. The Camp Creek North camera recorded a flash flood through the culvert. Upon inspection it was realized that this culvert has two to four feet (0.6-1.2 m) of fill in the bottom. If it could be cleaned out, its size would be increased, thereby making it more attractive to mule deer. Future actions should include conservation easements on the bordering private lands.

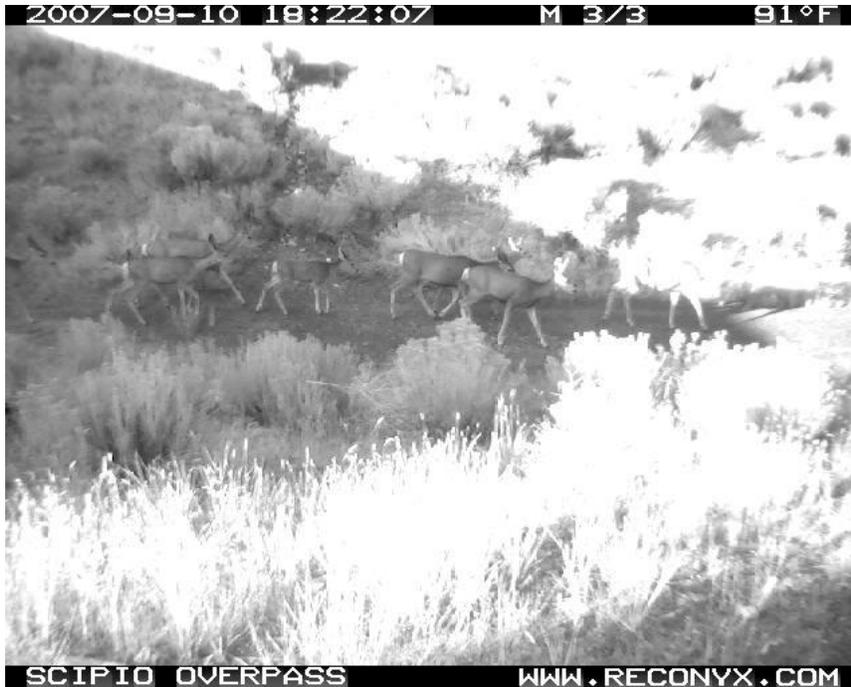
The Scipio North underpass bridge (MP 186) camera recorded 722 mule deer passes in 174 days of monitoring. This is a rate of 4.5 deer per day. This value is representative of movements from March into October, but even if the mule deer average went to half of this use over the course of a year, this crossing would be one of the top five wildlife crossings in Utah based on numbers of deer. There was a definable herd of 8 does and 3 fawns that were viewed in photos going back and forth almost daily (Figure 90). Bucks occurred in only 5 sets of pictures over this time. Due to the fact that these were the first cameras installed as preliminary cameras for this study, the camera at this site was positioned in the middle of the crossing in the median and did not record repel actions. Overall, the Scipio North passage functioned as a successful wildlife underpass for mule deer. No elk were observed and a casual survey of fecal pellets in the hills east of the crossing found four piles of elk pellets that appeared to be several years old, thus there may not have been elk in the area to use the crossing during monitoring.

Figure 90. I-15 Scipio North bridge wildlife crossing being used by seven mule deer.

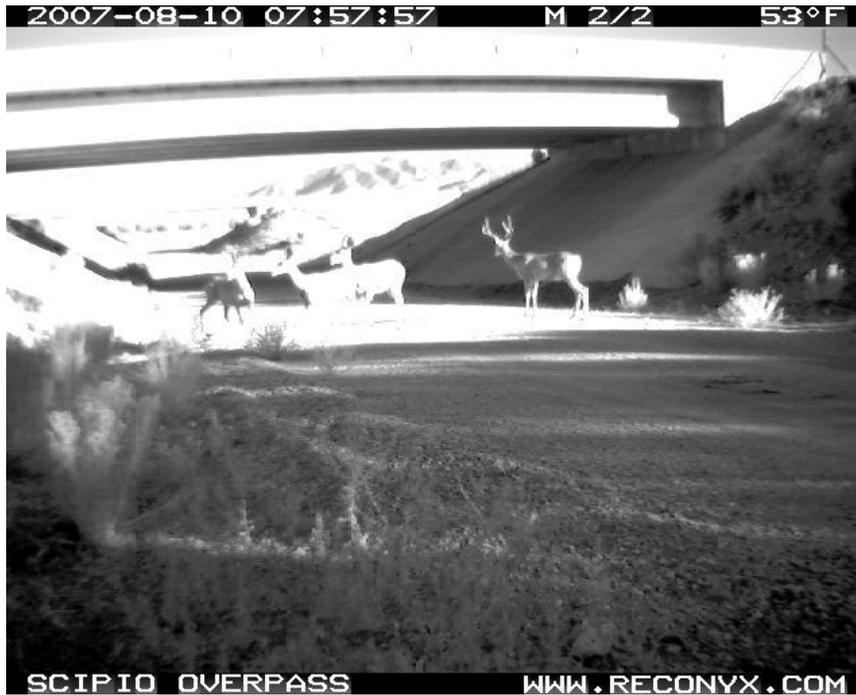
Scipio South bridges (MP 182) were in an area with little vegetation (Figure 91). This and the fact that a U.S. Forest Service dirt road ran through the area and cameras recorded vehicles all hours of the day and night (there were as few as 12 vehicles in a month, to a high of 334 in May) make it unlikely that mule deer or elk used this area under the bridge. In 214 days of monitoring on the east entrance of this bridged area, 93 deer observations were recorded. The rate of deer observed per day was 0.4. Deer could not be verified using the area under the bridge due to limits of the camera and large extent of the area both in width across and length between opposing lanes of traffic bridges at the site. Rabbits were the only other wildlife recorded at this site. The South Scipio bridges had limited use by deer that are often skittish and on guard. No elk were recorded. A casual count of fecal pellets to the west revealed no mule deer or elk fecal pellets.

Figure 91. I-15 Scipio South Bridge over U.S. Forest Service road with mule deer pondering using the area under the structure. It is not known if the mule deer used the passage.

Prescription for Improvement: The U.S. Forest Service road running through the structure is used at all hours of the night, the time that would be preferable for wildlife trying to avoid humans and vehicles. If there were restrictions on the use of the road, this would help wildlife. There is no vegetative cover near the entrances or in the median. If there were some juniper or Pinyon pine trees or sagebrush planted in the median and nearby, this may encourage mule deer and elk use.

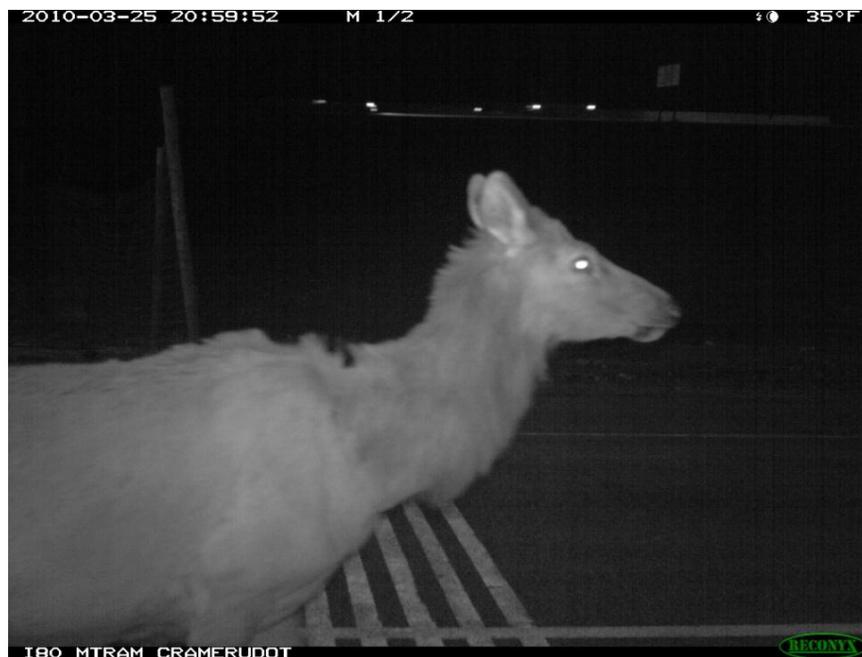
and 115 elk passes photographed moving across the stripes (Figures 93 and 94). More wildlife was recorded at this site entering and exiting the highway than all the camera nights combined from the four cameras at the Mountain Dell and Lamb's Canyon interchanges. Some mule deer crossed the site on the rocks placed along the sides of the stripes. The camera was removed because results were clear: the painted white stripes did not deter wildlife from entering the highway.

Figure 93. Elk walked across painted white lines on I-80 entrance ramp at Mountain Dell interchange. Note lights of tractor trailer truck in background.

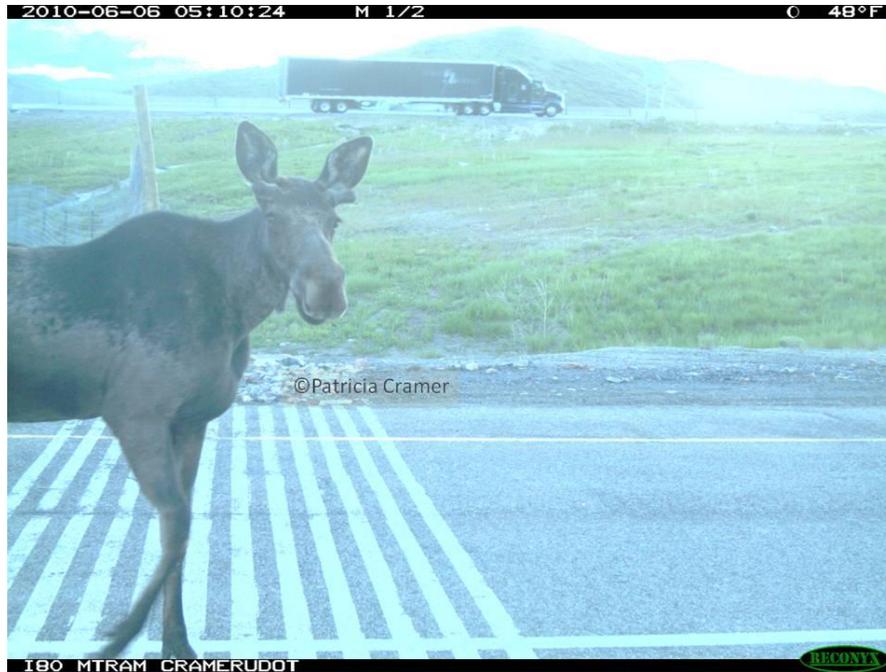
Figure 94. Moose walked across white stripes on I-80 entrance ramp at Mountain Dell interchange.

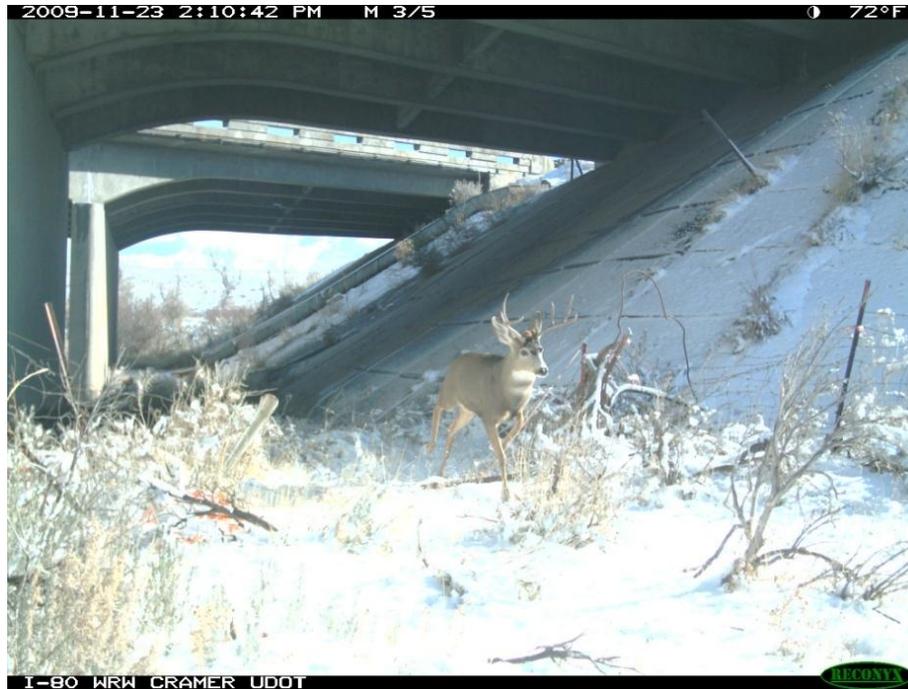
Figure 96. Mule deer buck used the south side of the Weber River Bridge on I-80.

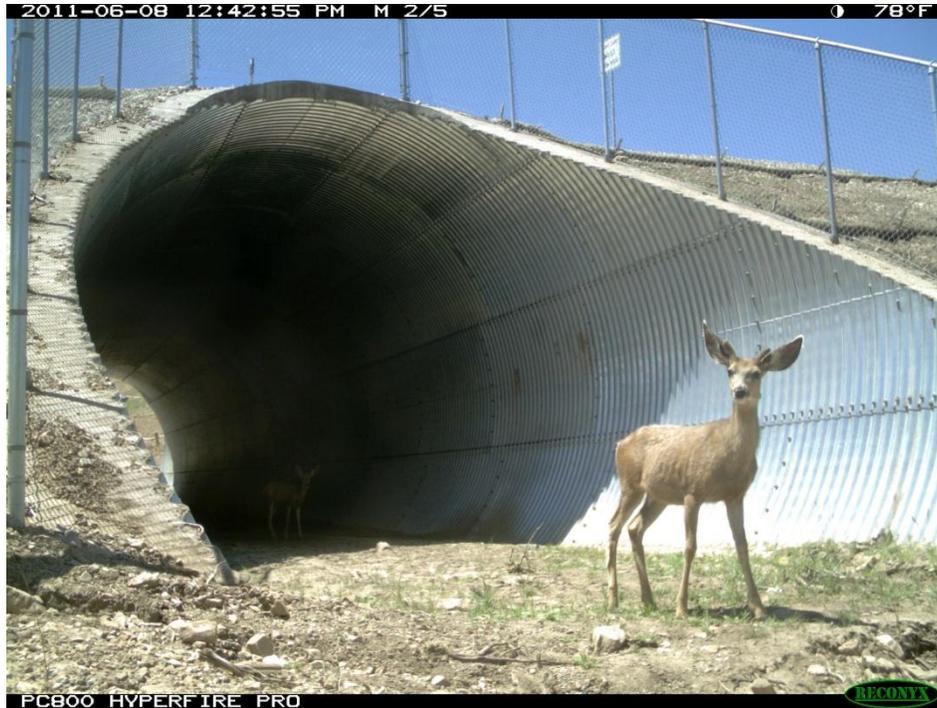
Figure 99. Two mule deer came through the Deer Creek State Park culvert under US 189 in Provo Canyon within several months of its installation.

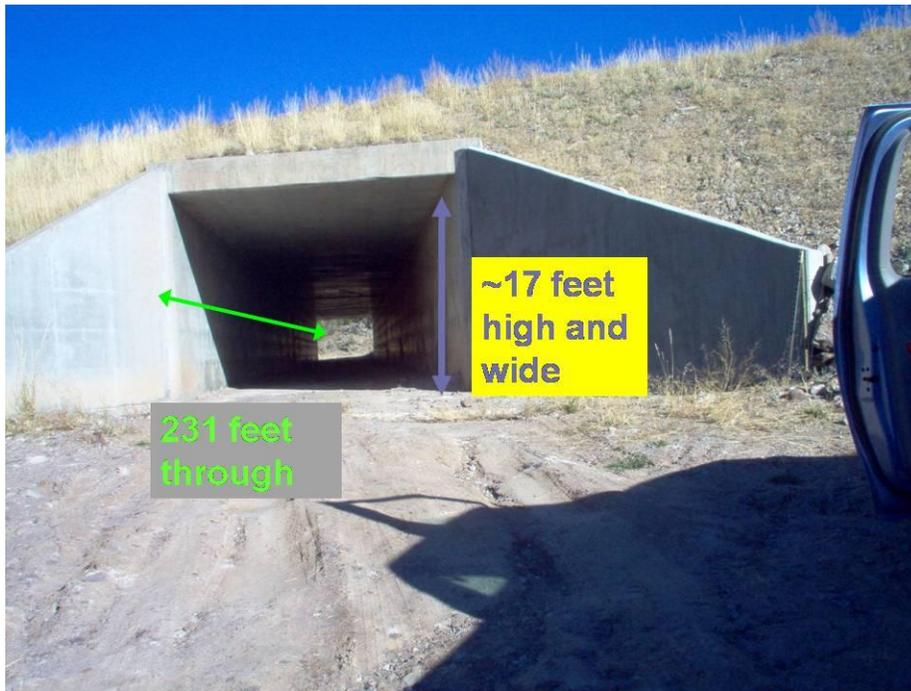
I-70 box culvert at MP 6, not a wildlife crossing and no wildlife fencing. Received wildlife fencing with construction of new crossing at MP 5.3 in Fall 2010.

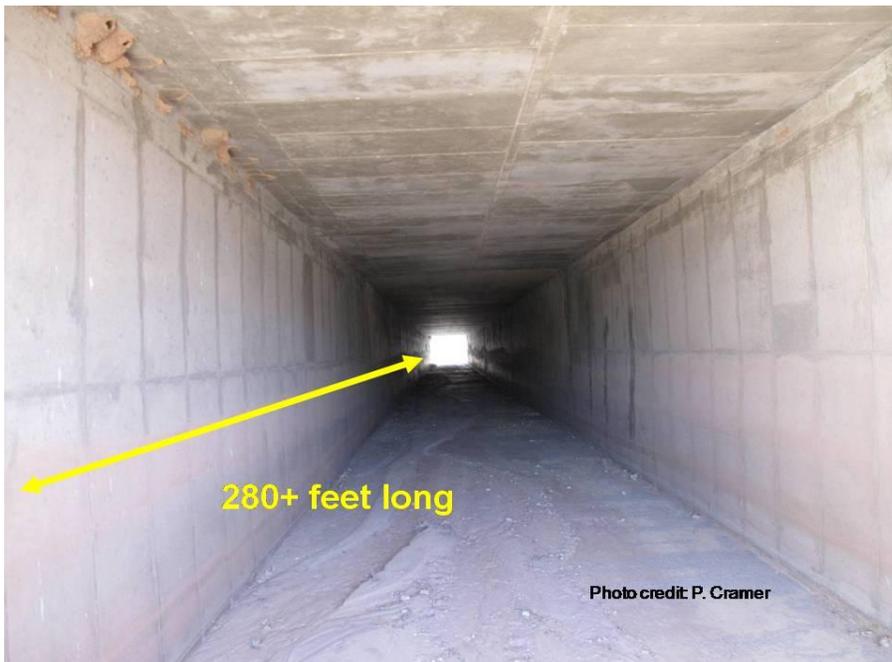
Three long concrete box culverts without wildlife fencing south of Cedar City were monitored for one year as a pre-fencing study (Figure 86). They had very little mule deer use, but high meso-mammal use. The longest culvert in the study, at the Camp Creek South Culvert (MP 42.5), was 9.8 feet (3 meters) high, 11.8 feet (3.6 meters) wide, and 280 feet (84 meters) long. See Appendix A for photo of this culvert's dimensions. All mule deer that approached the site (n=32) were repelled. The Camp Creek North Culvert (MP 44) was 9 feet (2.7 meters) high by 11.5 feet (3.5 meters) wide, by 175 feet (53 meters) long, and had 12 mule deer passes and four repels. The Ash Creek Reservoir culvert (MP 36) was 26 feet (8 meters) high and wide, and 135 feet (41 meters) long. Eleven mule deer approached it and used it, none were repelled. Mule deer use of just the two culverts (Camp Creek South was not used) occurred in the fall migration from September through November, and the spring migration from April through May. In 1,067 camera days, 59 mule deer were photographed at the entrances to these culverts, and just 23 successful crossings were recorded (Table 18). The Camp Creek North and Ash Creek culverts provided a limited amount of connectivity for mule deer in this area. The Camp Creek South culvert provides no connectivity for mule deer (Figure 87) and a limited amount for other mammalian species.

I-15 Camp Creek South culvert. No deer were caught on camera using this culvert.

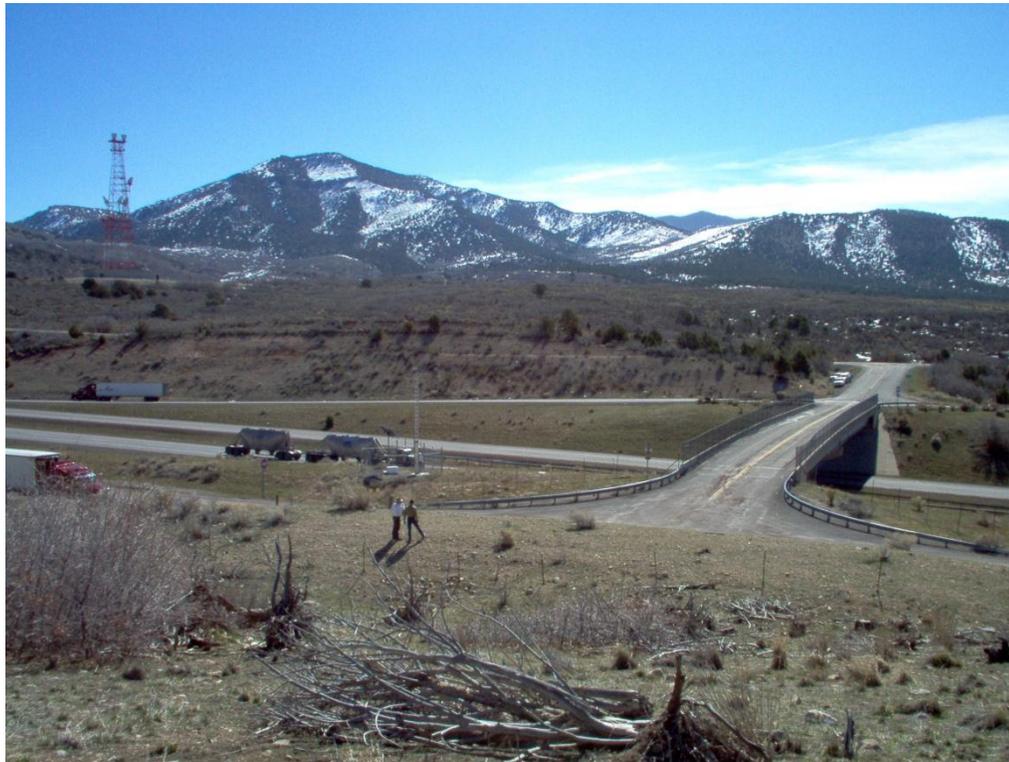
The overpass bridge was monitored for 69 days. No wildlife was viewed in the photographic data other than birds landing on nearby signs. Cows were recorded regularly using the bridge after June 1. Because each month revealed thousands of vehicle photos, only sample periods of time were examined for the number of vehicles. In 30 days from March to April, 454 vehicle passes on the bridge were recorded. In four days in June there were 24 vehicle passes. These samples indicate that there was approximately an average of six to 15 vehicle passes per day on the overpass bridge. The overpass camera revealed this overpass was not used by wildlife for movements over I-15.

I-15 Scipio Overpass, as viewed from west side hill. Randall Taylor (UDOT) and Bruce Bonebrake (UDWR) stand in foreground. Camera was positioned on east and north side of overpass, in the background.

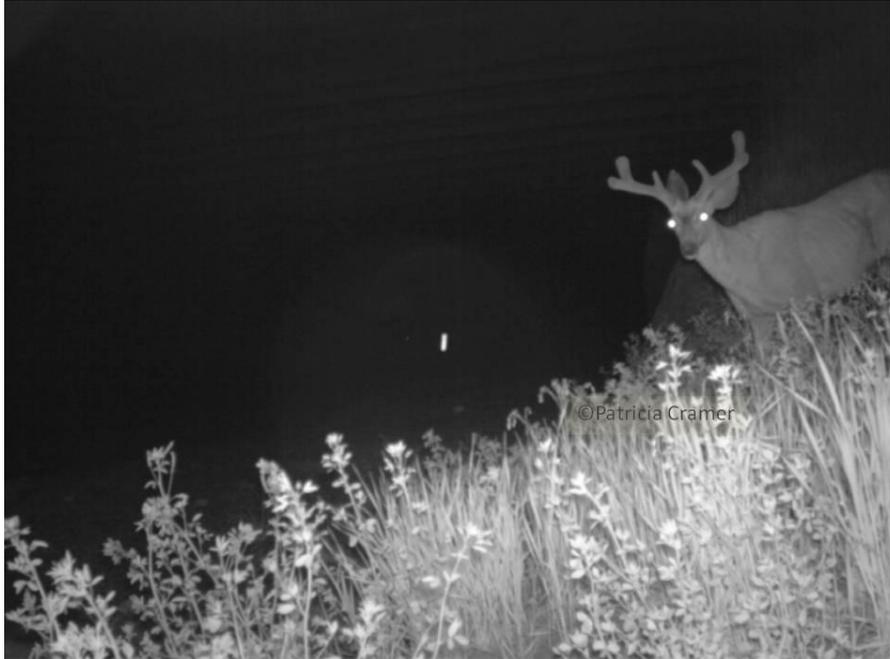
I-80 Lamb's Canyon bridge and interchange MP 137, mule deer at entrance, this animal did not use the area under bridge.

Prescription for Improvement: The noise under both bridges was in high decibels (not officially measured) as heavy traffic moved over the bridges. The sound was akin to guns being fired. This noise will always cause repels with wildlife until it is mediated. The Mountain Dell interchange had dozens of car passes under the bridge each day, even during the darker hours when the cameras are programmed to come on. That, and the fact that there is a firing range on the south side of the highway, makes this area unlikely to ever function for wildlife. The Lamb's Canyon bridge area had wildlife fencing added on the south side (eastbound) of the highway in 2011. In the future the cameras at this location will help to determine if this helps to better persuade wildlife to use the area under the bridge.
