Report No. UT-10.05

FAILURE OF SURFACE COURSES BENEATH PAVEMENT MARKINGS

Utah Department of Transportation
Research Division

University of Utah
Department of Civil and Environmental
Engineering

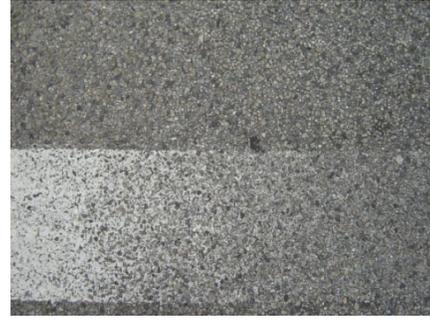
(b) faded paint markings but no visible distresses (EB Lane)

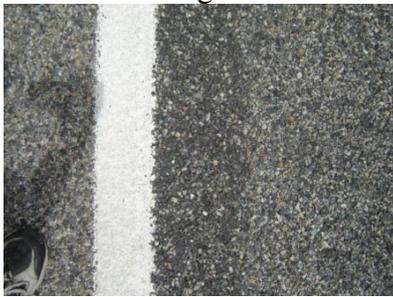
(c) new markings showing no visible distresses.

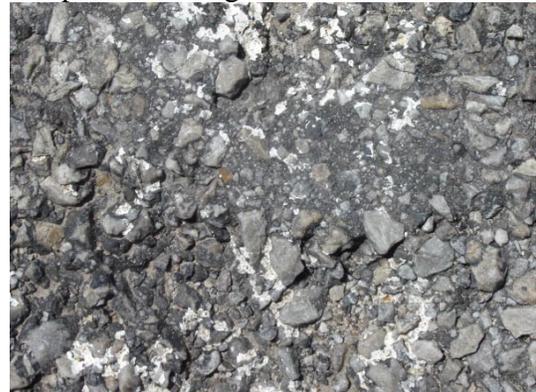
SR-209 is 9400 South and was evaluated from 2200 East to the mouth of Little Cottonwood Canyon. The majority of the observed damage was raveling that occurred almost exclusively underneath the paint marking. Some of this raveling has led to potholes. In addition, there is also a fair amount of moderate to severe transverse cracking, probably caused by either reflective cracking or thermal cracking. In some places the paint is so worn out that it is non-existing.

(d) Almost faded paint marking

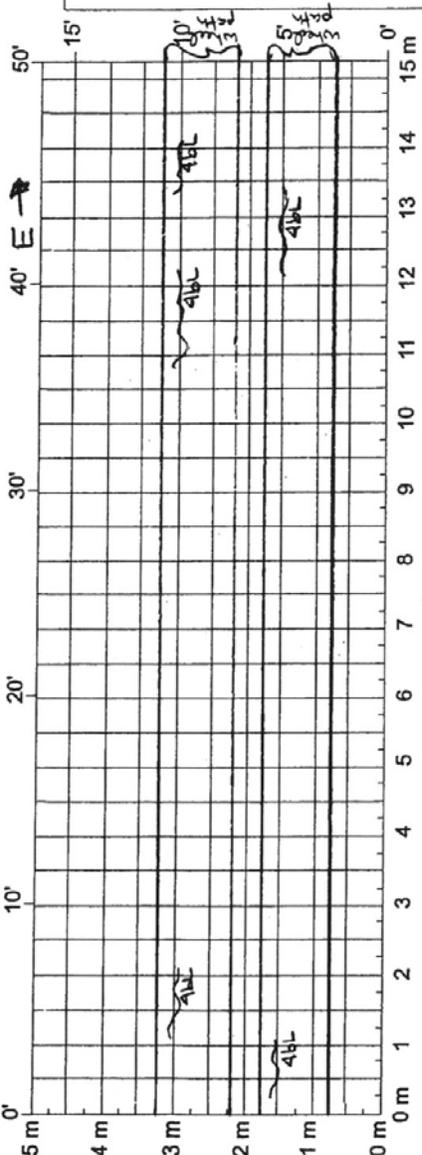
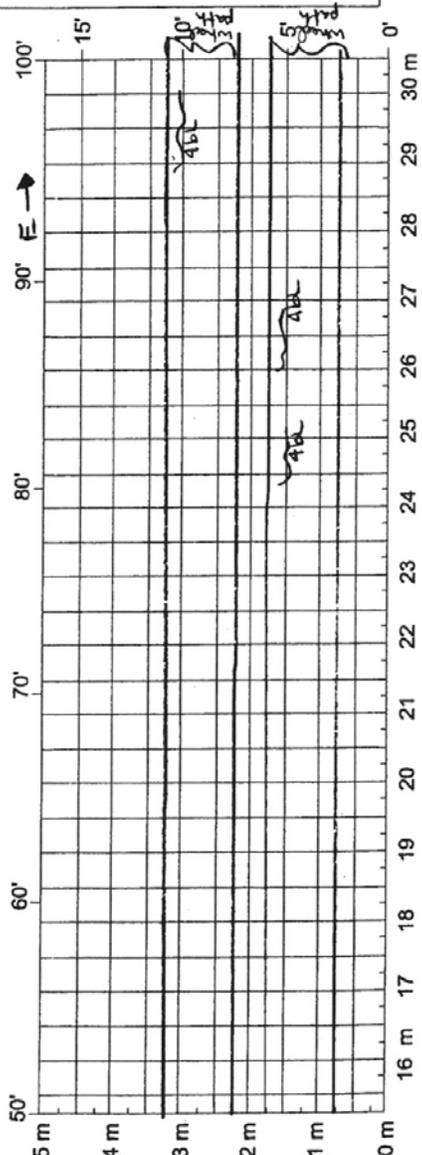
Comments: 7200 South from 700 West to State Street East Board

Sheet Summary
 7200 South from 700 West to State Street East Board. Road appears to be new. The paint appears to be new. The damage present consists of sporadic low grade longitudinal cracks that appear to be due to seam over lap.

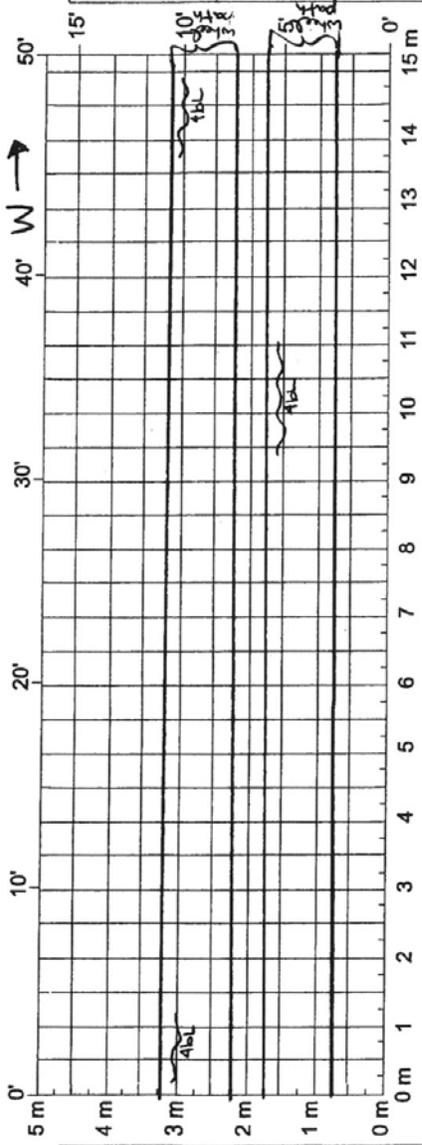
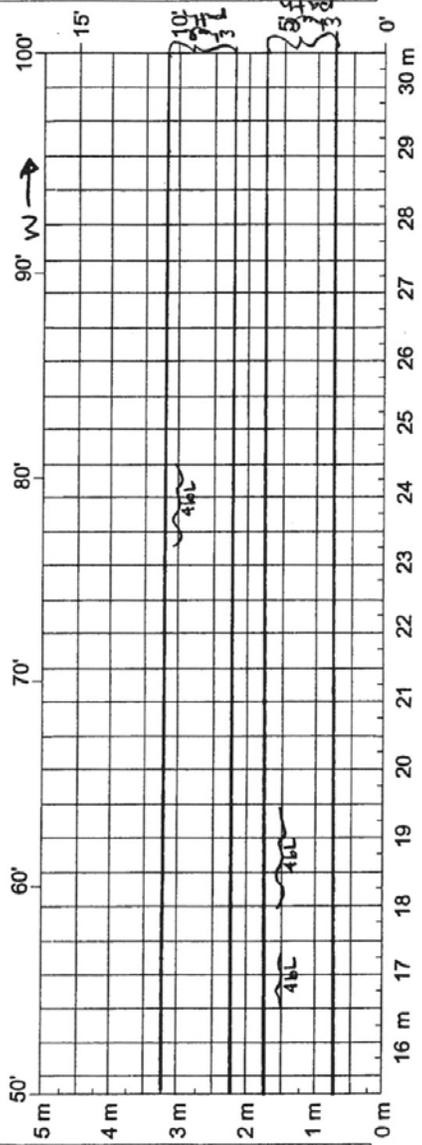
Comments: 7200 South from 700 West to State Street West Bound

7200 South from 700 West to State Street West Bound. Both the paint & road appear newer. The damage that is present appears isolated to the areas where the seams overlap & consists of low grade longitudinal cracking.

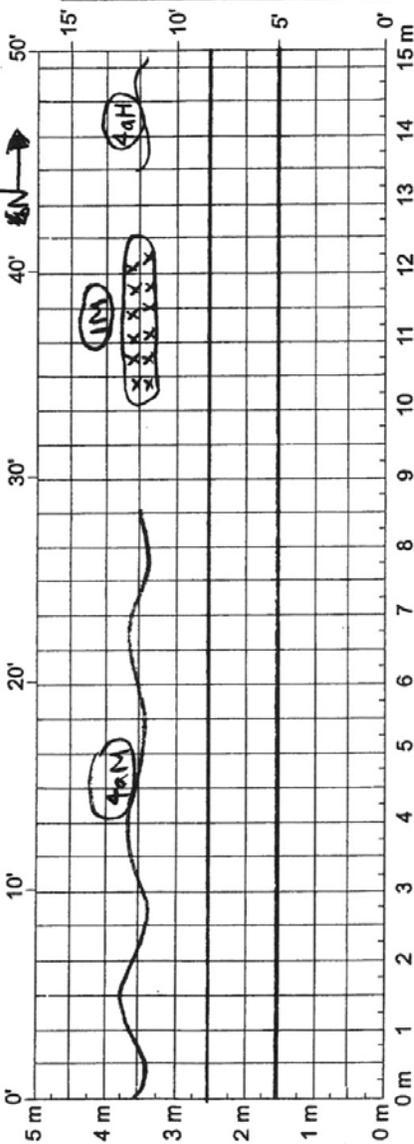
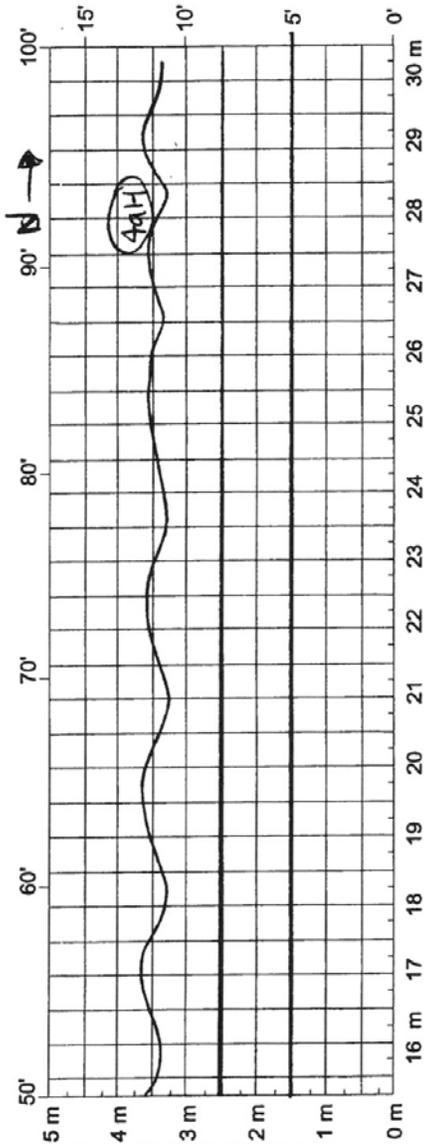
700 East from 10200 South to 10500 South Northbound. A majority of the damage consists of med-severe longitudinal cracks. There is also substantial fatigue cracking. The damage appears to be isolated mostly to the shoulder & the wheelpath. The paint shows normal wear. There is occasional medium to severe transverse cracking that mostly appears in the center of the road.

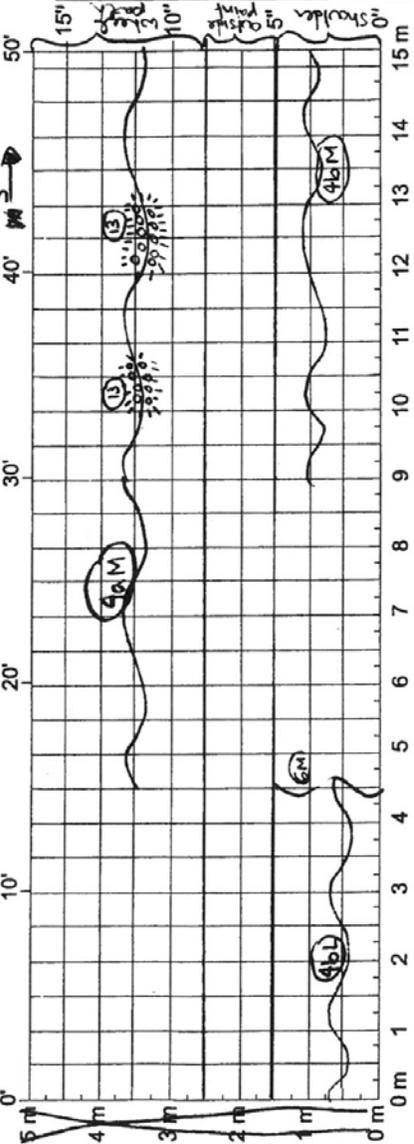
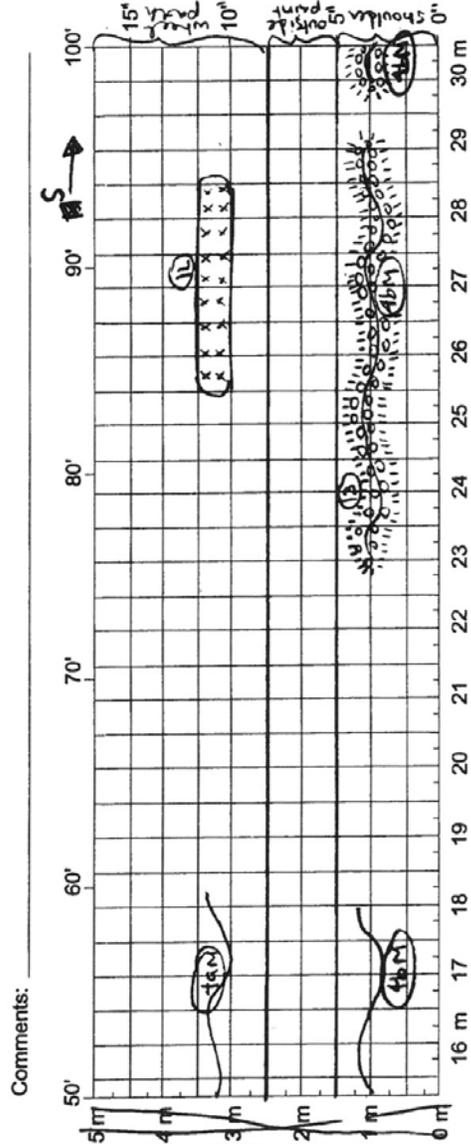
Sheet Summary
700 East From 10200 South to 10500 South Southbound lanes, A majority of the damage is due to med-severe longitudinal cracking with raveling present. The damage is not isolated to the paint. There is also significant damage due to med-severe transverse cracking mostly occurring between the outside paint & the shoulder.

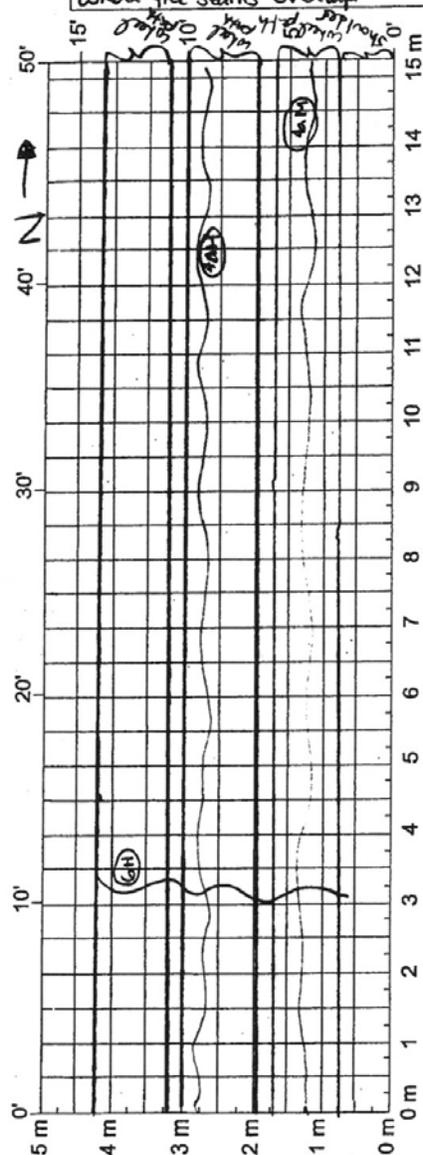
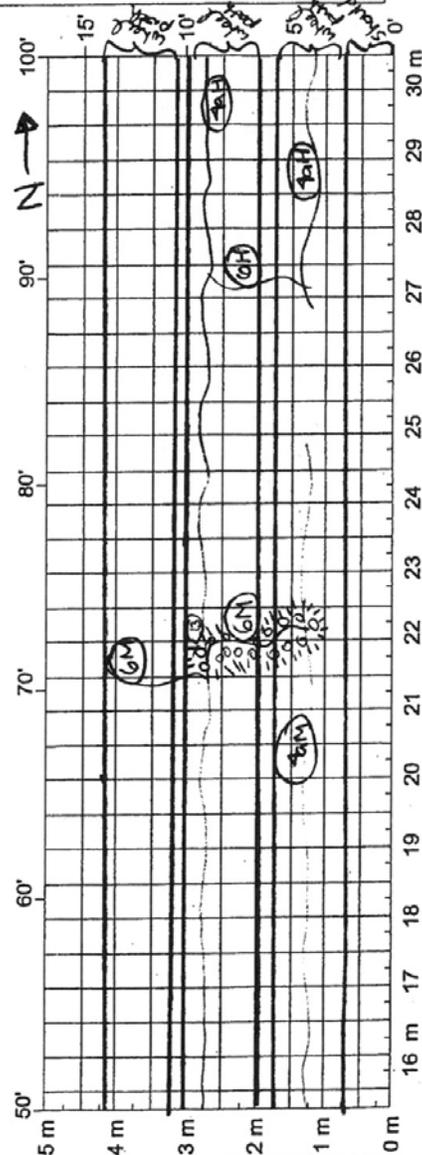
Comments: State Street Northbound 3000 South to 3300 South

Sheet Summary
State Street 900 South to 3300 South Northbound. A majority of the damage present is from 3000 South to 3300 South. The damage present consists mostly of moderate to high longitudinal cracking with moderate raveling & occasional small pot holes. There is also moderate to high transverse cracking that is mostly present in travel lanes. A majority of the longitudinal cracks occur where the seams overlap.

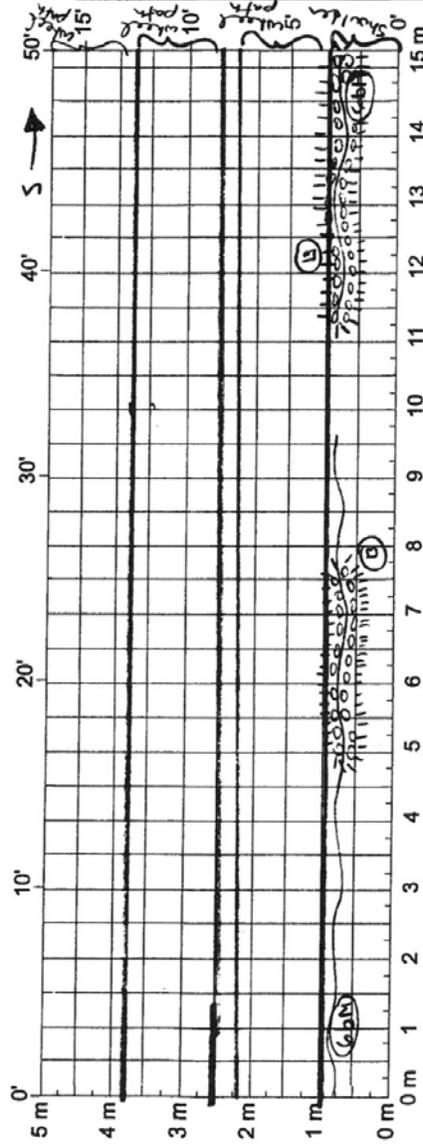
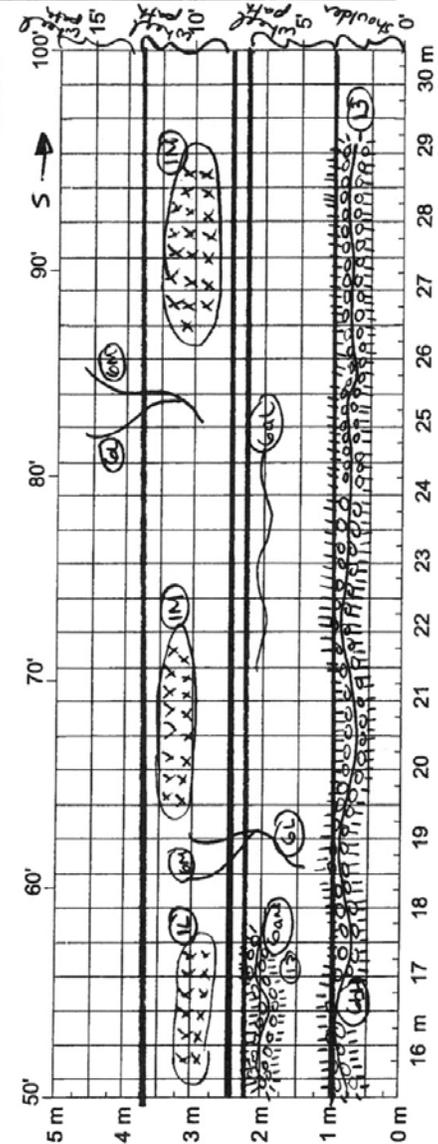
Comments: Foothill Blvd from 1300 East to I-80 South Bound

Sheet Summary
Foothill Blvd from 1300 East to I-80, South Bound. A majority of the damage is moderate-severe longitudinal cracking with raveling present. The longitudinal cracks appear mostly isolated with seam overlaps. There is also occasional/sporadic low-medium fatigue cracking in the outside wheel path. ~~There~~ All lanes of travel have occasional low-moderate transverse cracking from wheel path to wheel path. The paint does not seem to have any isolated effects.

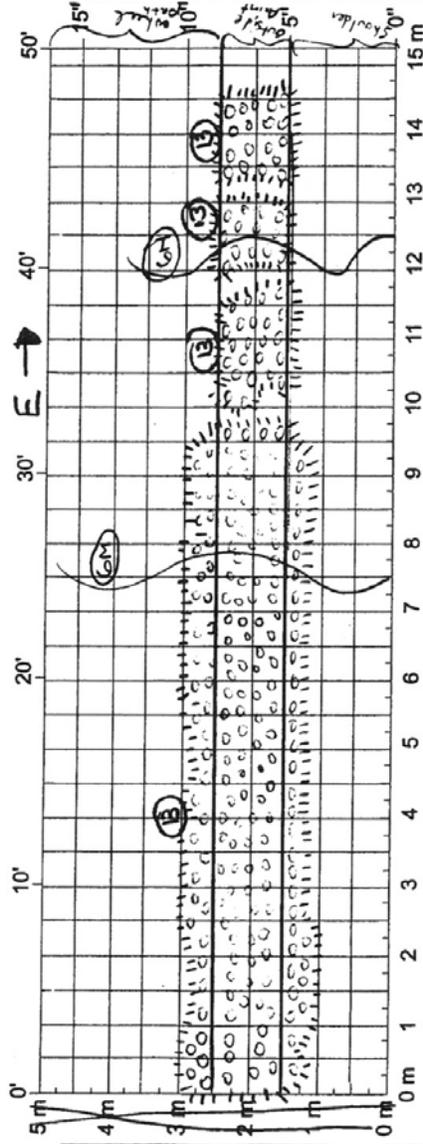
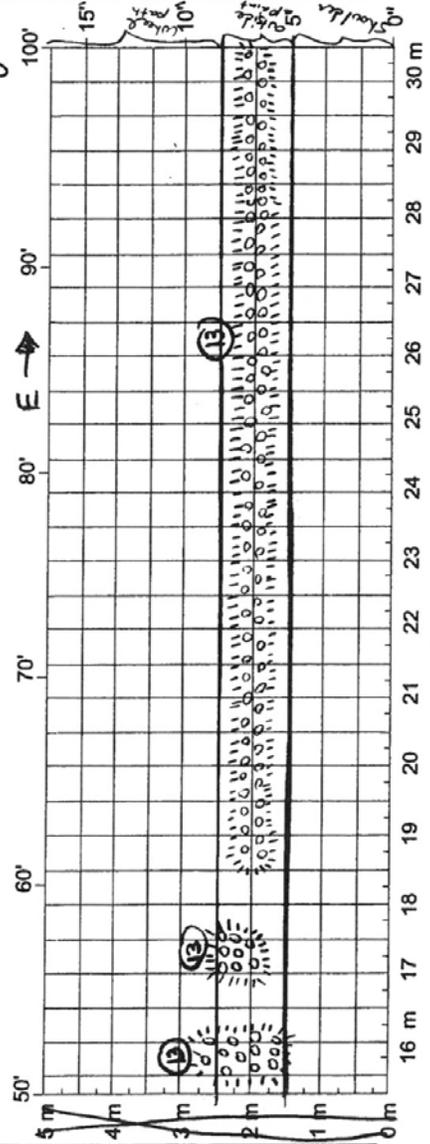
Comments: East Bound 9400 South 2200 East to mouth of Little Cottonwood Canyon

Sheet Summary
 9400 South from 2200 East to mouth of Little Cottonwood Canyon East Bound. Majority of damage is due to raveling & is isolated to the point. In addition there is also a fair amount of moderate-severe transverse cracking, no isolated to point. Paint is almost non-existent except where patches have been placed.

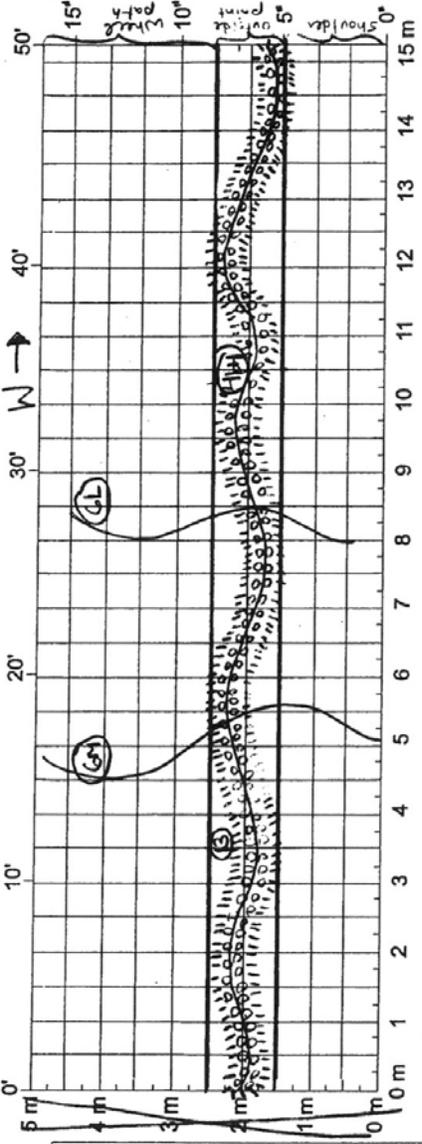
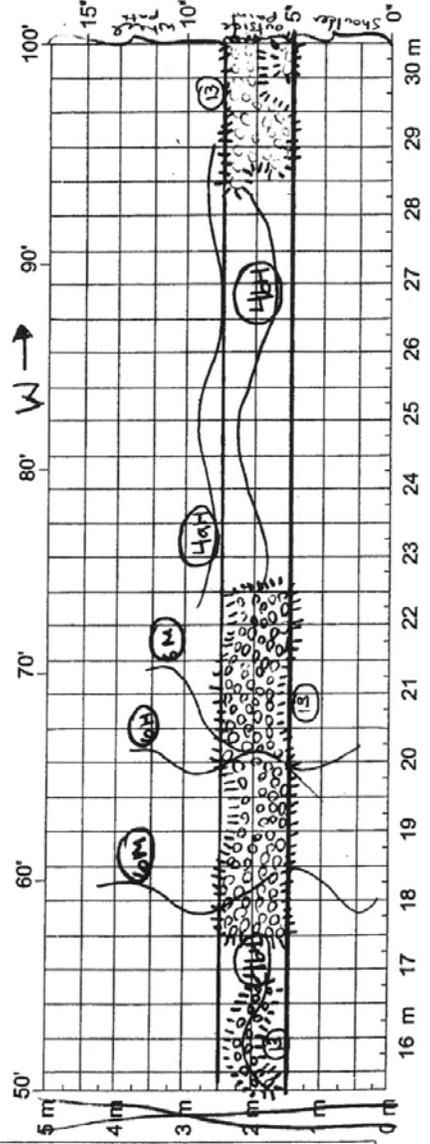
Comments: West Bound

Sheet Summary
 9400 South from 2200 East to mouth of Little Cottonwood Canyon West Bound. Majority of the damage is raveling & moderate-severe longitudinal cracking, both appear isolated to the paint. In addition there is a fair amount of moderate to severe transverse cracking that does not appear isolated to the paint. Paint is worn & faded & non-existent in some areas.

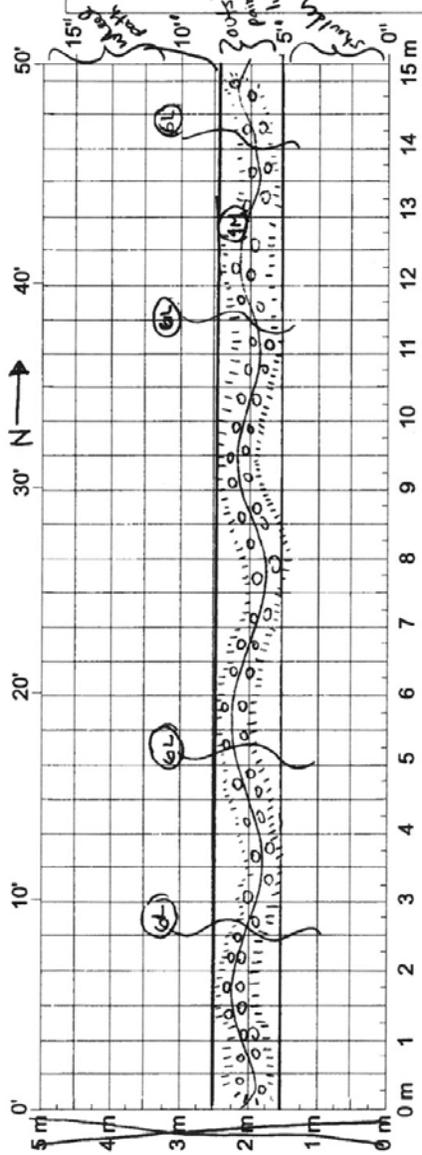
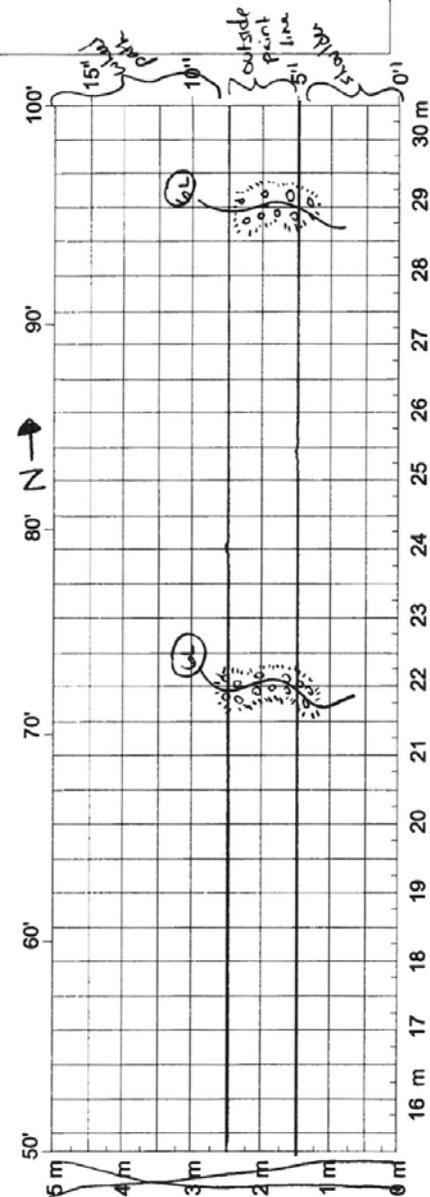
Comments: SE 224 North Bound

Sheet Summary
 SE 224 from Bean Hollow Dr to Junction SR 248 in Park City North Bound. A majority of the distress appears to be where the sears overlap. At the sears overlap there is moderate-severe longitudinal cracking & raveling. The paint shows minor distress & fading with occasional longitudinal & transverse cracking in addition there is occasional sections with fatigue cracking & raveling.
