Report No. UT-08.08

FISH PASSAGE AT UDOT CULVERTS: PRIORITIZATION AND ASSESSMENT

Utah Department of Transportation
Research and Innovation Division

Brigham Young University
Department of Civil and Environmental
Engineering

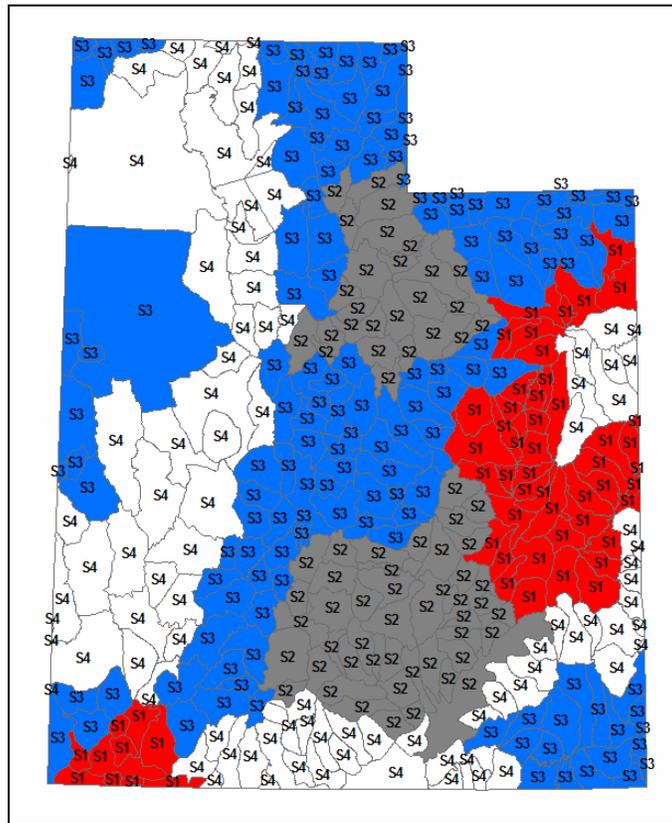
The Utah_CAPI.shp file initializes culvert prioritization at the state level (figure 3-1). Using UDOT fish passage strategy guidance, regional areas were identified and delineated based on value related to threatened & listed fish concentrations. This value is derived from habitat distribution data obtained for threatened and listed fishes found on the UDWR SSL located in Appendix A.

Figure 3-1: Utah State Culvert Assessment Priority Index Shapefile

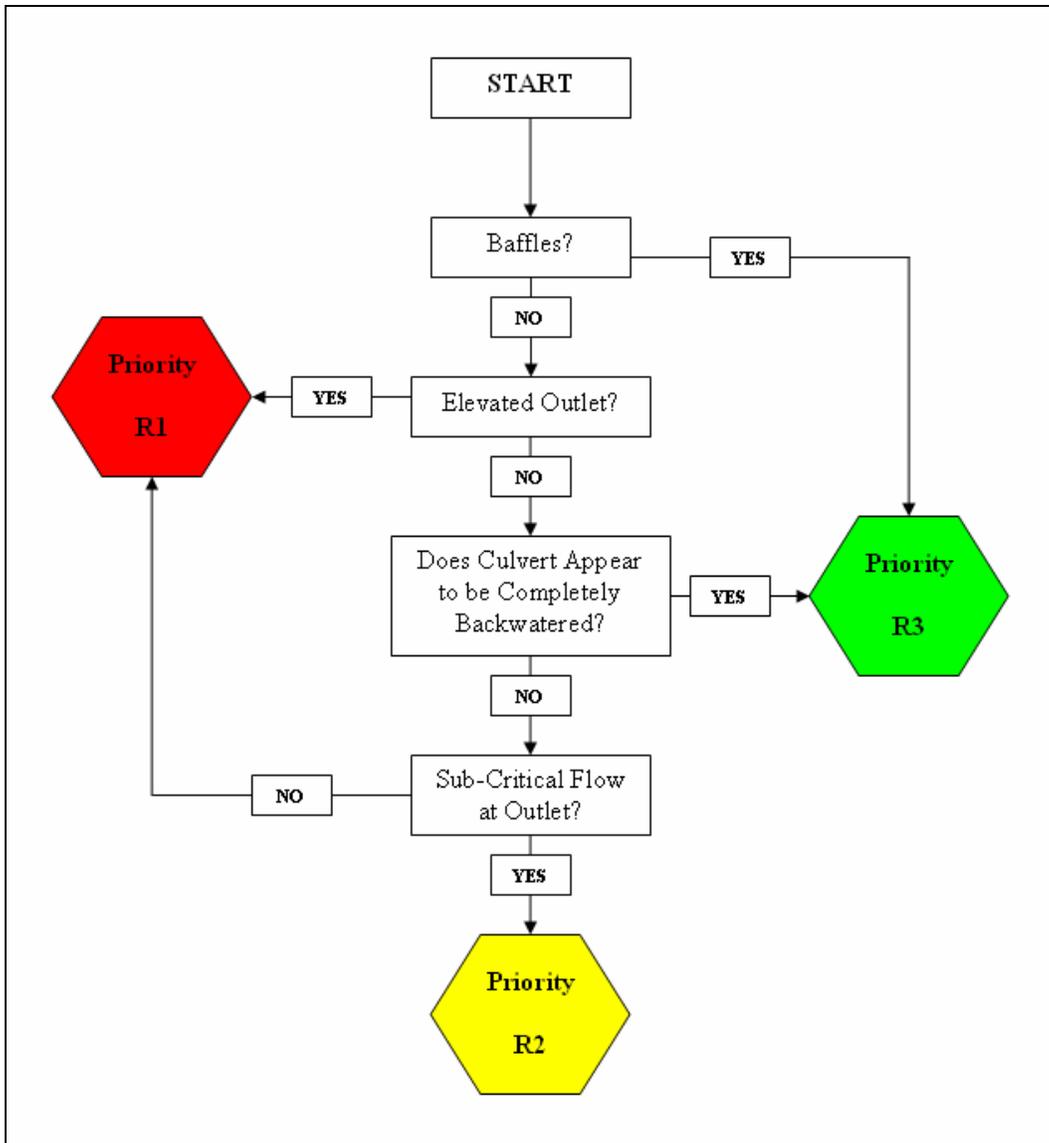
The Hydraulic Filter was developed to use as a method of further prioritizing culverts for assessment. The filter is based on a brief analysis of a culvert's base flow hydraulics. This filter is meant to be a rough filter and not a precise evaluation of the culvert's hydraulics at all flows. The filter process is illustrated in figure 3-2.

Figure 3-2: Hydraulic Filter Used with the Level I Culvert Assessment

R denotes prioritization code for the regional level. The filter is applied for base or “low flows”. In arid regions such as Utah this base flow condition is the predominant

condition. Annual peaks in the hydrograph typically occur during snowmelt in the Spring. This generalization allows us to conclude that for approximately 9-10 months out of the year the base flow condition is the dominant flow. This allows us to make some reasonable assumptions concerning stream discharge, culvert hydraulics and fish passage for prioritization of culverts.

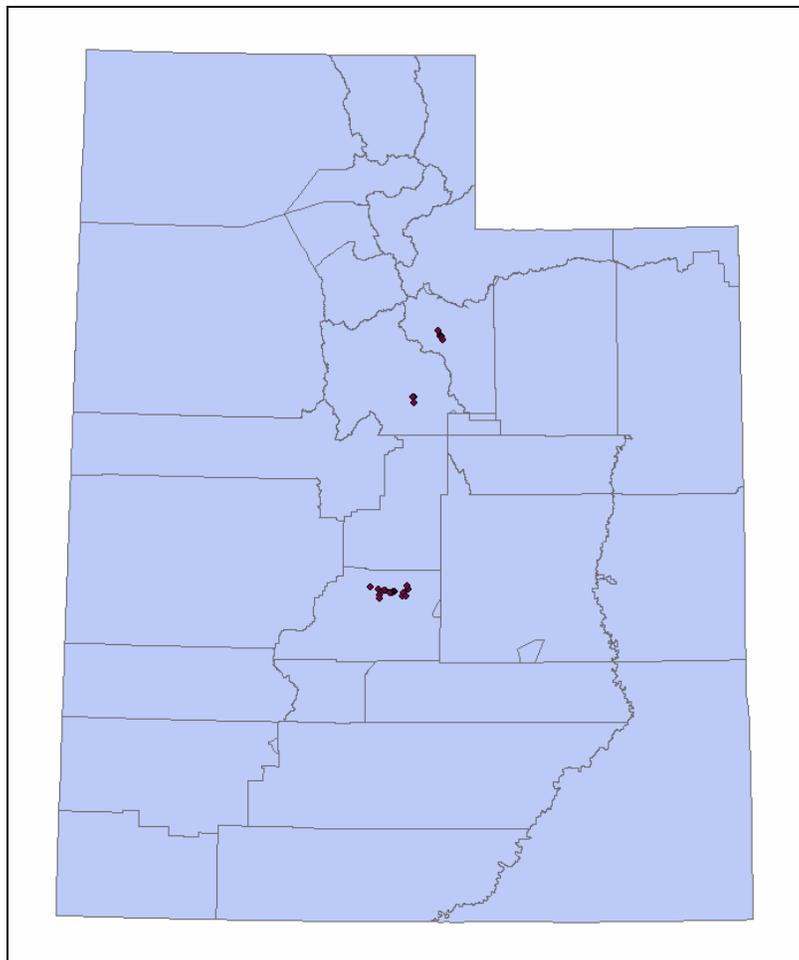
The UDOT_culverts.shp file was generated in GIS to spatially display Utah culvert locations and assist in prioritizing culverts and store fish passage prioritization and assessment data (figure 3-7).

Figure 3-7: Fish Passage Culvert Shapefile UDOT_culverts.shp

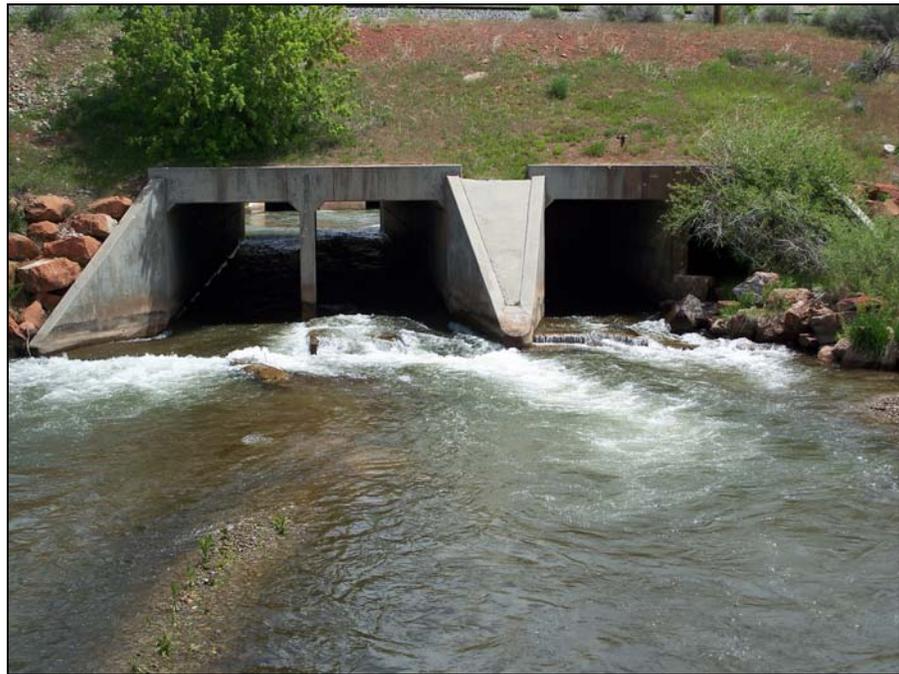
Figure 6-3: Diamond Fork Culvert #1 Outlet Located at the Diamond Fork Field Verification Site

Diamond Fork #1 and #2 culverts possessed fish baffles to facilitate upstream passage of fish. These baffles were found to have been completely filled in with sediment in several places creating a total barrier to upstream passage. This condition may be why no observation of fish passing through the culvert at these sites was observed.

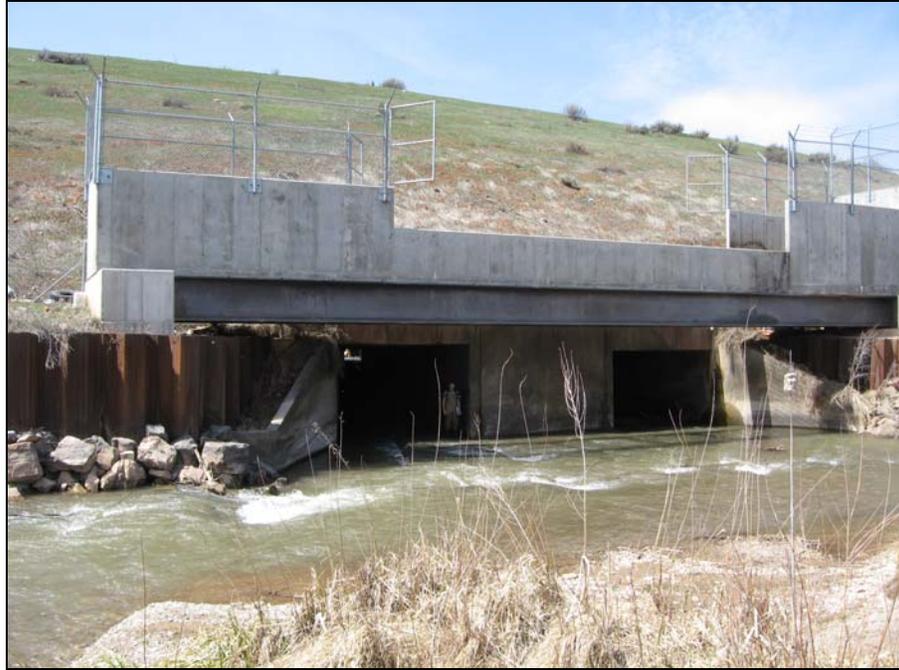
Figure 6-6: Diamond Fork Culvert #2 Inlet Located at the Diamond Fork Field Verification Site

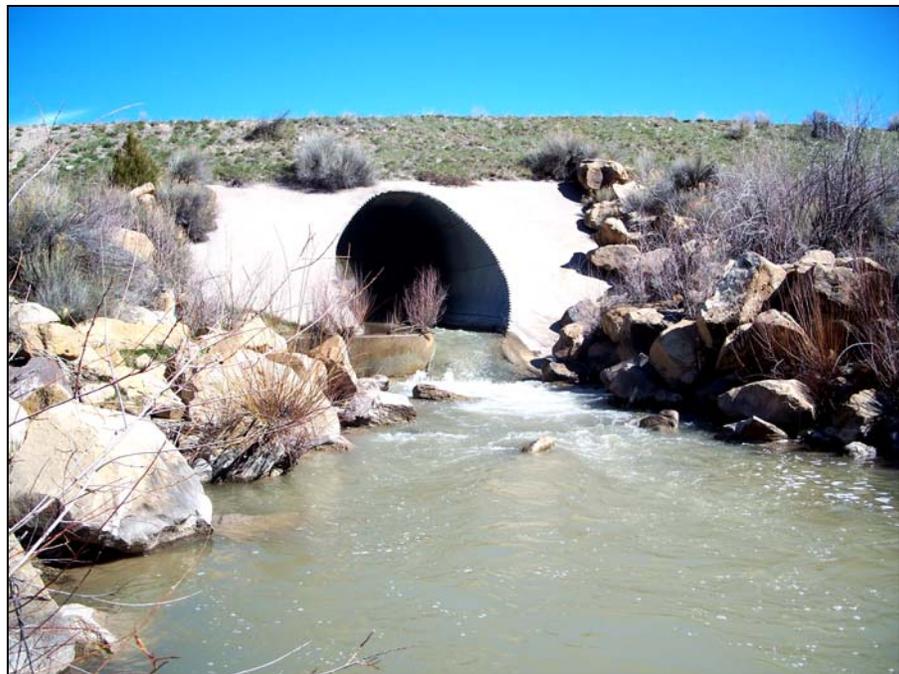
Figure 6-7: Salina Creek Culvert Outlet Located at the Salina Creek Field Verification Site

The Salina Creek culvert possessed a slope of 0.56 % and a perched outlet of greater than 2 ft with a cascading outlet flow over concrete and riprap. It also possessed a wildlife trail which greatly constricted normal flows. The culvert was inlet controlled during the assessment and sub-critical flow was absent the entire length of the culvert. One Mountain sucker was observed moving completely upstream through the culvert.

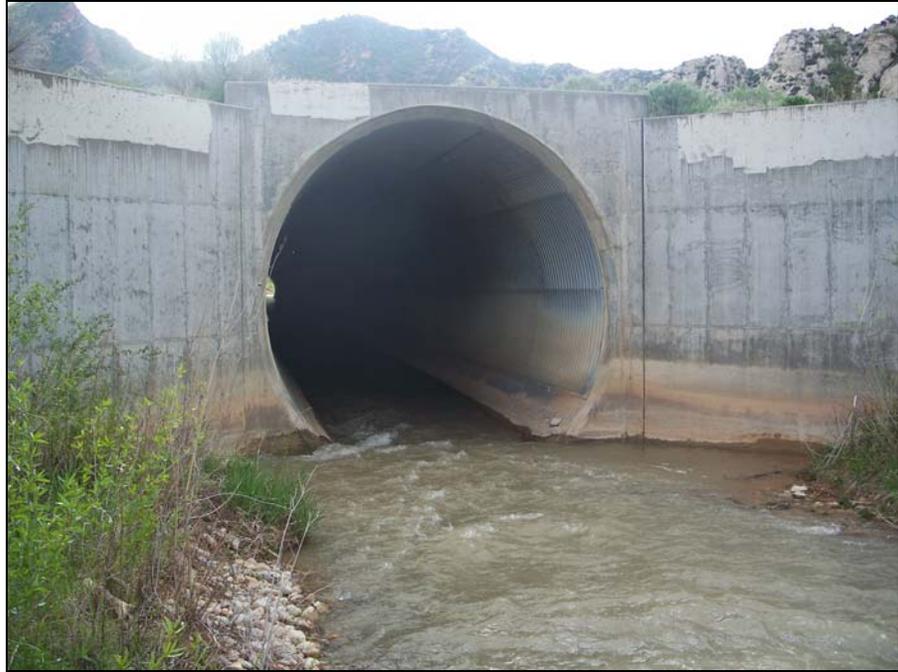
Figure 6-10: Soldier Creek Culvert Inlet Located at the Soldier Creek Field Verification Site

The Soldier Creek culvert possessed a slope of 0.27 % and was completely backwatered. This indicated that the tailwater control elevation was greater than the culvert inlet invert elevation. The culvert was outlet controlled during the assessment and the culvert possessed sub-critical flow the entire length of the culvert. Four Leatherside chub, two Mountain sucker, and one Longnose dace were observed moving completely upstream through the culvert.

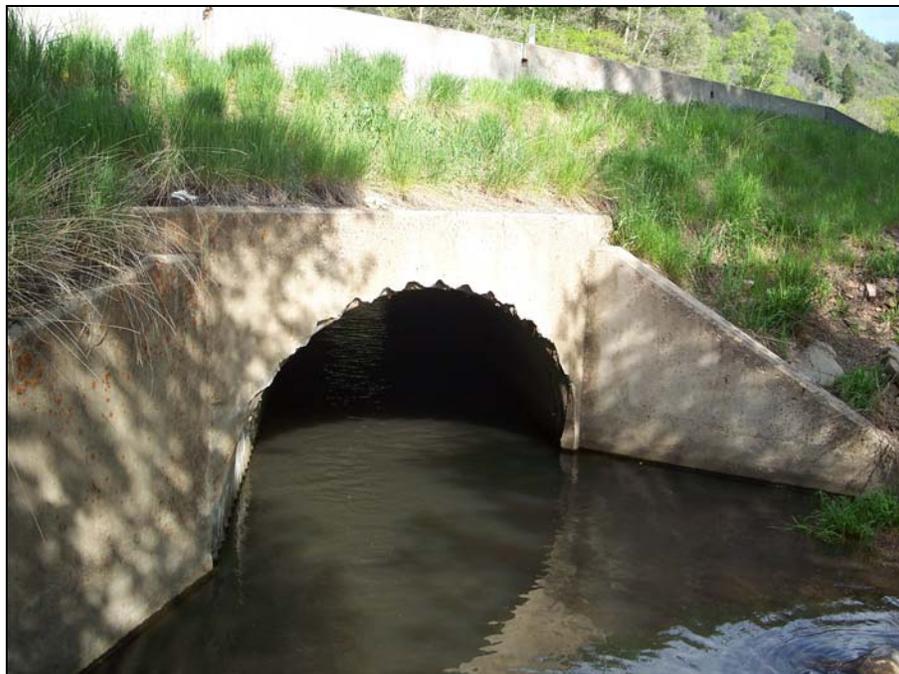
Figure 6-11: Daniel's Creek Culvert #1 Outlet Located at the Daniels Creek Field Verification Site

The Daniel's Creek #1 culvert possessed a slope of 0.83 % and was completely backwatered. This indicated that the tailwater control elevation was greater than the culvert inlet invert elevation. The culvert was outlet controlled during the assessment and the culvert possessed sub-critical flow the entire length of the culvert. Two Mottled sculpin and four Brown trout were observed moving completely upstream through the culvert.

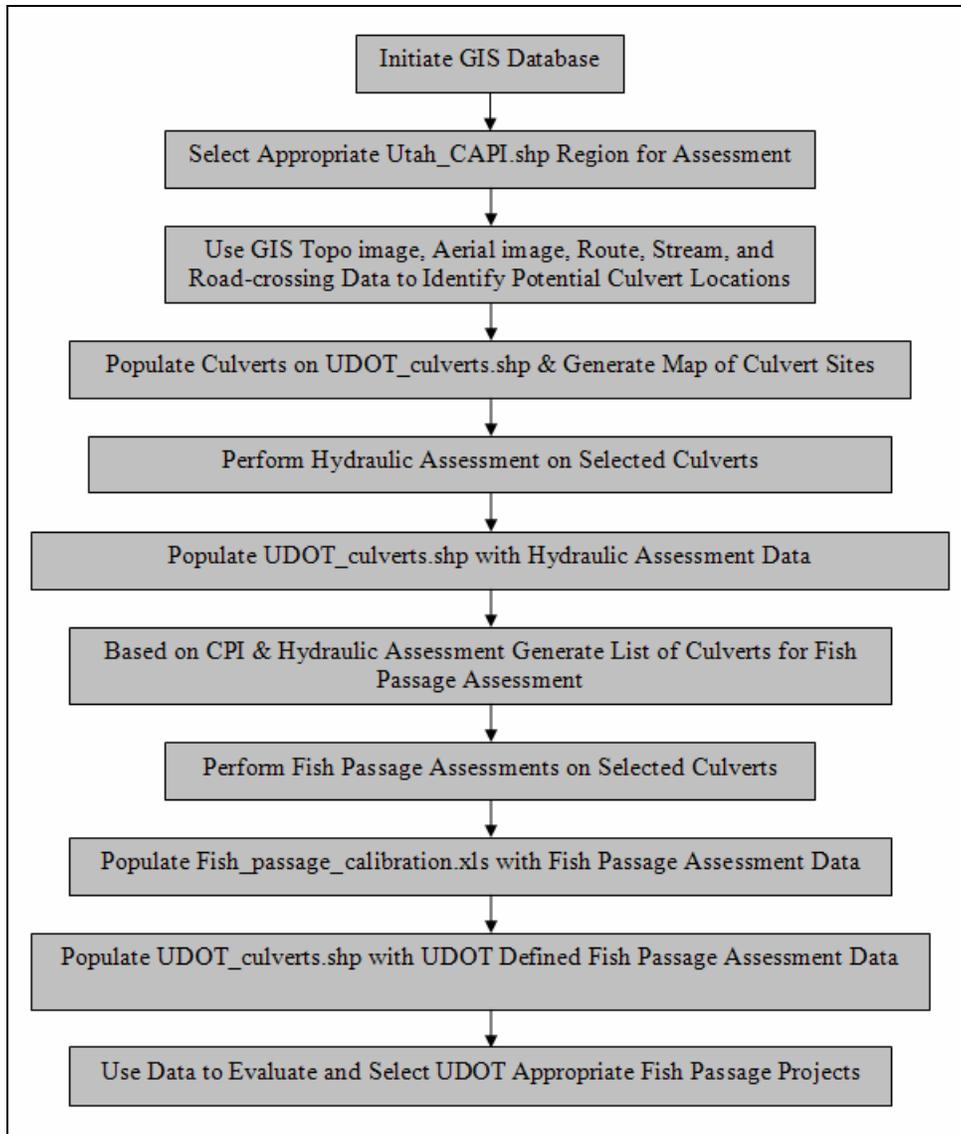
A conceptual framework was created to establish critical progression for prioritizing culverts for fish passage utilizing the project deliverables. This framework has been developed to meet the established criteria for UDOT fish passage strategy expectations. The implementation and execution of the several project deliverables as they pertain to the developed UDOT fish passage strategy has been termed the UDOT Fish Passage Prioritization & Assessment Implementation Plan (FPAIP) (figure 8-1).

Figure 8-1: Flow Chart Outlining the FPAIP

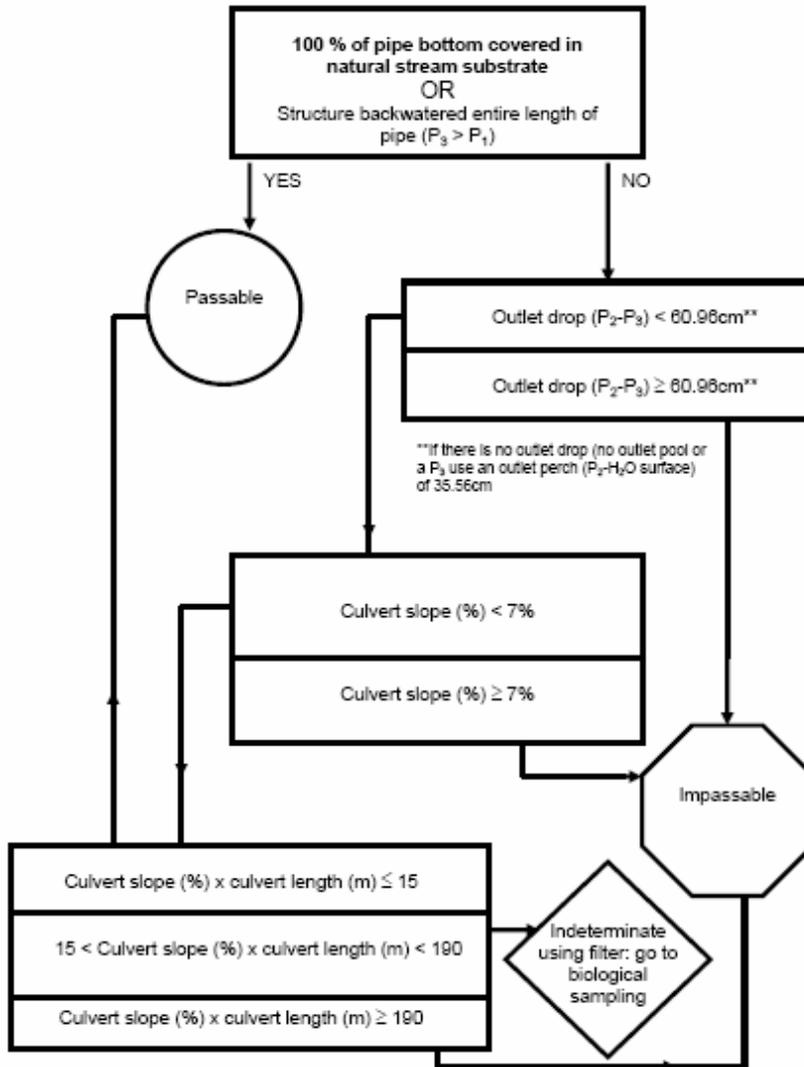
Figure 3. Modified upstream fish passage predictive model A for Salmonidae. See Figure 1.1 for a profile of survey points used in fish passage coarse filter. P_n = elevation measurements.

Figure B-21: Coffman (2005) Group (A) Adult Salmonid Fish Screen

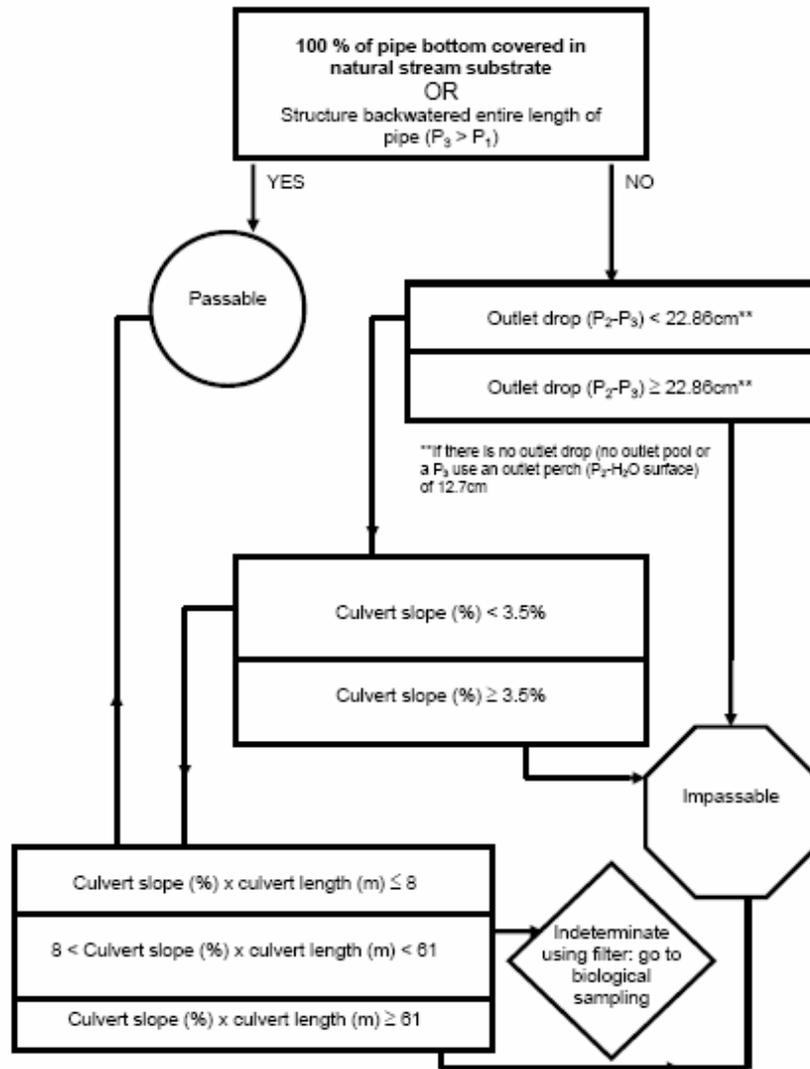
Figure 7. Modified upstream fish passage predictive model B for Cyprinidae and young of year salmonids. See Figure 1.1 for profile of survey points used in fish passage coarse filter. P_n = elevation measurements.

Figure B-22: Coffman (2005) Group (B) Young of Year Salmonid & Cyprinidae Fish Screen

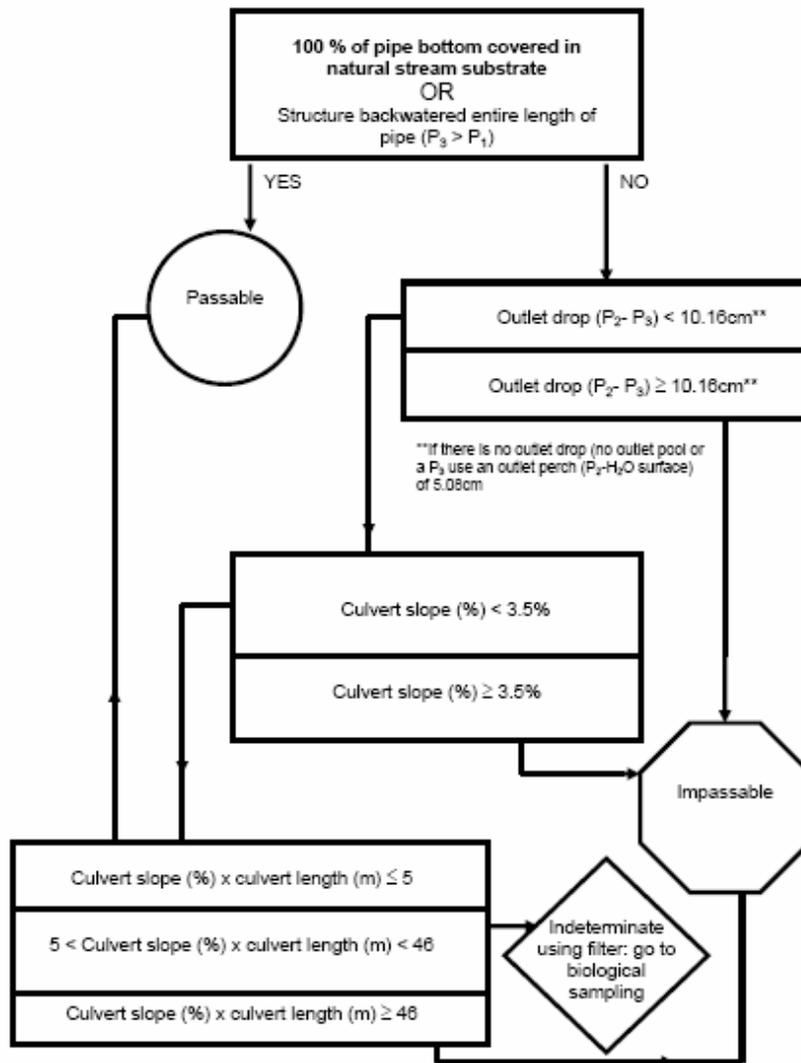
Figure 11. Modified upstream fish passage predictive model C for Percidae (except *Sander vitreus*, *Stizostedion canadense*, and *Perca flavescens*), and Cottidae families. See Figure 1.1 for profile of survey points used in fish passage coarse filter. P_n = elevation measurements.

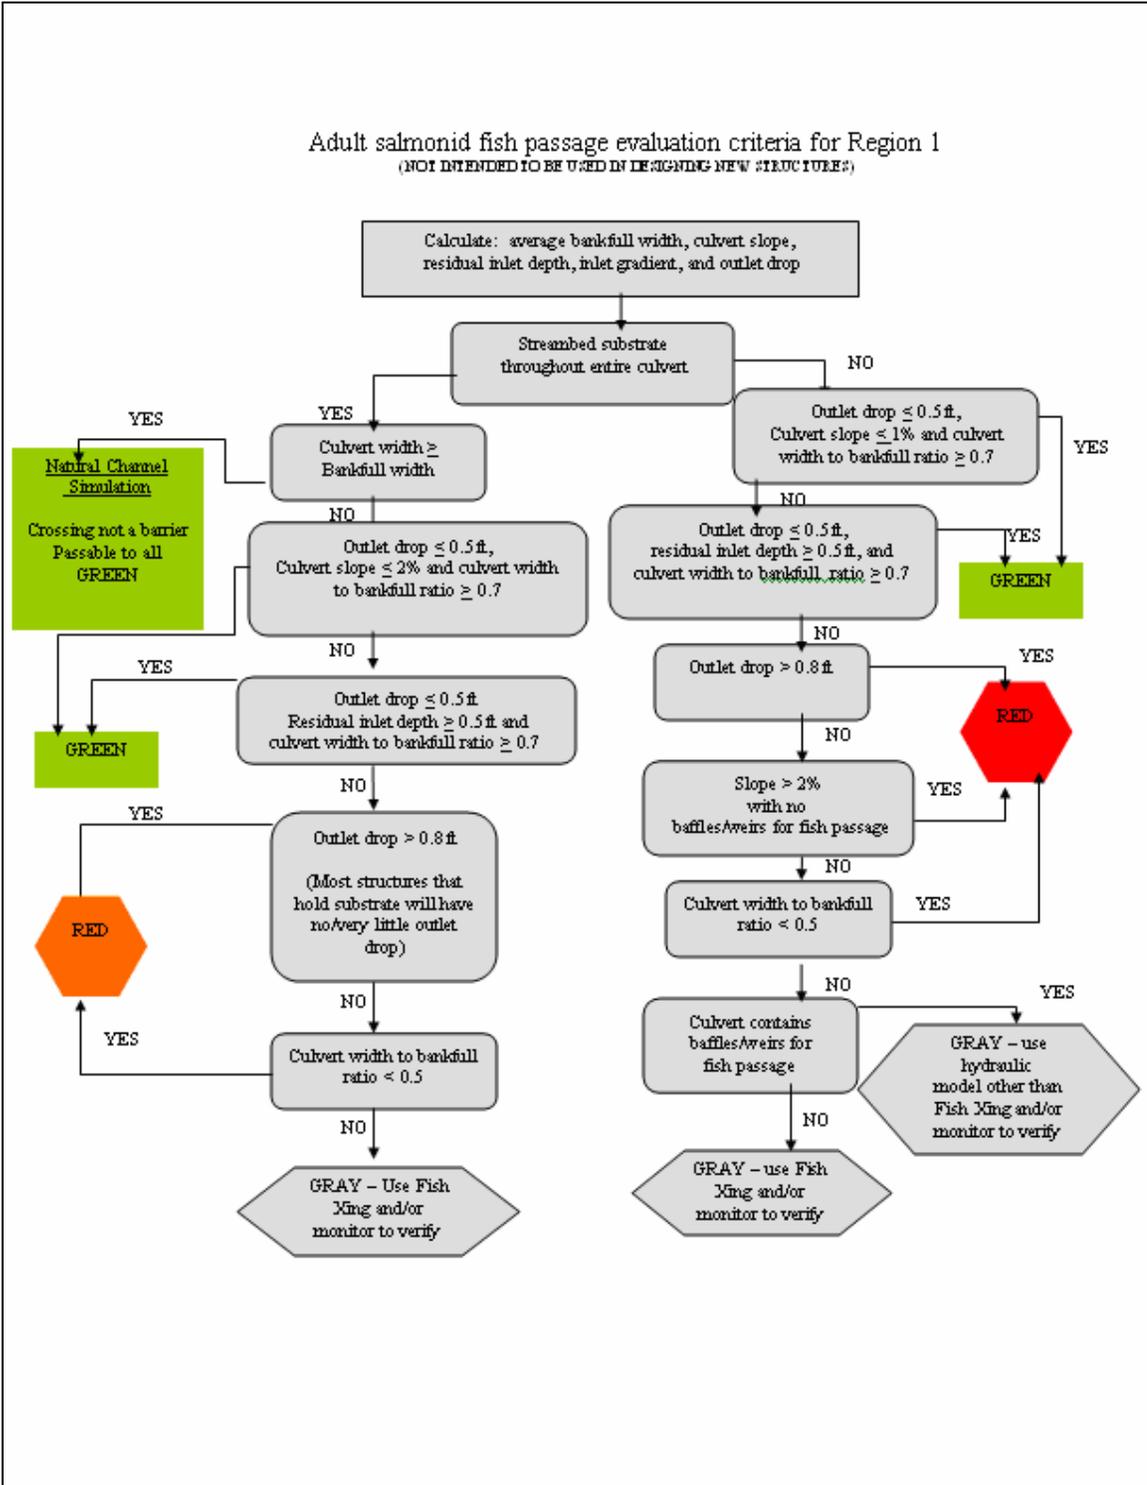
Figure B-24: USFS Region 1 Adult Salmonid Fish Screen

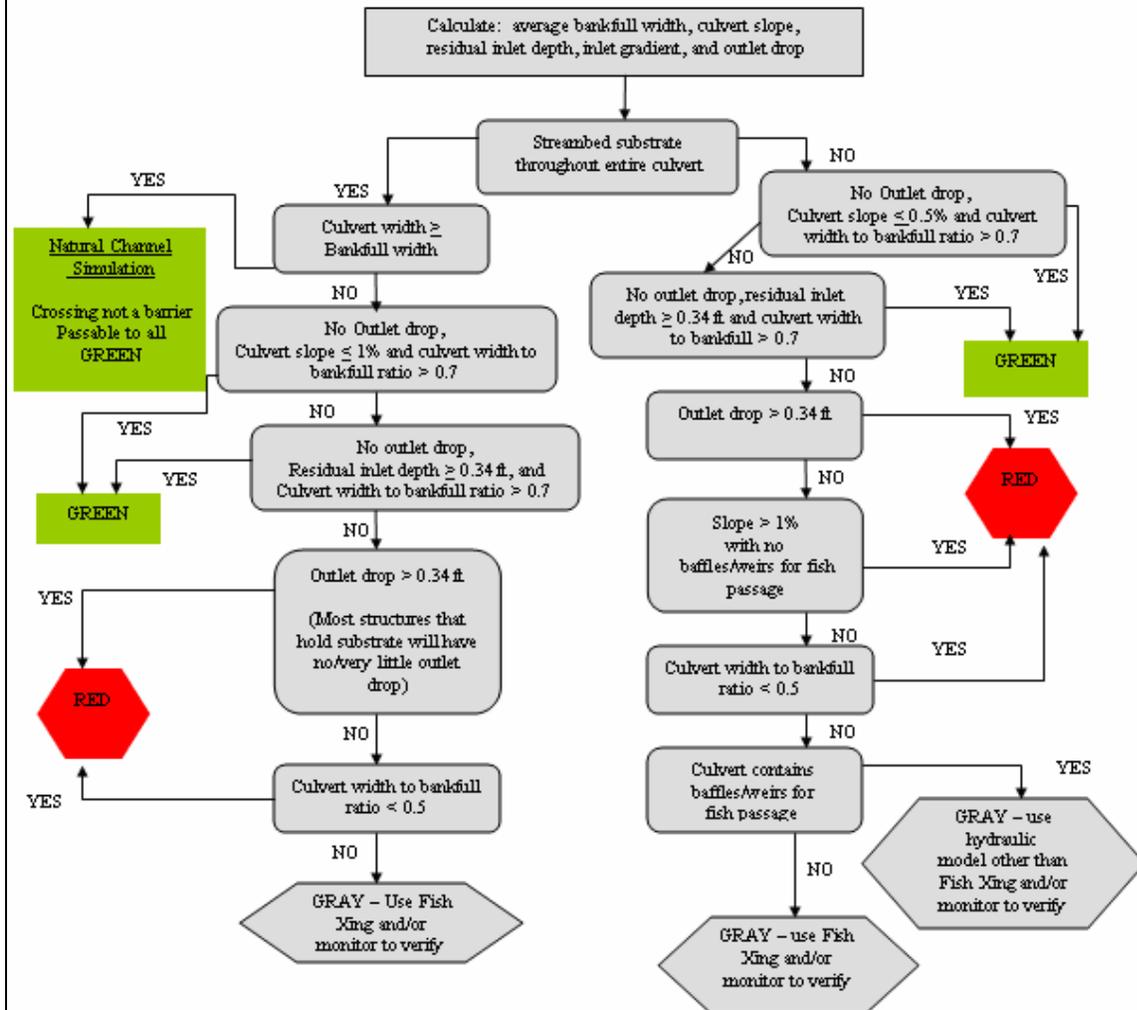
Juvenile salmonid fish passage evaluation criteria at flows less than bankfull flows for Region 1
(NOT INTENDED TO BE USED FOR DESIGNING NEW STRUCTURES)

Figure B-25: USFS Region 1 Juvenile Salmonid Fish Screen

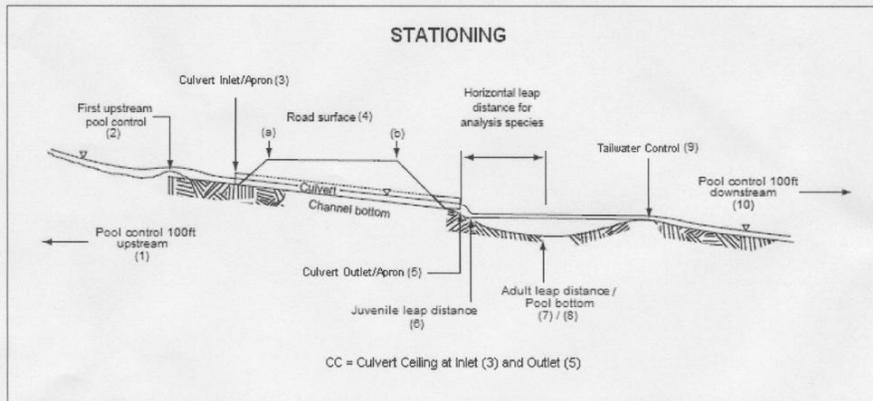
Figure 1. Longitudinal Profile Stations (Modified USFS Photo Clarkin et al)

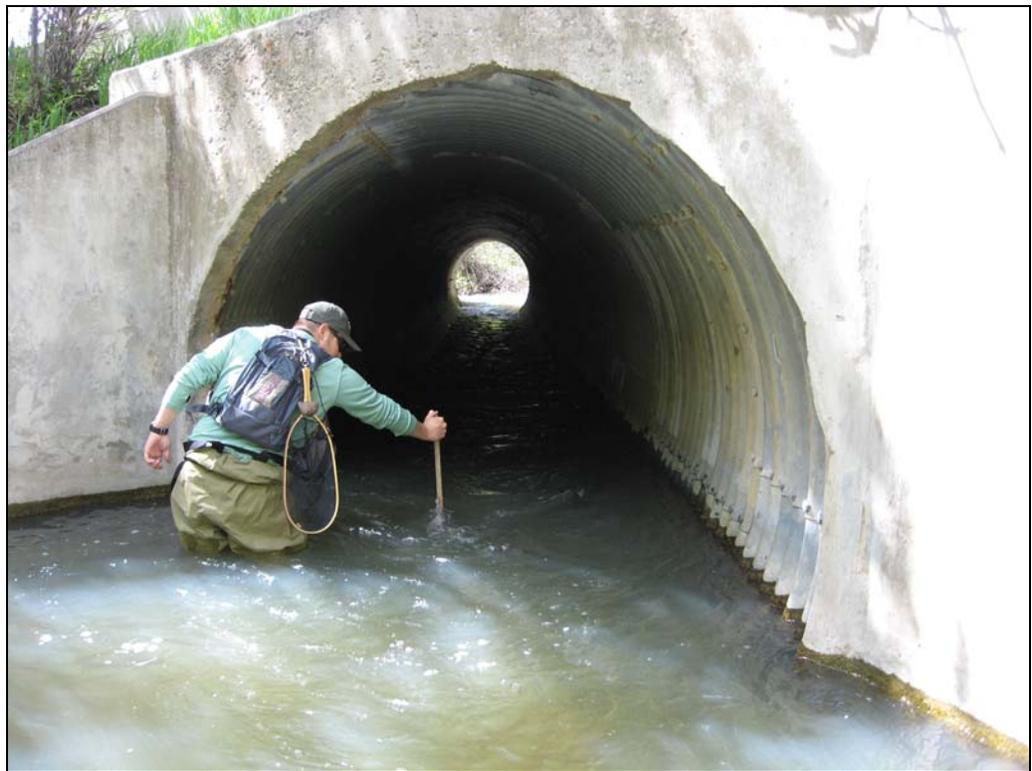
- At an arms length upstream of the holder
- Staff is placed in the middle of the outlet invert
- Holder stands downstream of the staff
- Holder positions her/himself to one side of the staff, not directly downstream

Figure 4-5: Correct Posture and Orientation for Determining Outlet Flow with a Wading Staff

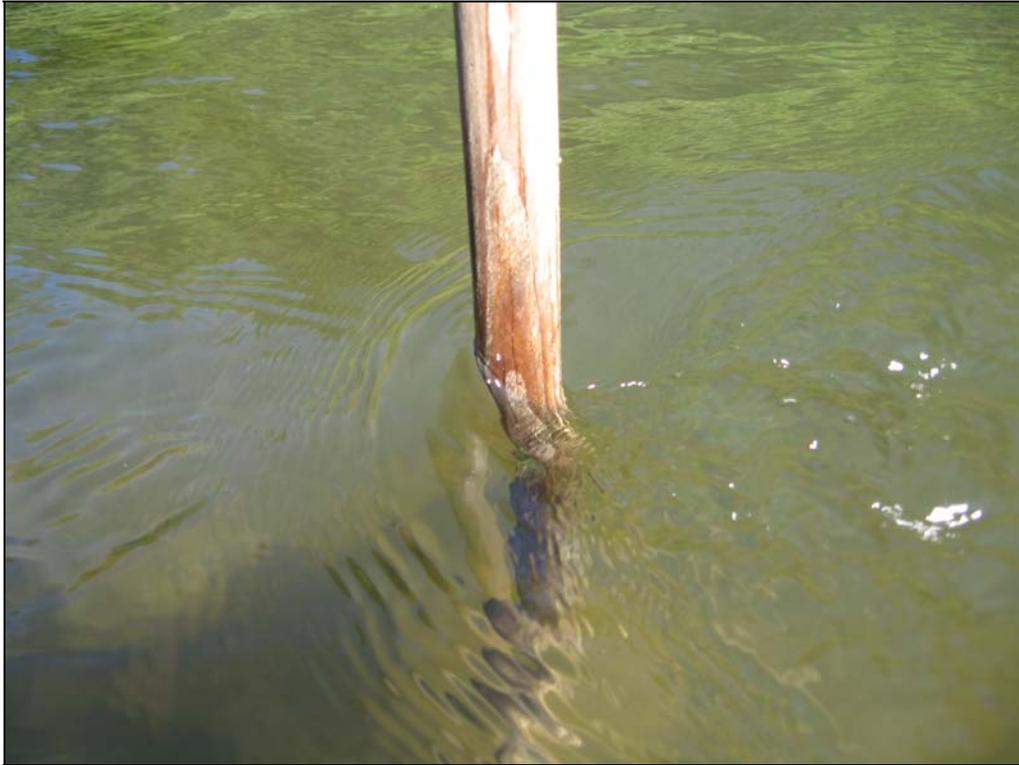
At this point wave action at the upstream side of the staff can be used to evaluate critical or sub-critical flow conditions. If waves can be seen propagating upstream of the staff this indicates sub-critical flow (figure 4-6). An absence of these upstream moving waves indicates critical flow (figure 4-7).

Figure 4-6: Sub-Critical Flow Wave Action on the Upstream Side of a Wading Staff

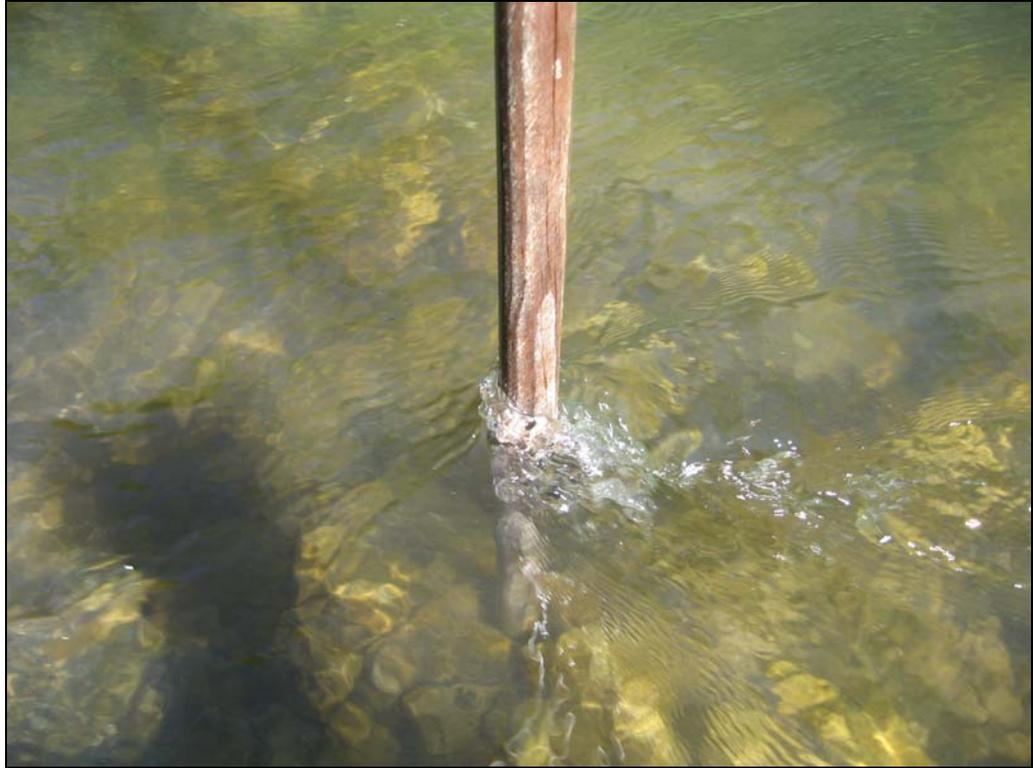
Figure 4-7: Critical Flow Wave Action on Wading Staff

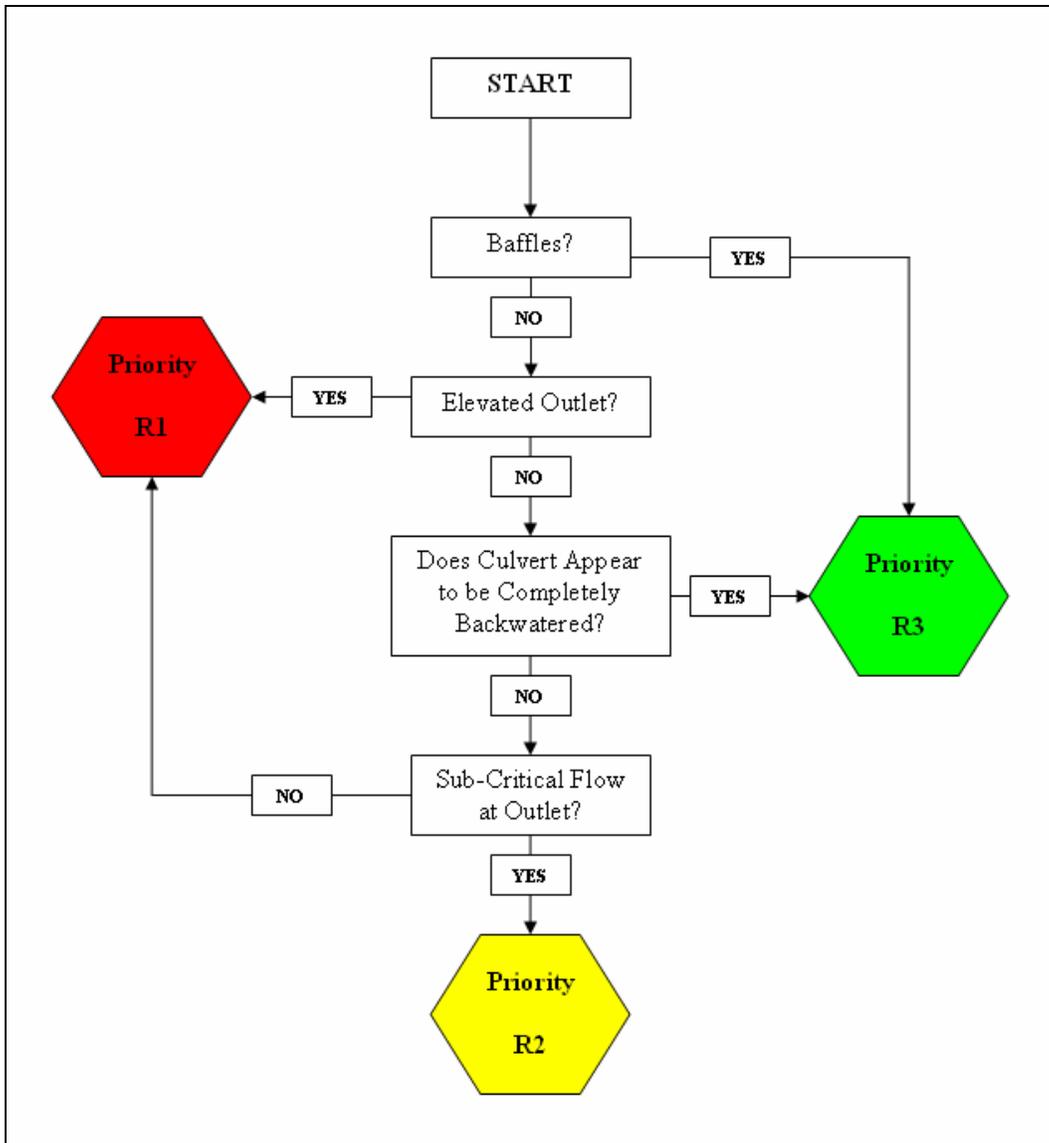
This assessment is to be used with the Hydraulic Filter. The Hydraulic Filter is meant to be a very rough filter, not a declaration of the culverts absolute fish passage status. It's used to regionally prioritize culverts by rating them on a scale of 1 to 3, with a value of 1 being the highest priority. The Hydraulic Filter aids in prioritizing culverts for the Fish Passage Assessment (figure 4-18).

Figure 4-18: Hydraulic Filter

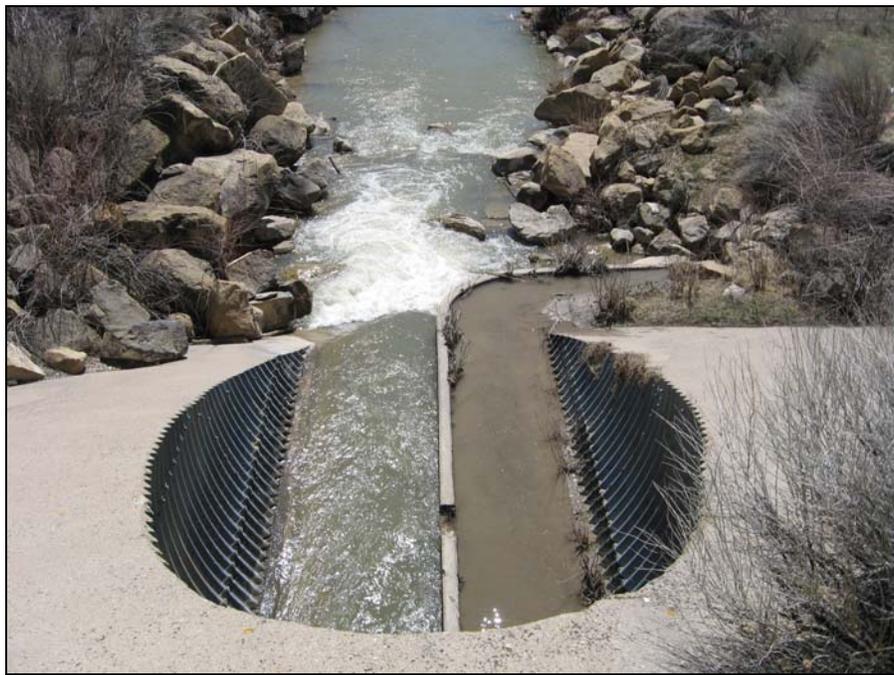
This photo should be taken from above the culvert outlet looking downstream. The photo should capture the immediate area of the culvert outlet and scour hole or the first pool immediately downstream of the culvert outlet. Usually, this photo also contains the first downstream riffle and the floodplain topography. If not, take additional photos which include the first downstream riffle and general topography of the area (figures 5-3 & 5-4).

Figure 5-3: Embankment Looking Downstream Photo

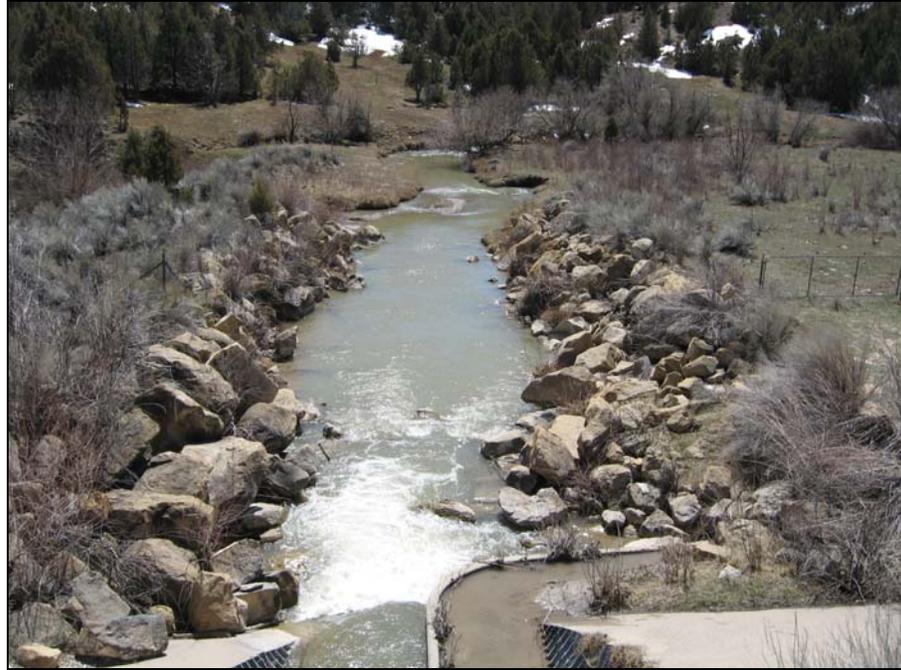
Figure 5-4: Additional Embankment Looking Downstream Photo Showing Floodplain

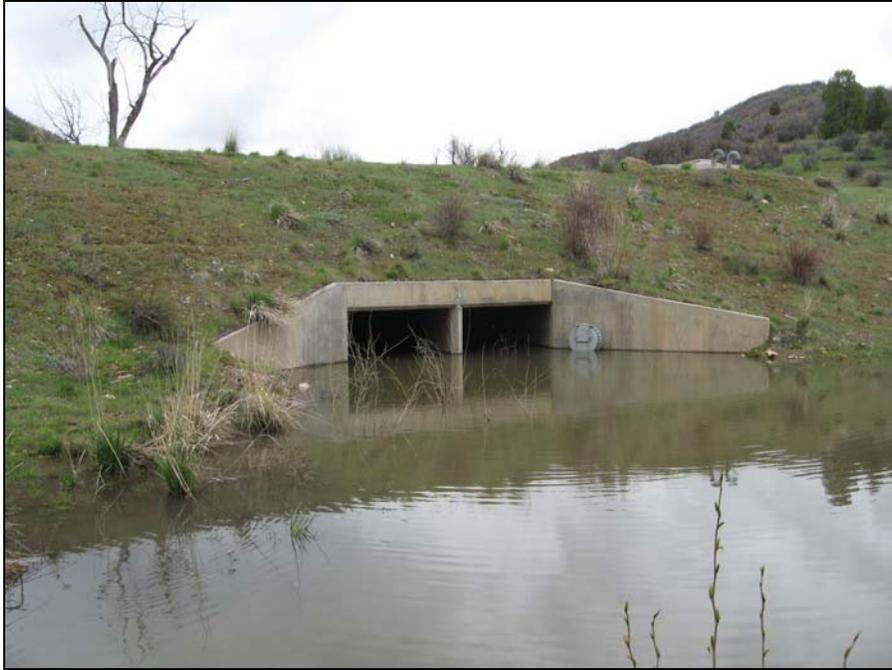
Figure 5-8: Backwater Conditions at Outlet Caused from Debris Dam

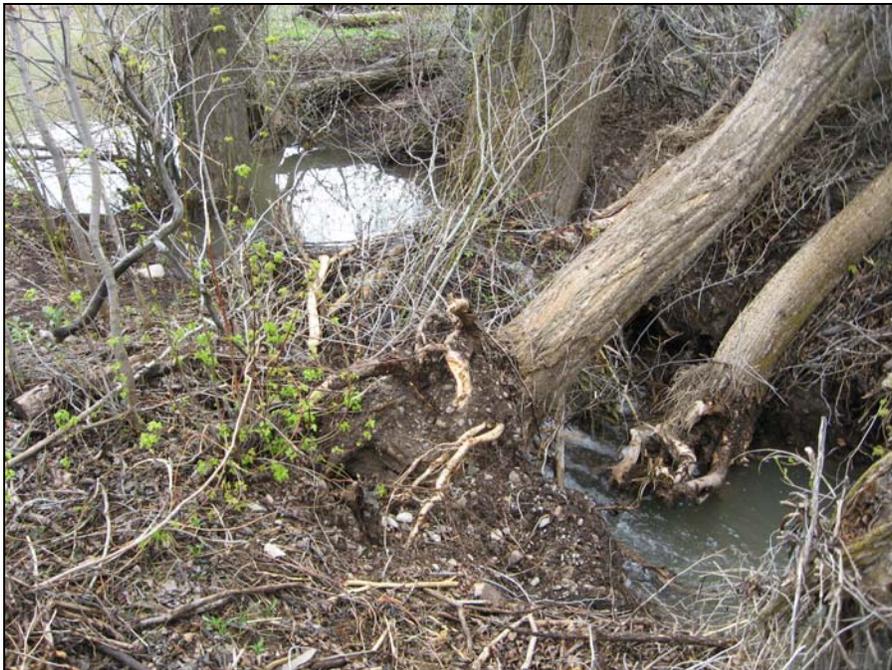
Figure 5-9: Debris Dam Causing Backwater Conditions

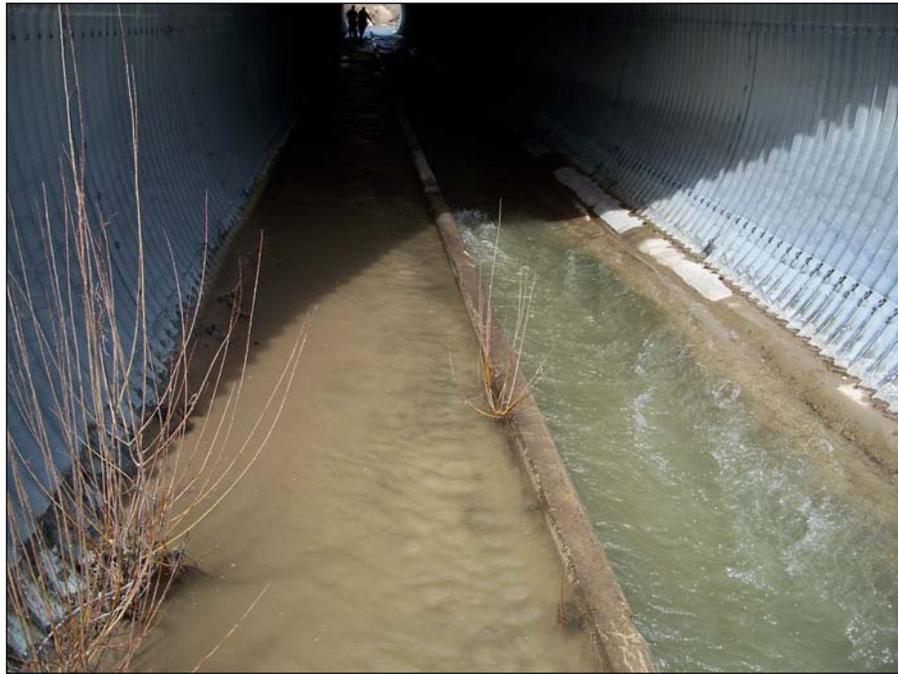
Internal structures can be natural or man made structures (figures 5-10 through 5-17). Man made structures might include fish baffles or wildlife/pedestrian trails. Natural structures may include wedged logs, debris piles or other material clogged in the culvert. Culverts containing fish baffles should include close up photos of the baffles at the outlet, mid-culvert, and inlet. Remember to mark the location of internal structures or conditions in the sketch.

Figure 5-10: Wildlife Trail in Culvert

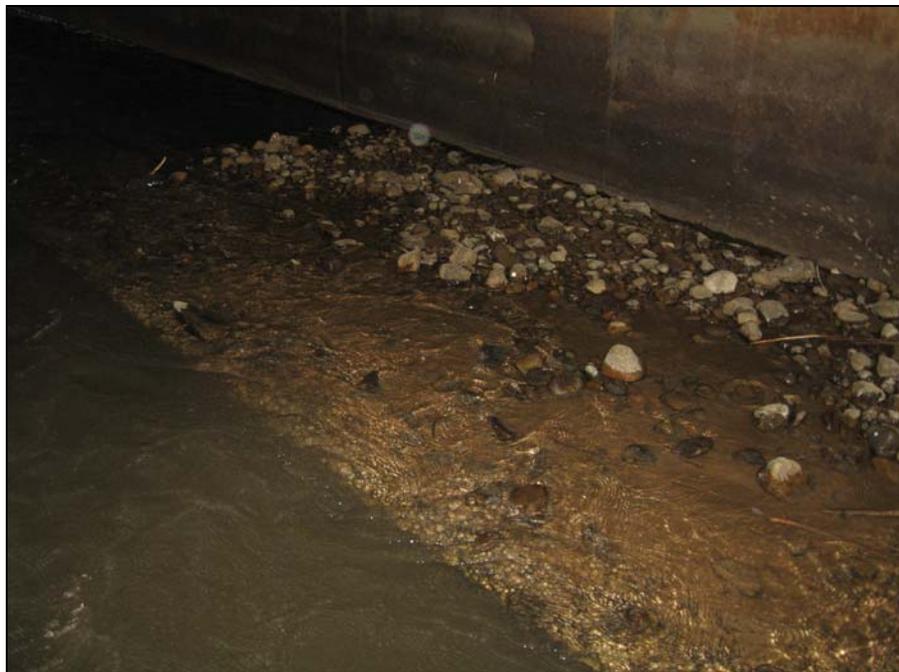
Figure 5-14: Fish Baffles Filled in with Sediment

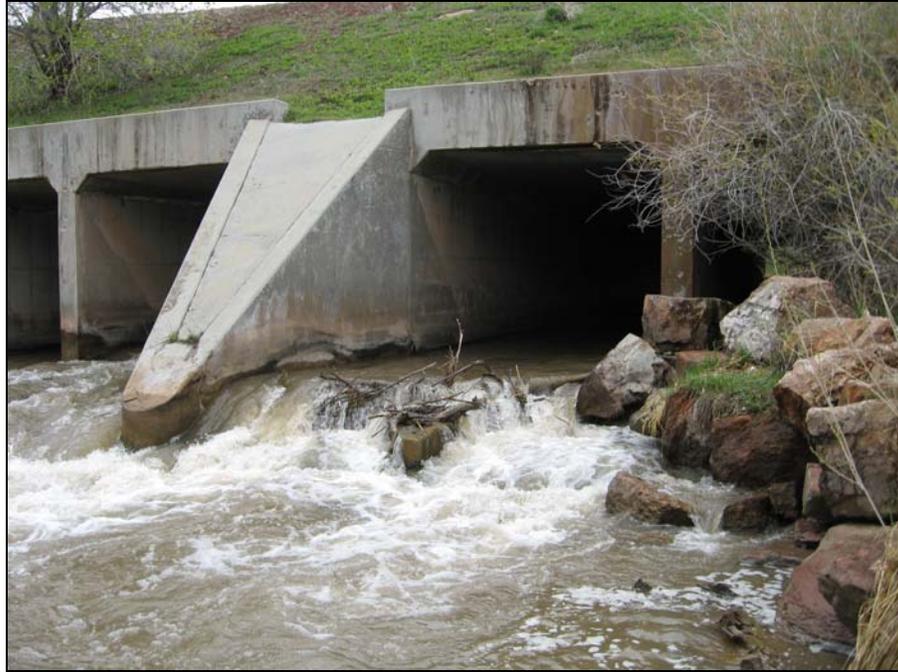
Figure 5-17: Debris Pile at Culvert Outlet

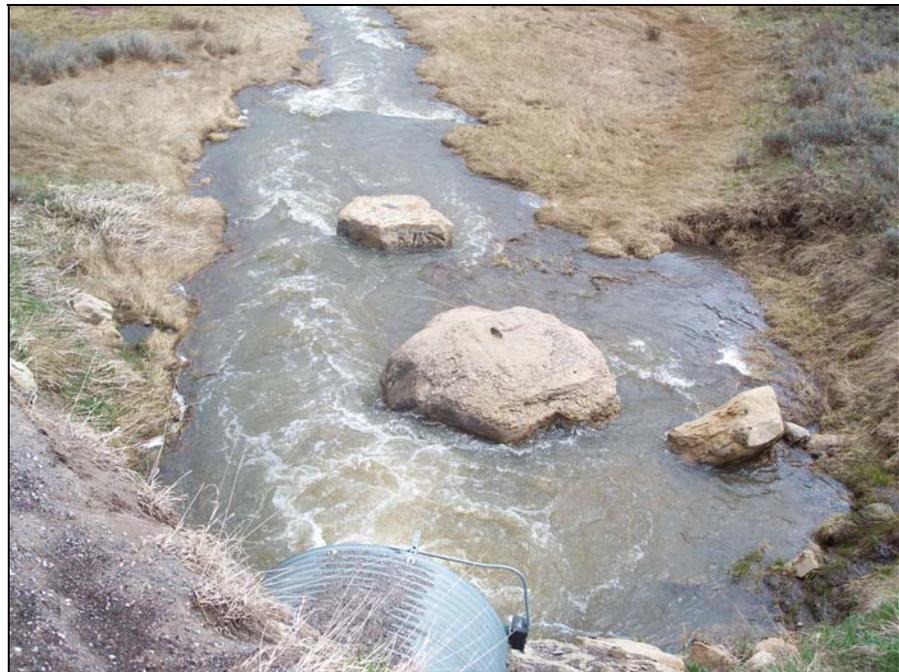
Figure 5-20: Large Boulders Downstream of a Culvert Outlet
