Report No. UT-08.08

FISH PASSAGE AT UDOT CULVERTS: PRIORITIZATION AND ASSESSMENT

Utah Department of Transportation
Research and Innovation Division

Brigham Young University
Department of Civil and Environmental
Engineering

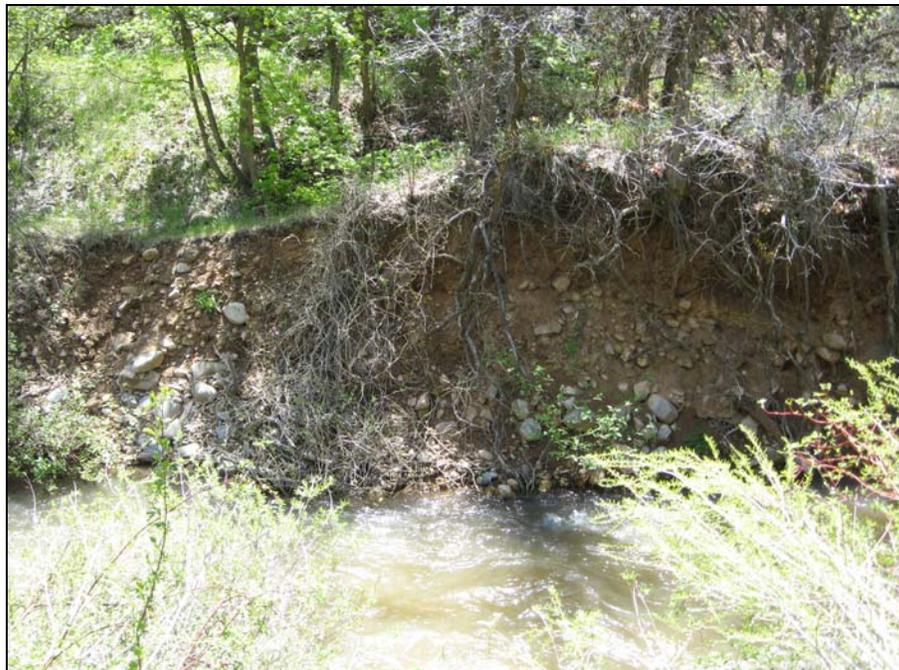
Figure 5-26: Stream Bank Erosion

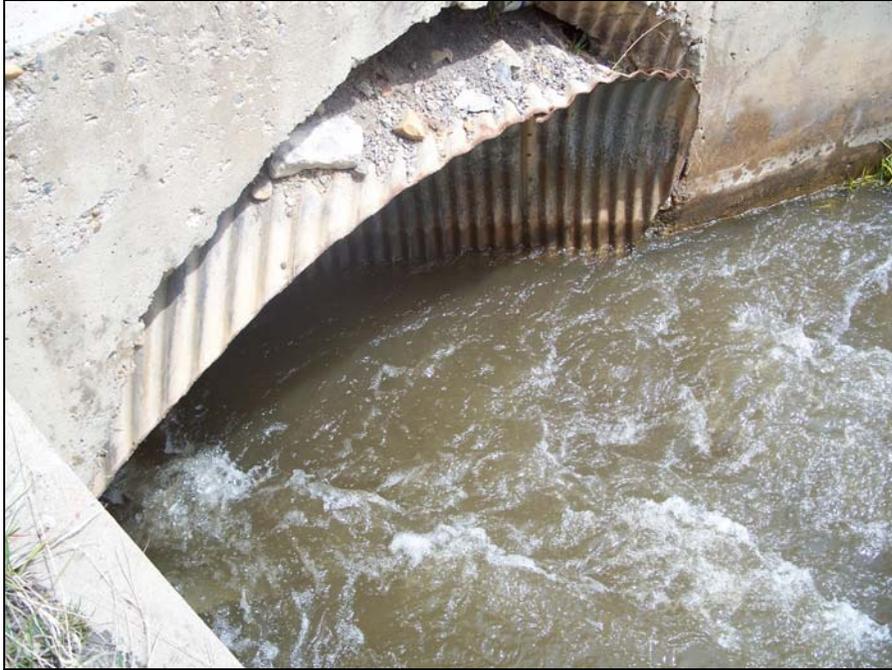
Any failures local to the culvert should be captured with close up photos. Even those failures already captured in previous photos (figures 5-2 through 5-29). Take these pictures from a vantage point which best captures the problem the photo is describing.

Figure 5-27: Culvert Separating from Headwall

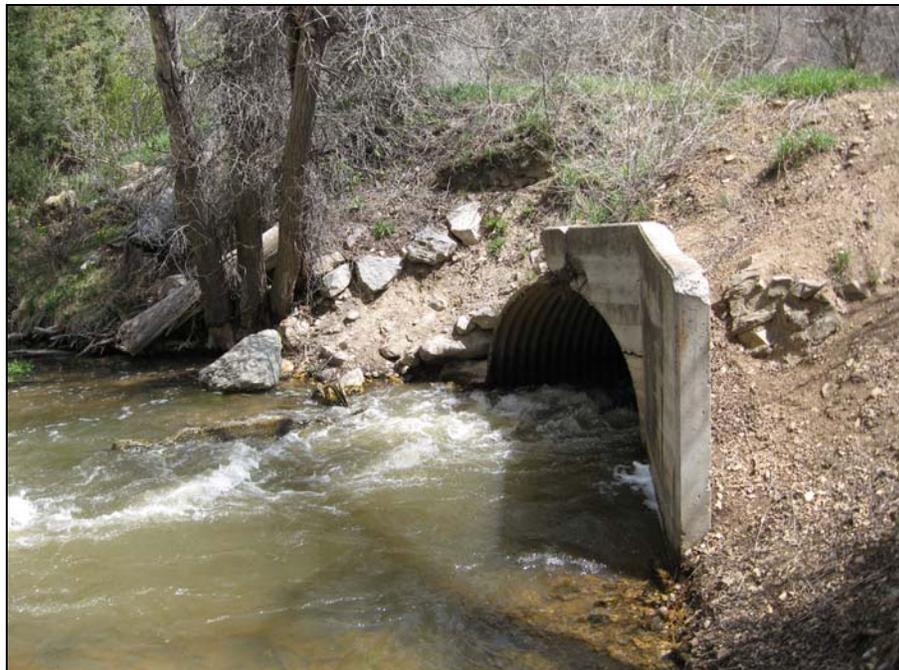
Figure 5-29: Stream Bank Erosion and Failure of a Culvert Headwall

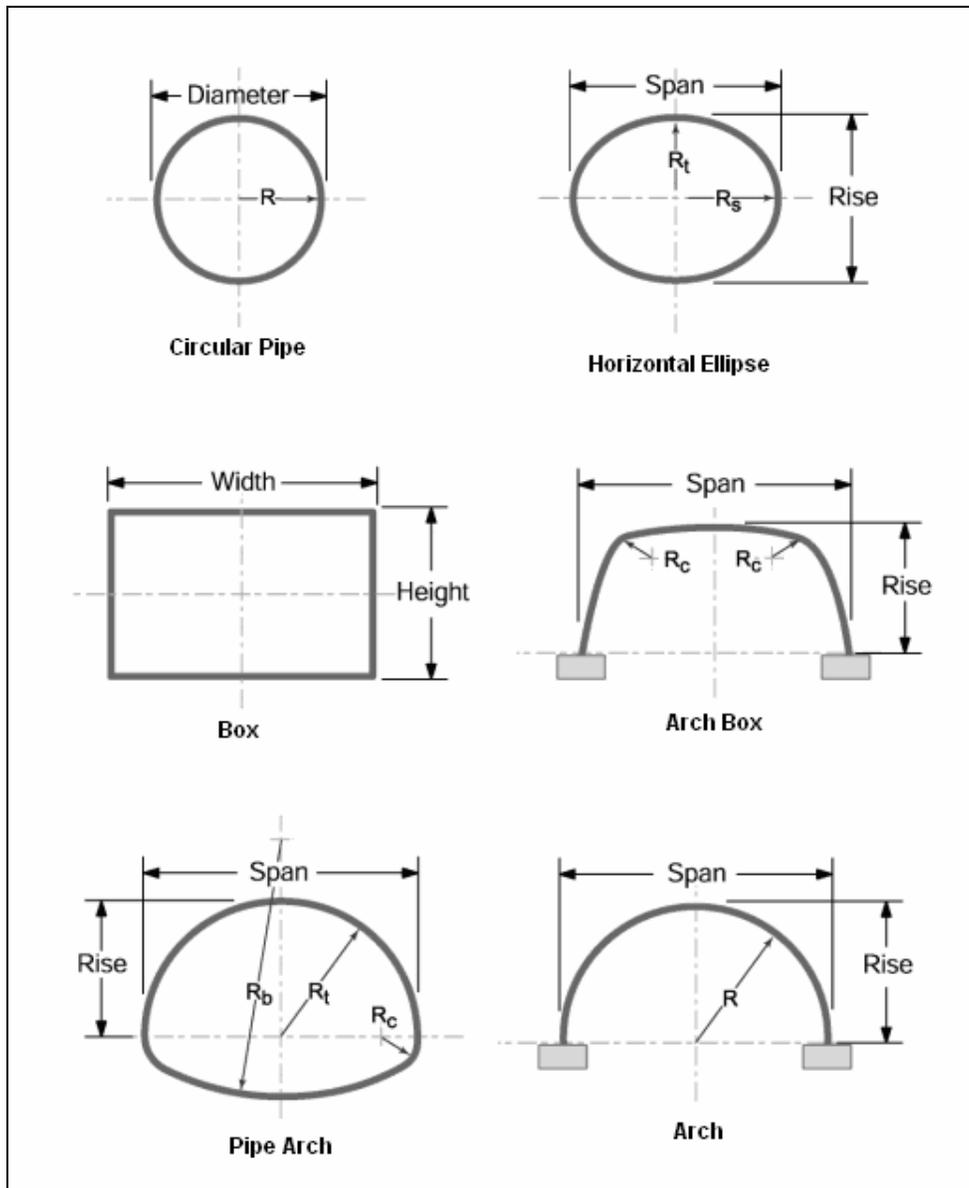
Culvert shapes included in the assessment procedure are contained in figure 5-32.

Figure 5-32: Culvert Shapes (Modified USFS 2006)

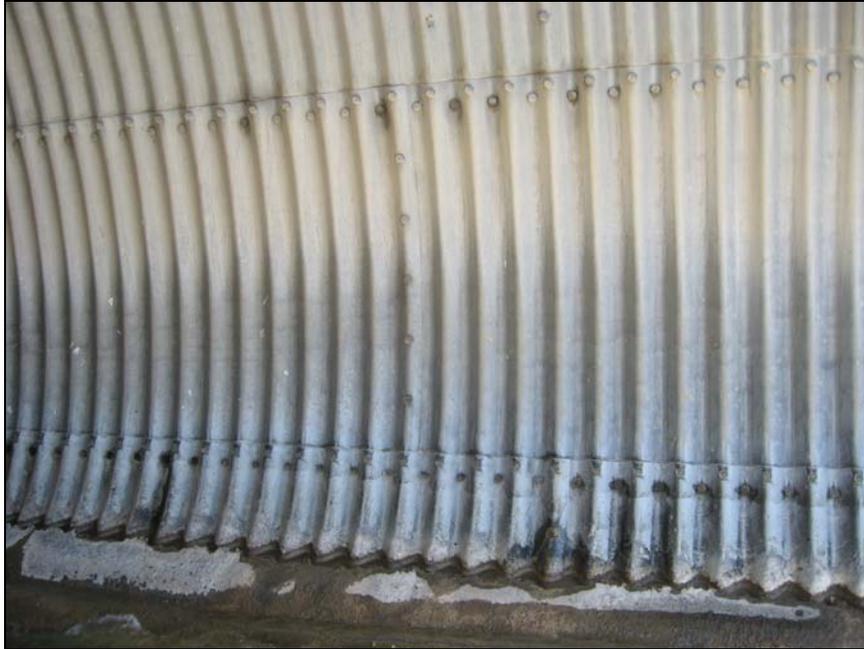
Often large culverts are plated. Plated culverts are identified by the sectional appearance of the culvert wall. These culverts are put together in pieces. Bolts can usually be seen along vertical and/or horizontal lines within the culvert indicating the several sections being bolted together (figure 5-34).

Figure 5-34: Plated Culvert

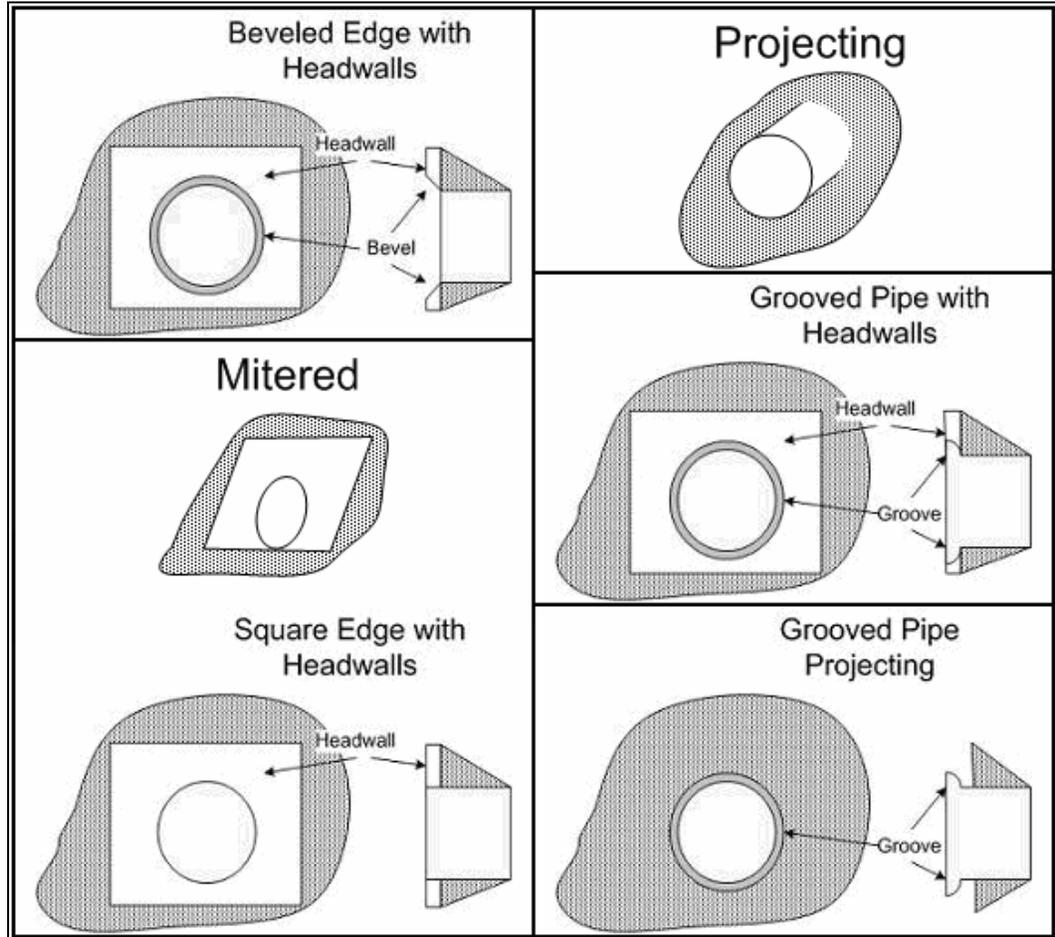
Figure 5-35: Several Inlet Types and Edge Configurations (Modified FHWA 2007)

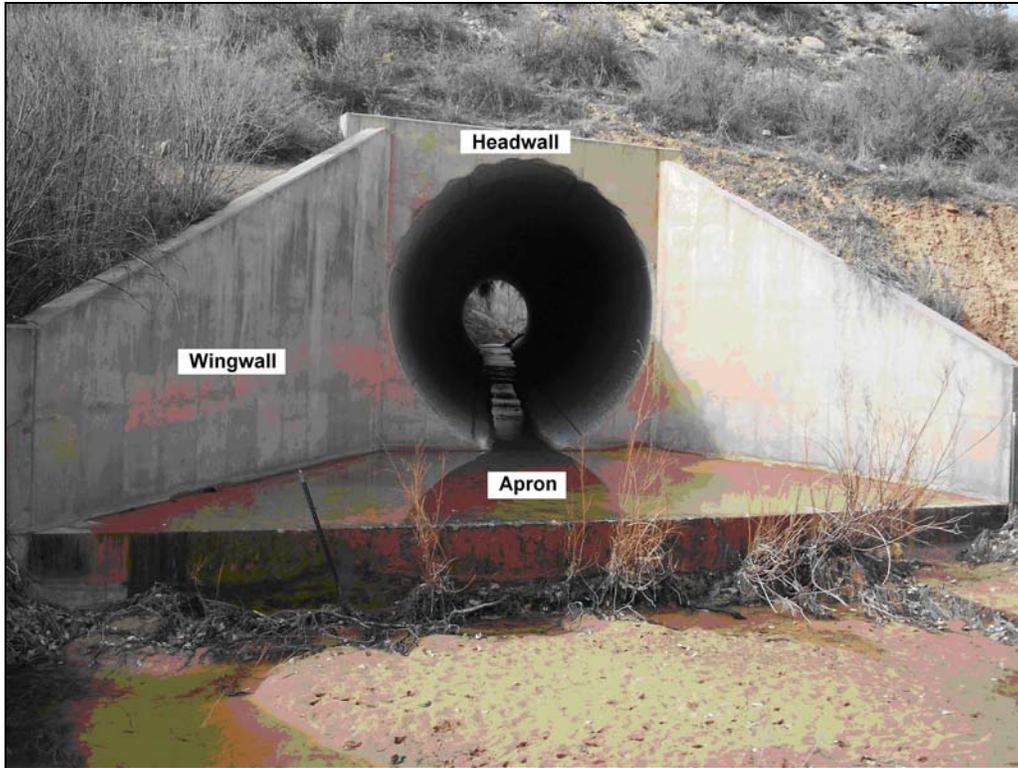
Figure 5-36: Culvert Headwall, Wingwalls and Apron

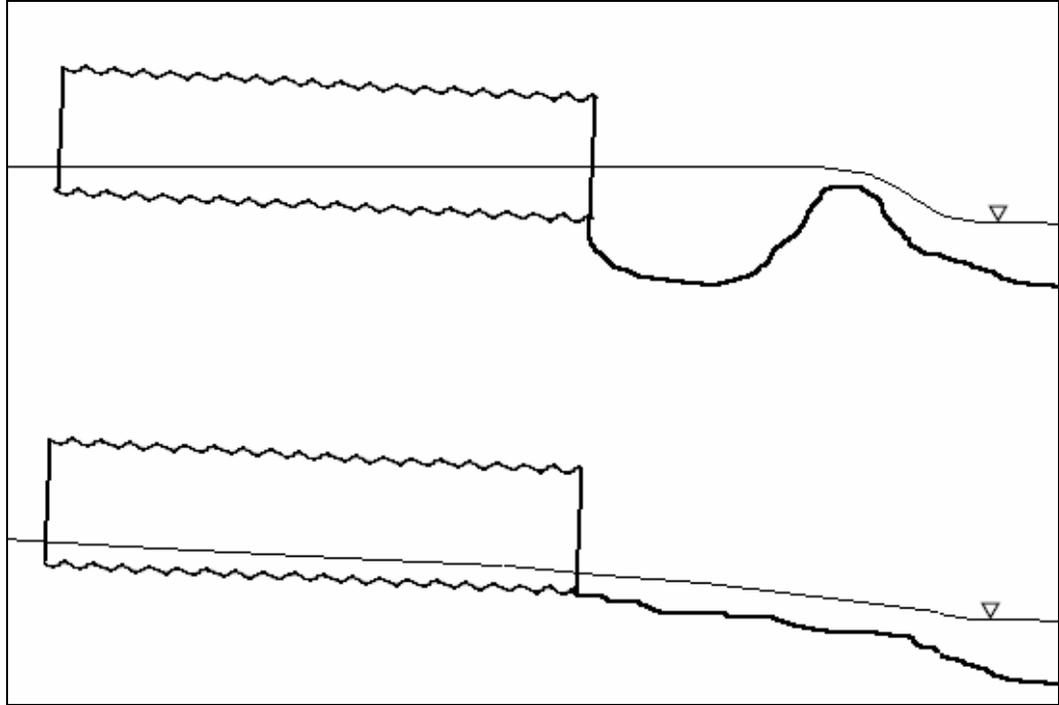
Figure 5-37: Probable Outlet Configurations at Stream Grade

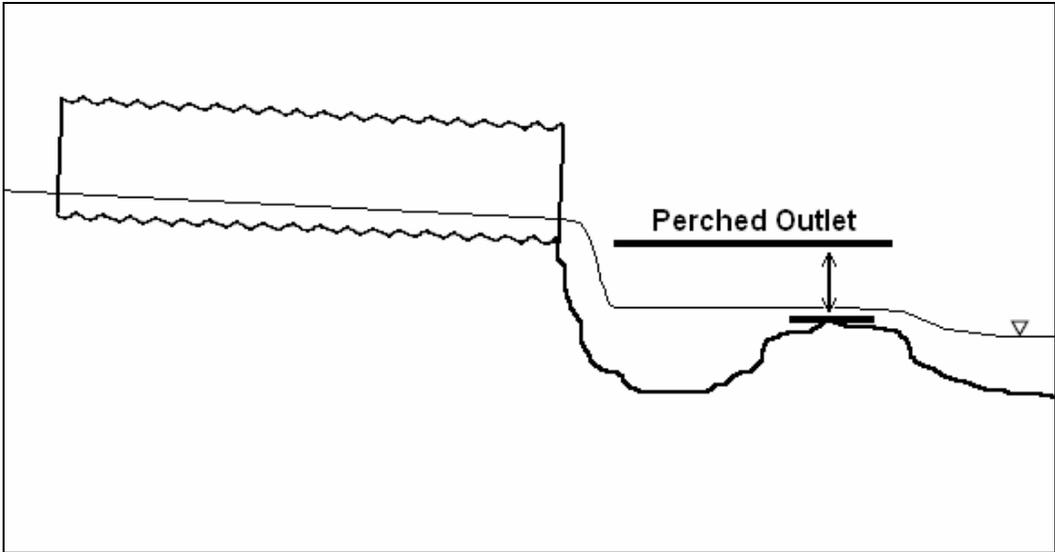
Figure 5-38: Free Fall into Pool or Perched Culvert

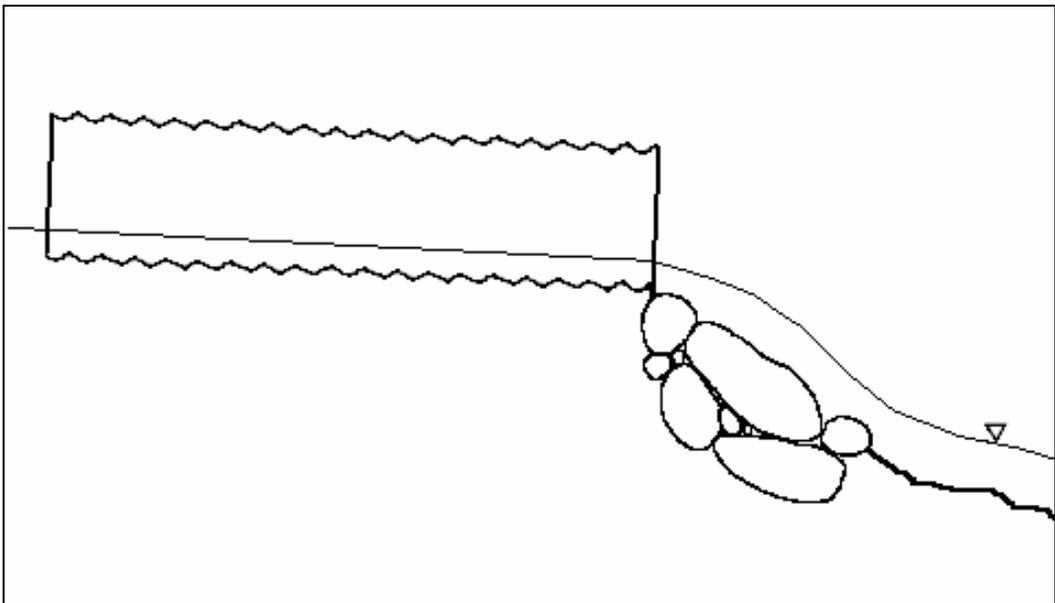
Figure 5-39: Cascade Over Riprap

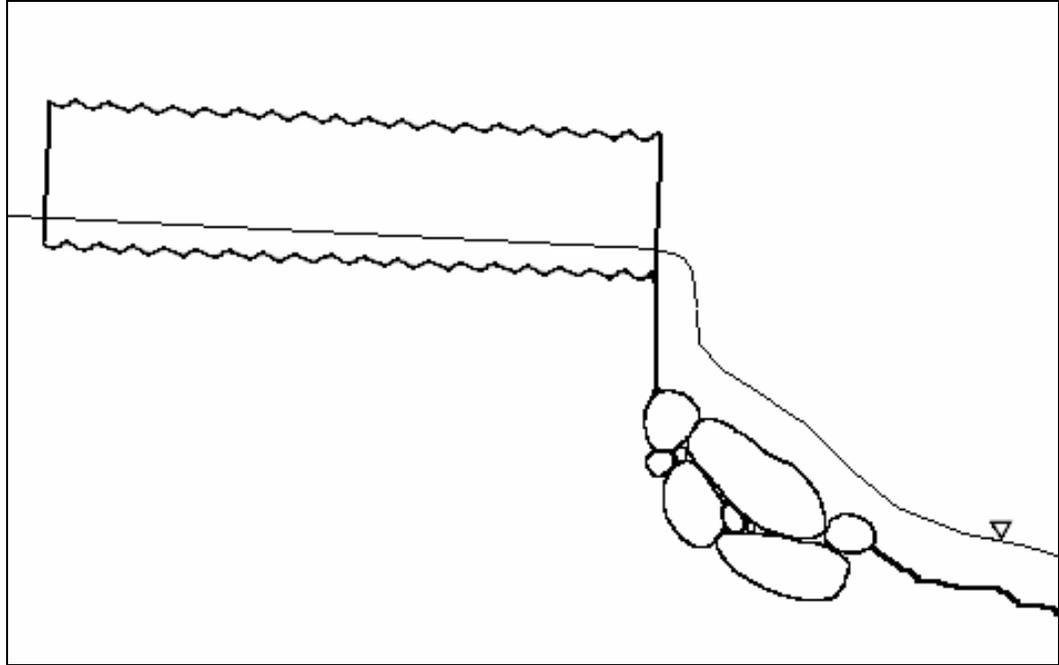
Figure 5-40: Free Fall Onto Riprap

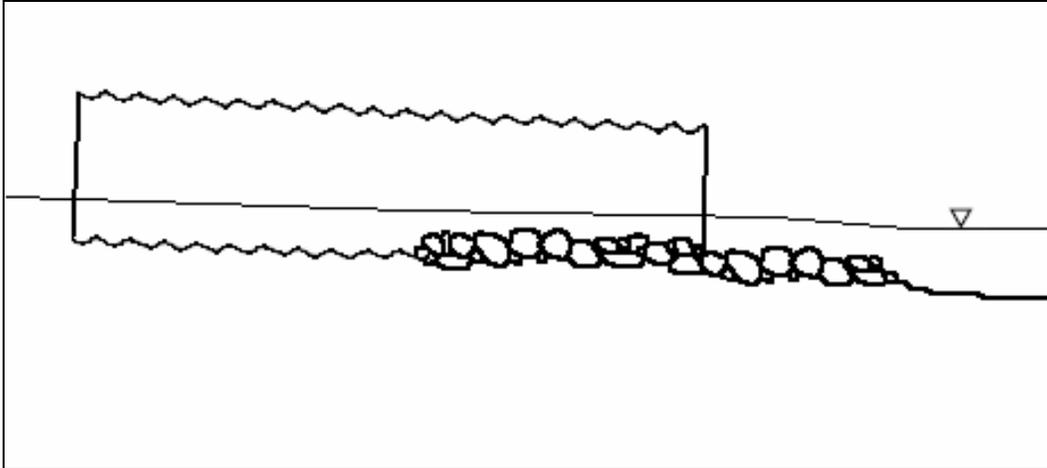
Figure 5-41: Embedded Culvert Outlet

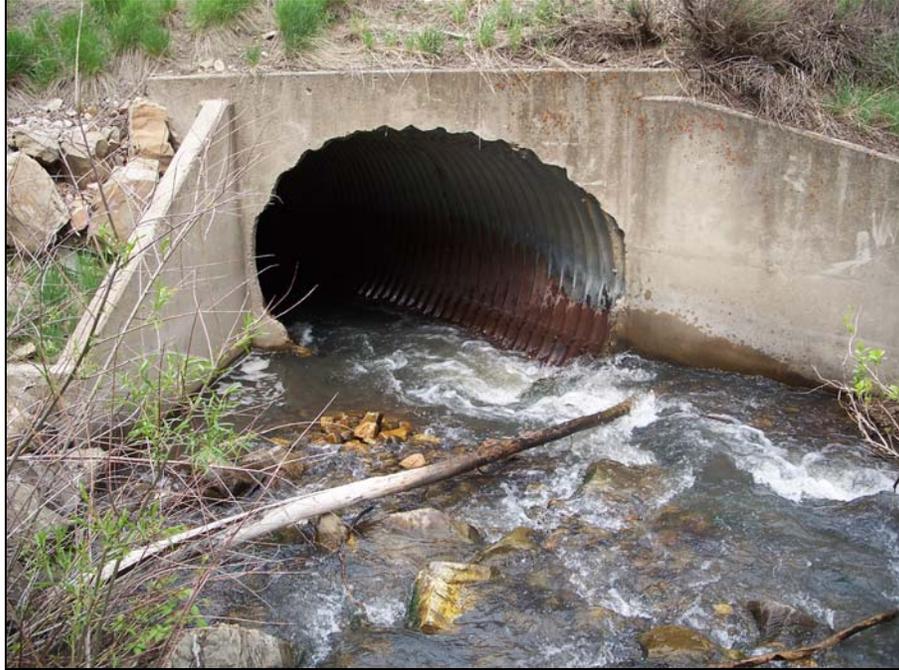
Figure 5-42: Hydraulic Jump Just Upstream of Inlet

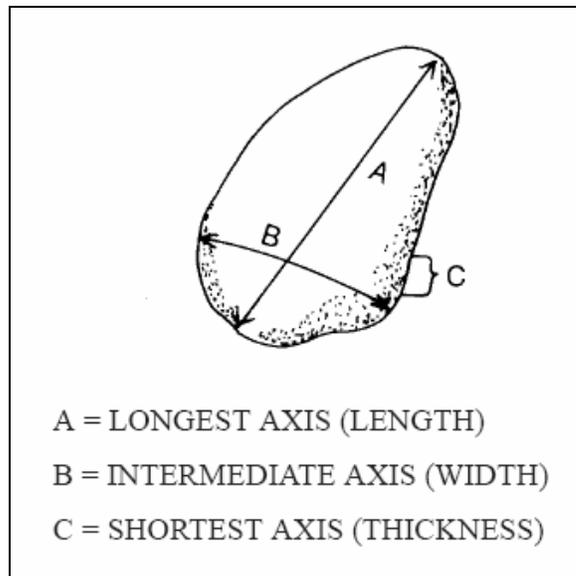
Figure 5-46: Measurement of the Intermediate Axis of Larger Substrate (Harrelson 1994)

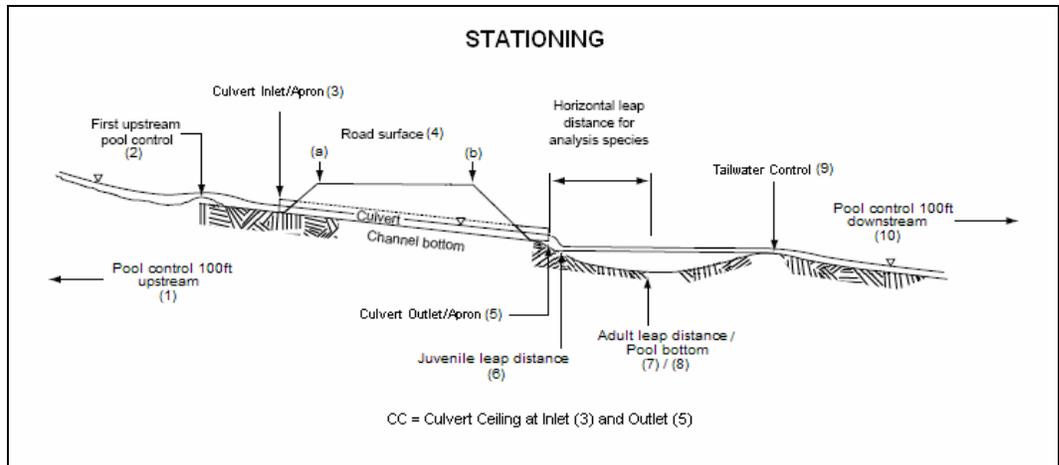
Figure 5-49: Stationing for Longitudinal Profile Survey (Modified Clarkin et. alt. 2003)

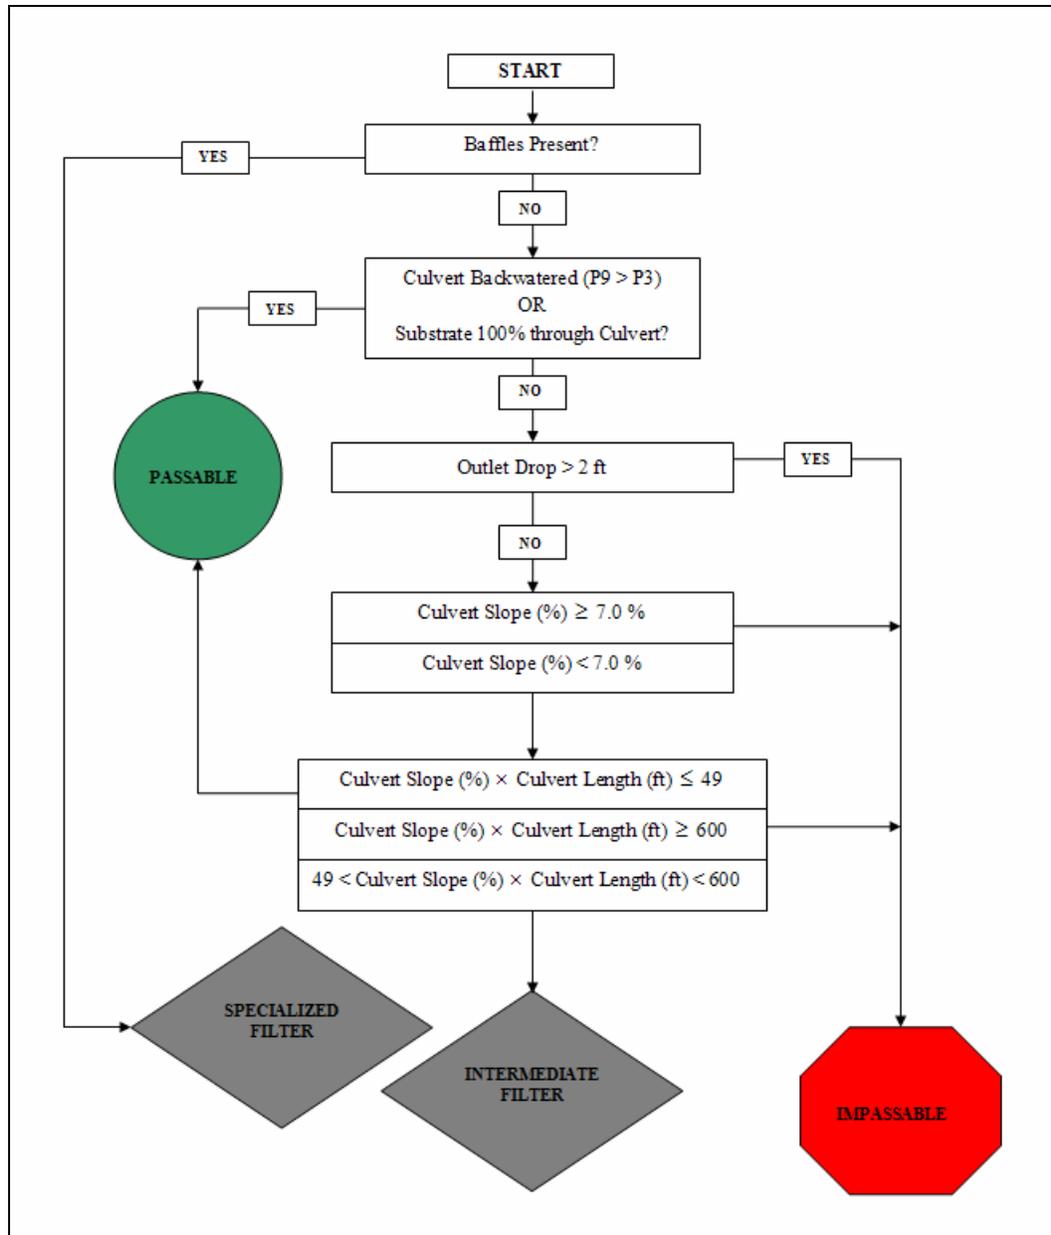
Figure 5-50: UDOT Adult Salmonid Fish Screen (Modified Coffman 2005)

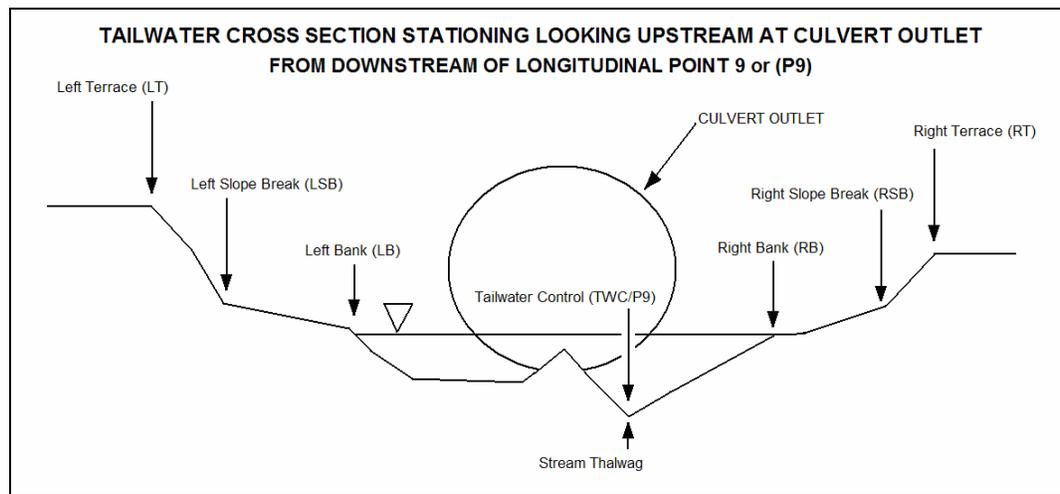
Figure 5-51: Stationing for Tailwater Cross Section Survey

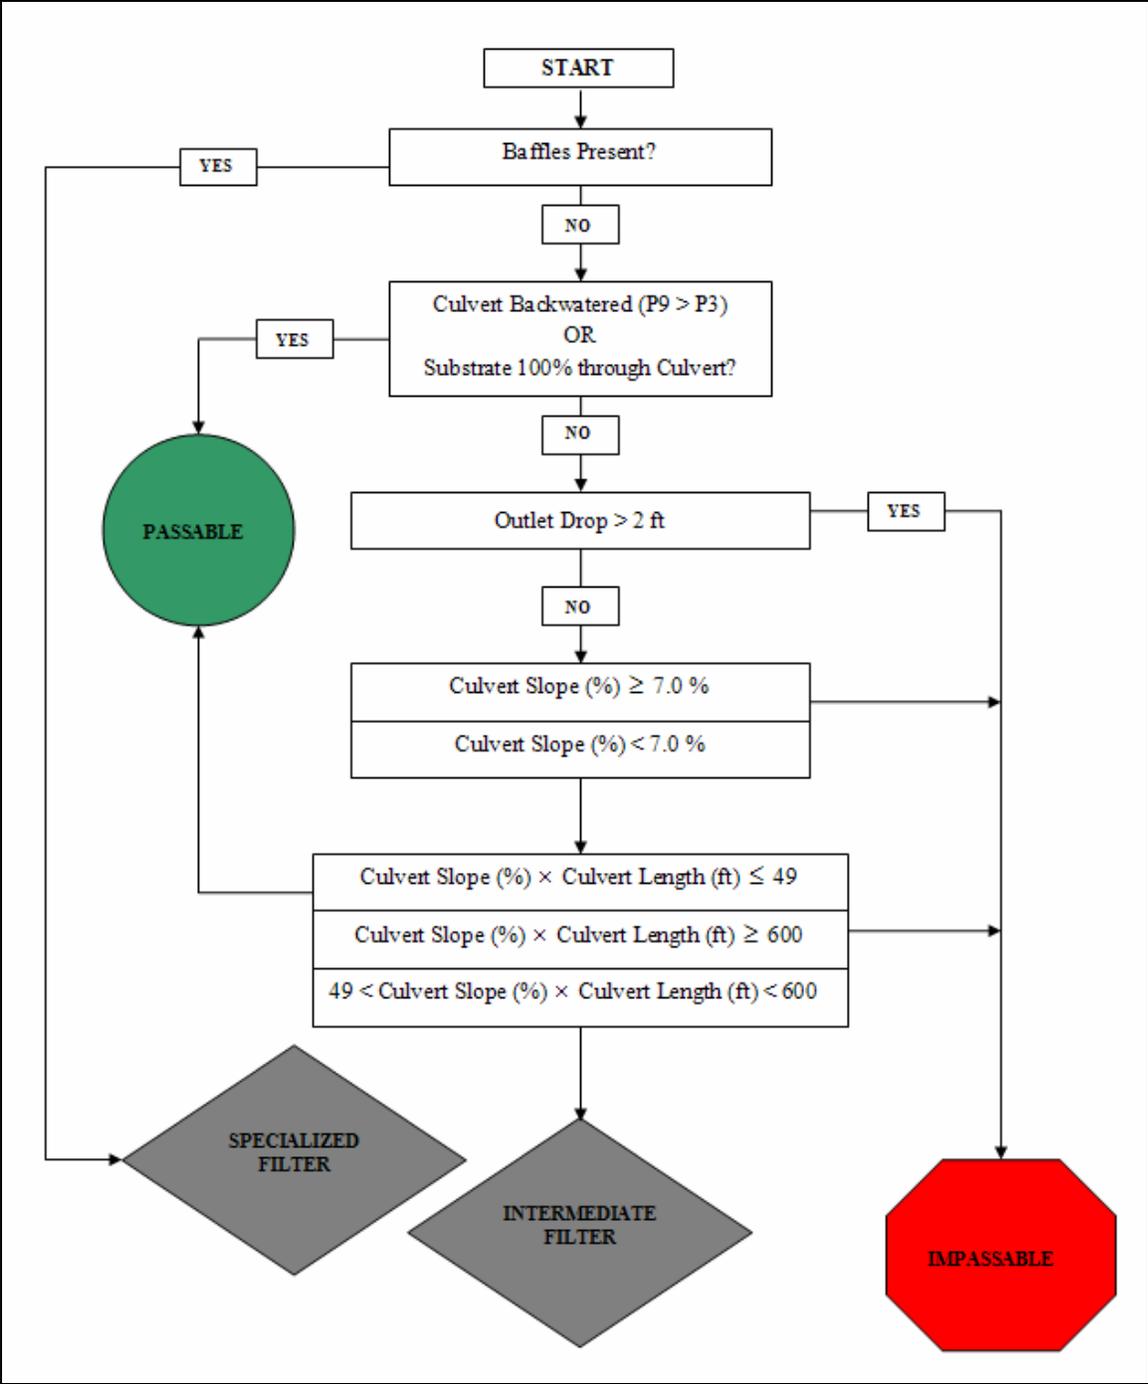
Figure B-1: Adult Salmonid Fish Screen (Modified Coffman 2005)

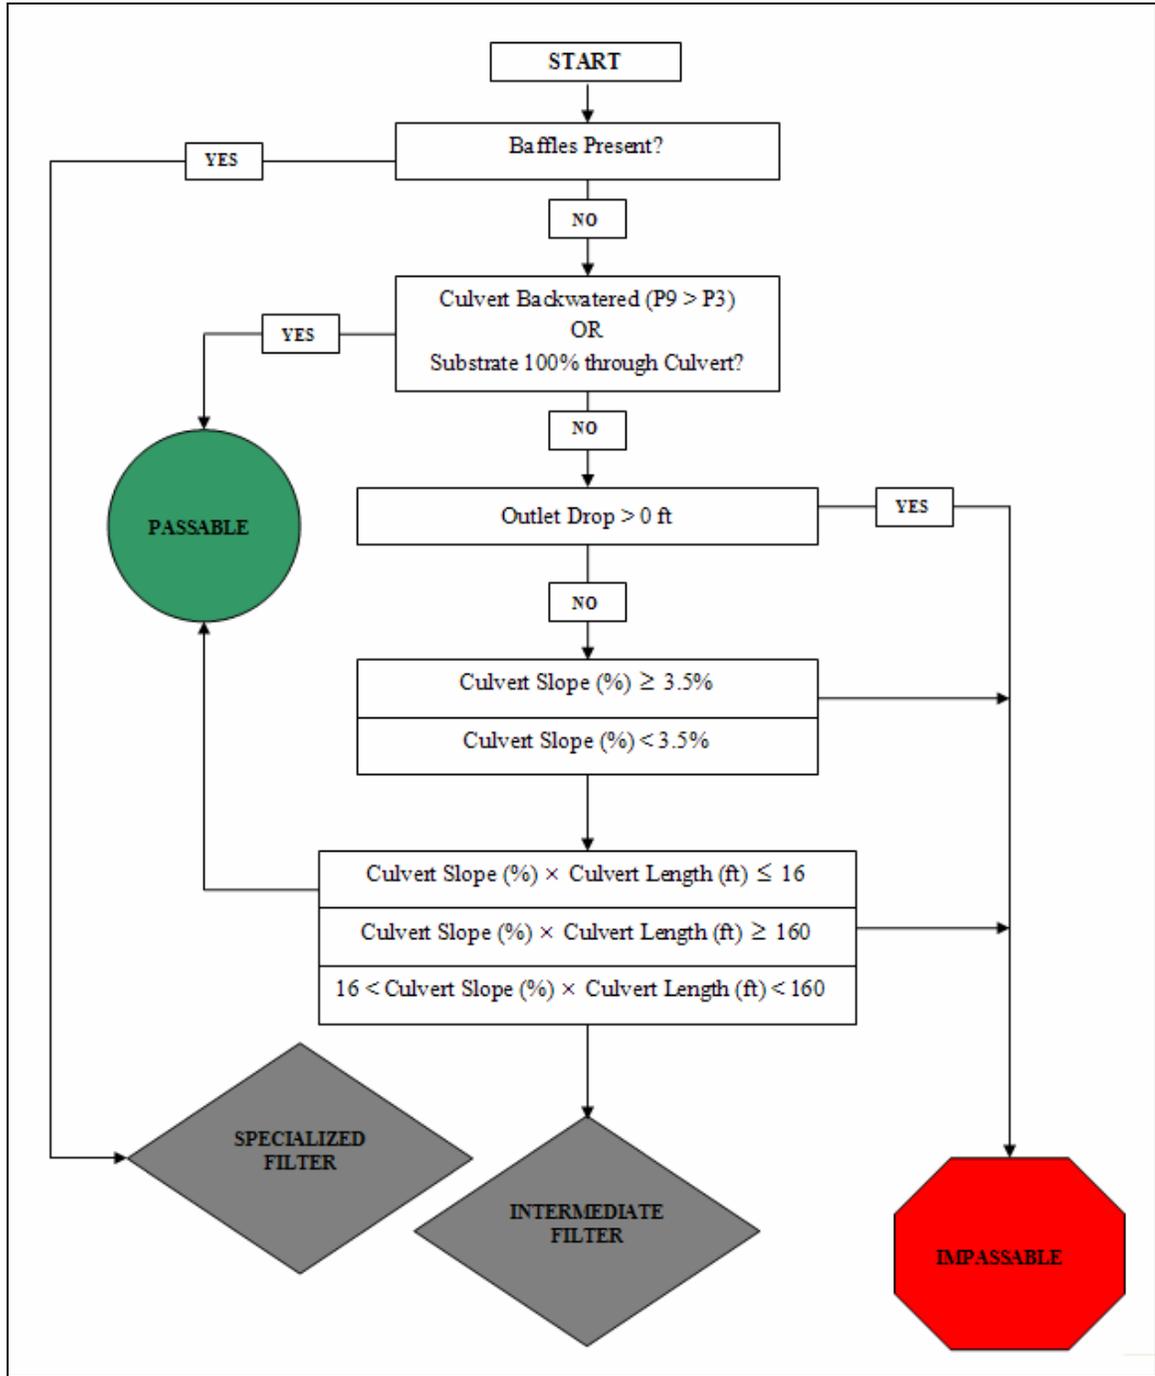
Figure B-2: Benthic Fish Screen (Modified Coffman 2005)

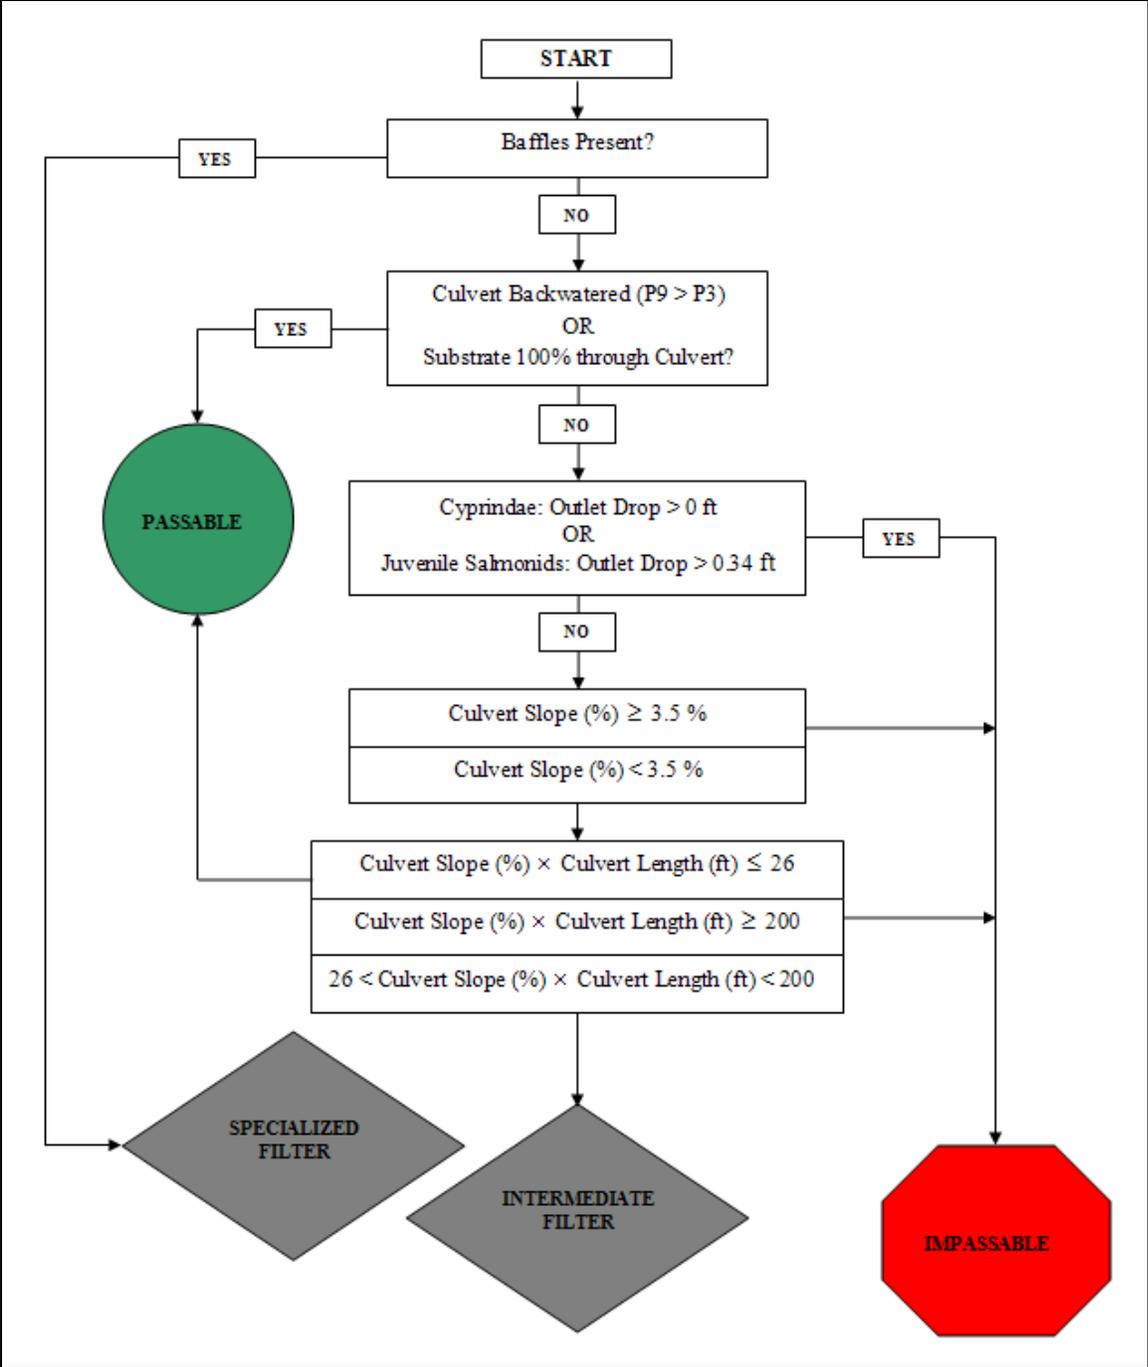
Figure B-3: Young of Year Salmonid and Cyprinidae Fish Screen (Modified Coffman 2005)
