UTAH DEPARTMENT OF TRANSPORTATION SALT LAKE CITY, UTAH STRUCTURES DIVISION			
SR-163 AT MEXICAN HAT SAN JUAN RIVER BRIDGE REPAIR DETAIL			
DESIGN	ABBY 3-88	CHECK	
DRAWN	M.U.S. 3-88	CHECK	R.L.R. 3-88
QUANT.	R.L.R. 3-88	CHECK	ABBY 3-88
APPROVAL	4/12/88	DATE	
RECOMM.		DATE	
PROJECT NUMBER			25+42.1
DRG. NO.			C-274 RI
SHT. 1 OF 1

Special Attention Items:	Notes:
Other	Bridge is on a 6-month special inspection cycle due to superstructure NBI rating of 4 and also containing fracture critical members. A defect plan was created from the defects found at the previous special inspection. Tables showing defects by element were also created. Verify the defects indicated on the plan and tables. Mark the end of the cracks with a sharpie pen and/or a steel punch and indicate the date with a sharpie pen. UDOT materials will be on-site to provide NDT of the known cracks to check for crack propagation. If time permits, check stringer to floor beam connections for cracks using mag-particle testing. For purposes of orientation, proper picture labeling and defect locating, label each floor beam in accordance with the naming shown on the defect plan. Consider also labeling the east and west ends of eac

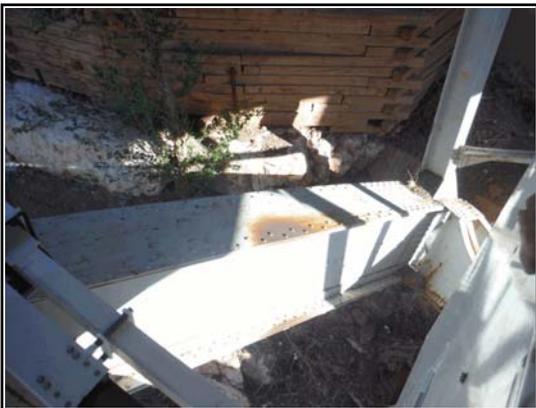
arch1 at fb0n-1n

03/07/2016 Travis Jones On the eastern arch at the north side between FB0N and FB1N there is packrust beginning to form on the bottom flange of the arch. Rust freckling is beginning to form throughout the arches, and paint is beginning to flake and chip throughout the arches.

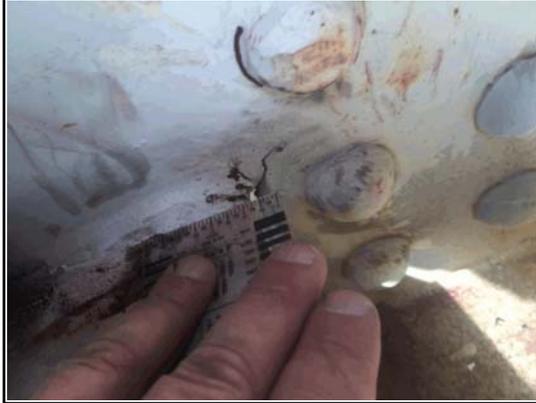
arch1-fb2n s_cxn plate

FB2N: on the east side there is a crack in the floorbeam to arch connection plate. On the west side there are two cracks in the floorbeam to arch connection plate (0.75in long 0.013in wide on the "up -hill" side of the arch, 0.5 in long 0.023 in wide on the "down-hill" side of the arch)

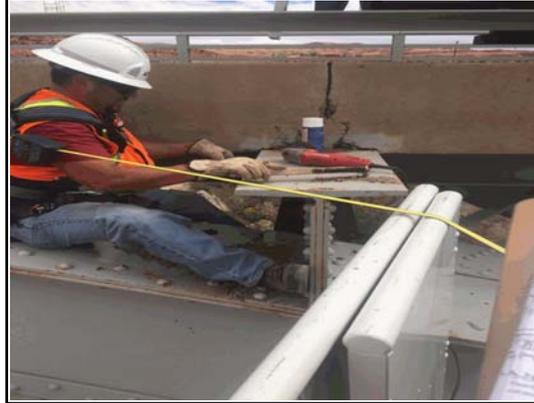
mag particle testing

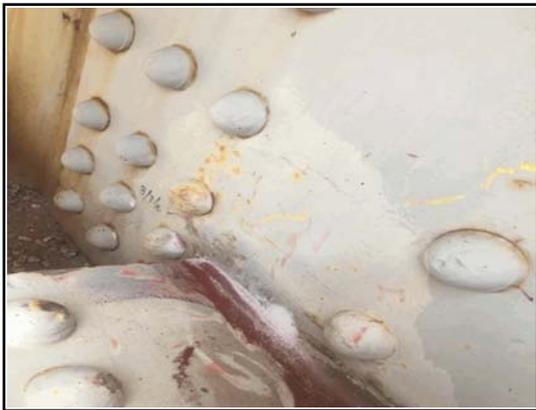
arch1-fb2s n_cxn plate

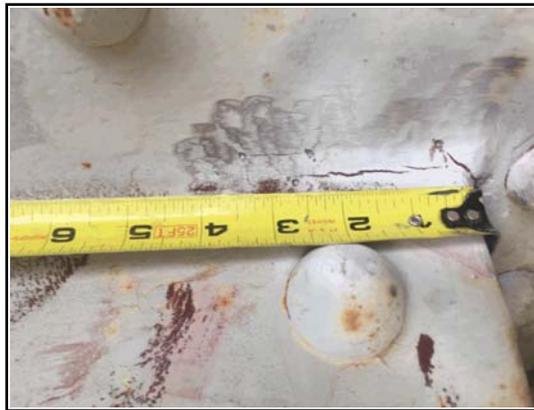
arch1-fb2s s_cxn plate

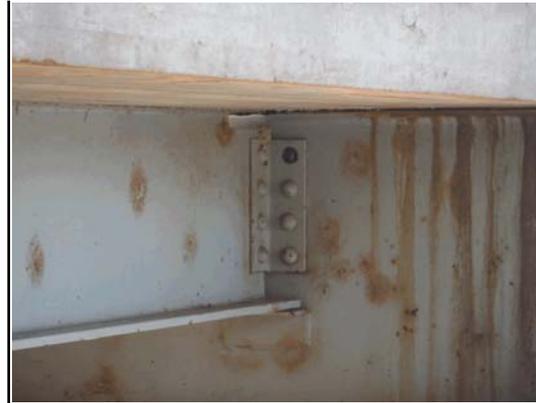
stringer1 @ fb2n-1n msg rivet

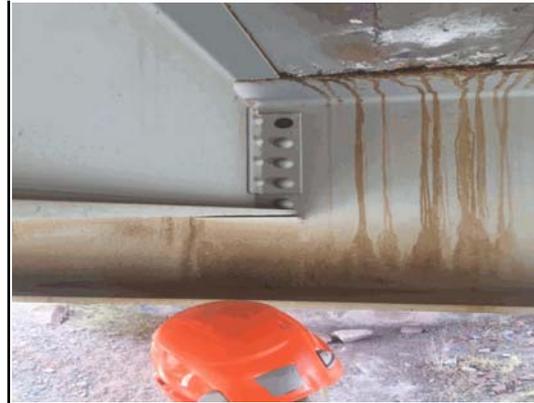
stringer2 @ fb0s msg rivet

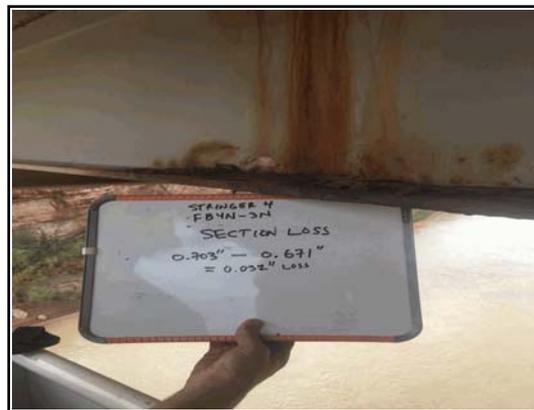
stringer4 @ fb4n-3n

Topside of the lower flanges have moderate rusting in most of the outside stringers (stringers 1 and 4). Stringer 4 between FB0N and FB1N has approx. 4 ft. of heavy pack rusting that has extended up in web. Rusting in some of the top flanges near the floor beam.

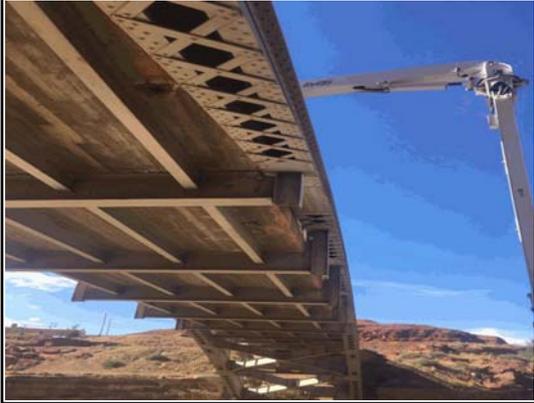
08/11/2015 Clint McCleery 08/11/15 CLM Underside of the deck is in good condition. Underside of the overhangs have spalling and delamination around most of the deck drains. No major transverse cracking or longitudinal cracking in the underside of the deck. Outside edges of the deck over all the floor beams have minor spalling the full width of the top flange and some exposed rebar and moderate efflorescence. Inside face of both curbs have some minor spalling in random locations. Sounding of the curbs are showing some minor delams on the inside face in random locations. Topside of the curbing is in good condition, only some minor scaling in a few locations. Topside of the deck is covered with asphalt overlay (looks more like a chip seal). Deck NBI was raised to a 6.
